# THE TECHNOLOGY OF BUILDING DEFECTS

John Hinks  
Geoff Cook

# Defects with materials

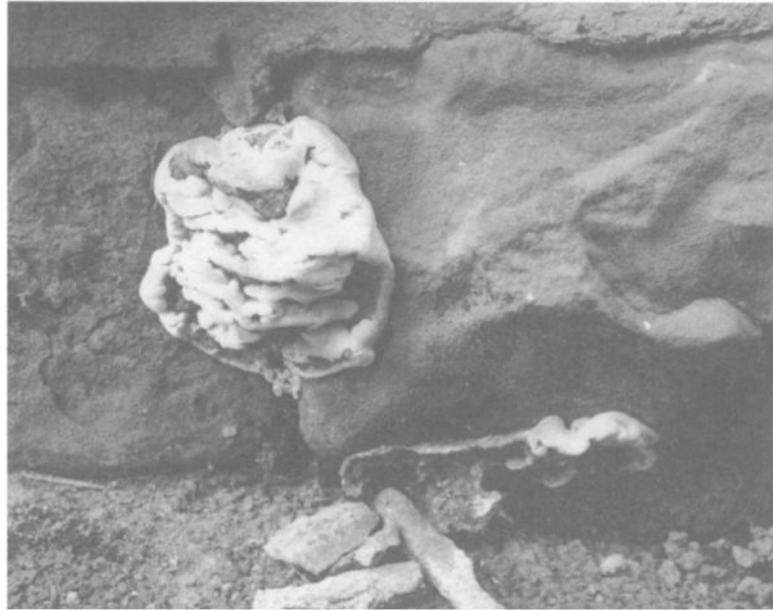
**Fig. 1.1.** The possible organic attack of stonework or of other material behind the stonework. Fruiting bodies may develop away from the direct region of attack. (S.D.McGlynn.)

There are also problems associated with the bacteria, algae, fungi and lichens commonly present on the stone surface. Some of the bacteria have the ability to convert the sulphurous and nitrous acids from environmental pollution to sulphuric and nitric acids, which can be more damaging to the stone.

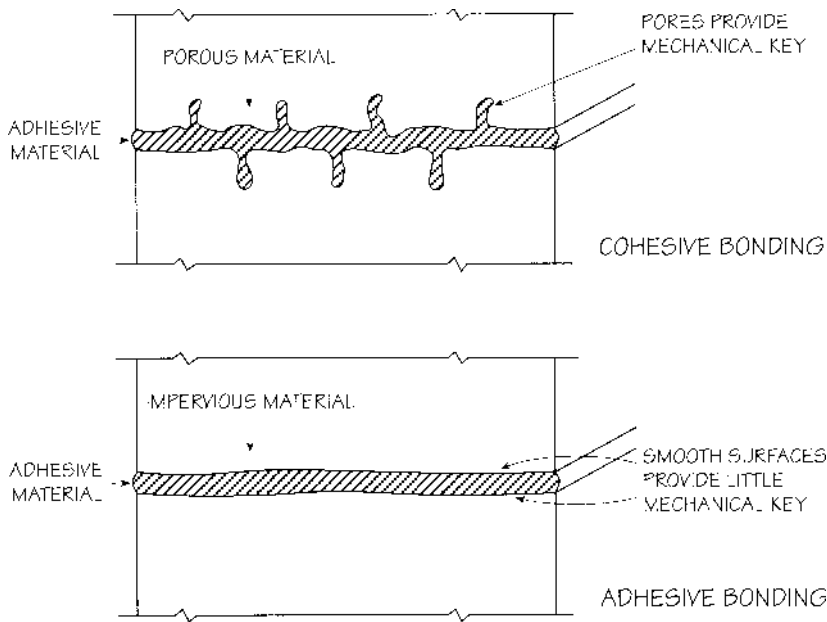
**Fig. 1.2.** Adhesive and cohesive bonding.

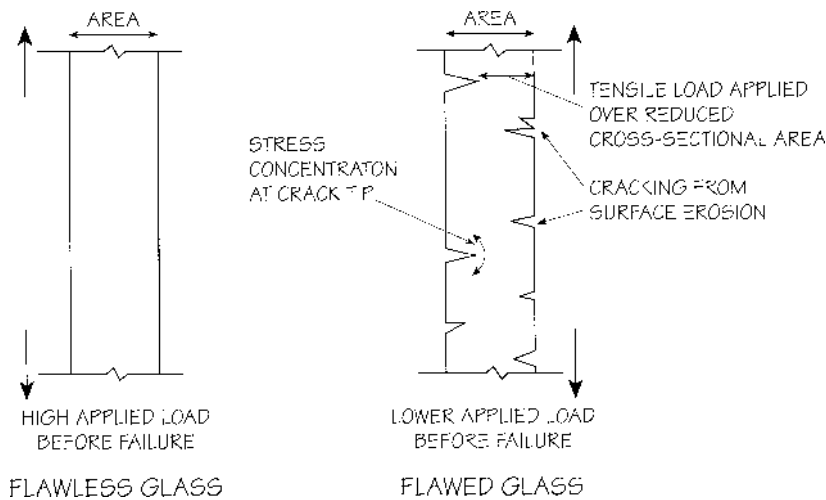
**Fig. 1.3.** Effects of flaws on the strength of glass.

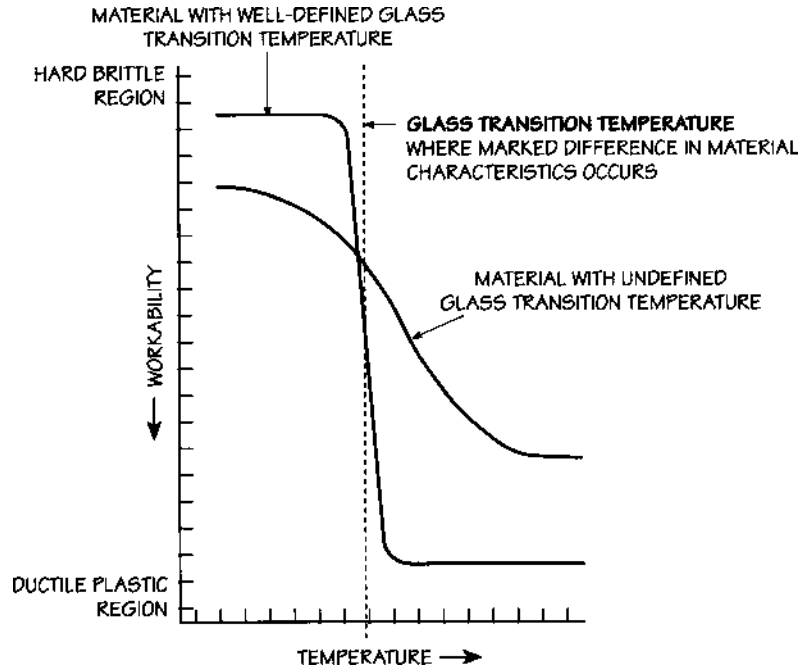
**Fig. 1.4.** The general physical property changes associated with the glass transition temperature zone.

The glass transition temperature ( $T_g$ ) identifies a point at which the physical properties of plastics change. Below  $T_g$  the plastic can be considered brittle and solid, whilst above  $T_g$  it can be considered a viscous

liquid. There is, unsurprisingly, an intermediate state somewhere between the two. This is the region where elastomeric properties exist. These materials are used for movement joints, isolation and bridge bearings. Since only crystalline materials exhibit well-defined melting points it follows that the degree of crystallinity of plastics varies considerably. Where plastics are used outside their recommended temperature range, then their physical properties will no longer match the performance requirements. A brittle or plastic failure may occur.

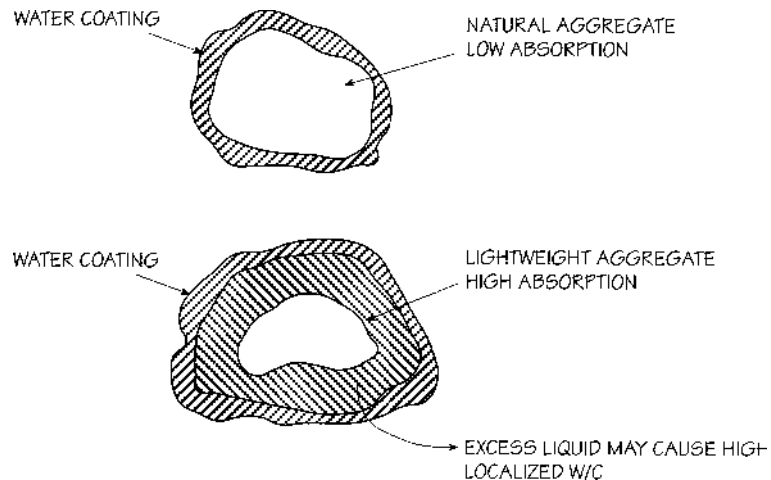
**Fig. 2.1.** Aggregate: water absorption effects.

The absorption rates of some types may be high and variable; this in turn can lead to high moisture contents as the voids within the aggregate fill with water. Since there is an increased need to correct the w/c at the mixer there is also the risk of variation in the actual w/c used in the mix.

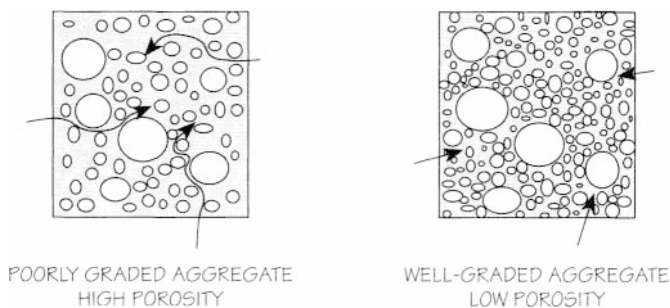
**Fig. 2.2.** Aggregate: effects of grading.

Where aggregates have a non-uniform grading there is an increased risk of voids in the concrete. Although there can be the advantage of increased workability when the 5 mm to 10 mm aggregate size is omitted, there is an increased risk of segregation. Where aggregate gradings are not consistent in

all the concrete mixes the workability, compressive strength, quality and appearance are likely to be equally variable.

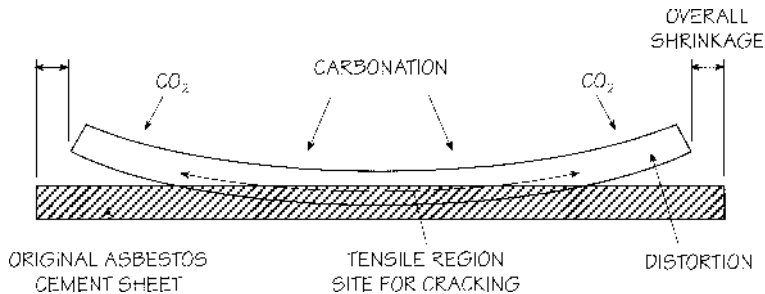
**Fig. 2.3.** Carbonation distortion of asbestos cement sheet.

Carbonation will cause embrittlement of the surface, as with other cementitious materials. Carbonation also causes shrinkage and this will interact with the expansive effects of moisture. In this way long-term exposure results in overall shrinkage. Carbonation can therefore reduce the strength of asbestos with time, perhaps as much as a 50% reduction. Differential carbonation effects can occur on the surfaces of sheets. This may occur across the thickness of sheets or over different parts of the same side of a sheet. Either effect can cause sheet distortion.

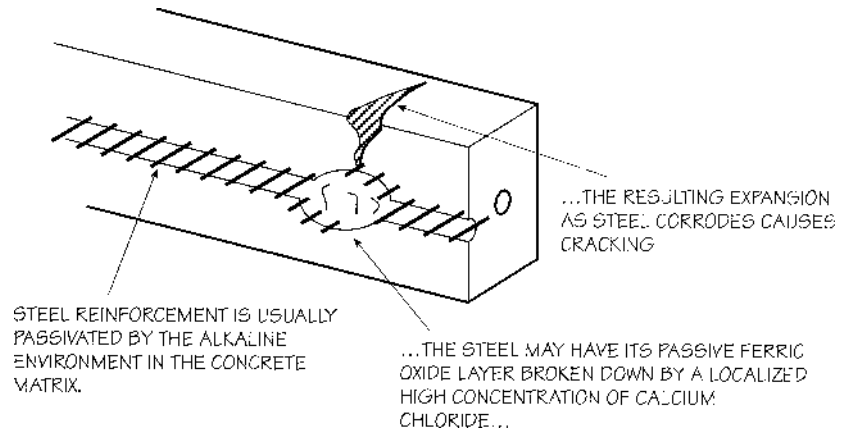
**Fig. 2.4.** Chloride attack in reinforced concrete.

The attack mechanism operates as the presence of chloride ions increases the electrical conductivity of the pore water, so creating a corrosive current which accelerates the dissolution of the iron in the steel reinforcement. The result is a localized, severe pitting corrosion of the steel, leaving it notched and brittle. Failure may be sudden. The expansion of the corroding steel produces bulging or cracking of the concrete and rust staining may appear at

the surface of the concrete. The localized nature means that the cracking is usually isolated and wide. Chemical tests may be used to establish the presence and concentration of chloride ions in concrete.

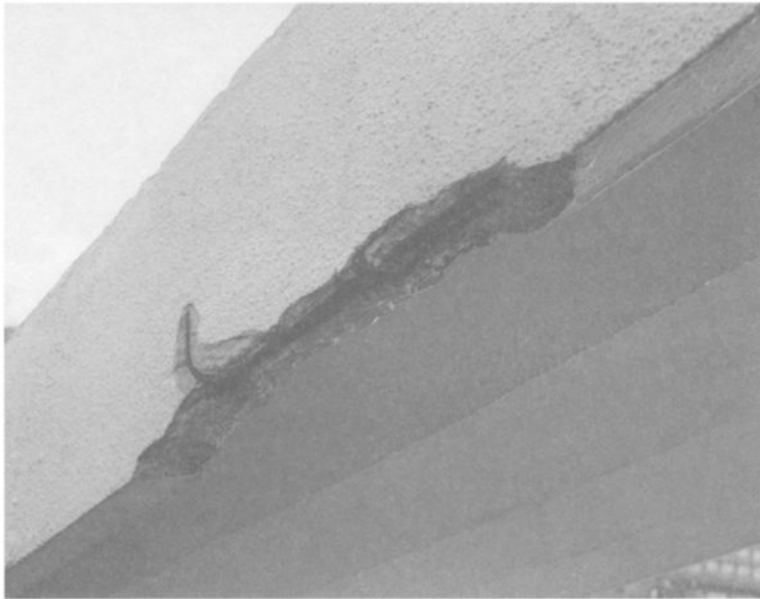
**Fig. 2.5.** Corrosion of buried reinforcement. Carbonation, due to the poor cover of the reinforcement, is a contributing factor. (University of Reading.)

The second problem arises with reinforcement steel, although it may produce the first obvious symptoms. If the carbonated zone penetrates to the depth of the reinforcement steel, the acidification of the bonding concrete leads to accelerated rusting. This may be distinguishable from other causes of rusting because of its uniformity. The expansion tends to produce a hairline crack along the line of reinforcement, often extending along its whole length. Obviously, the depth of reinforcement cover is critical. Predictably, thin or highly exposed components with minimal cover suffer most.

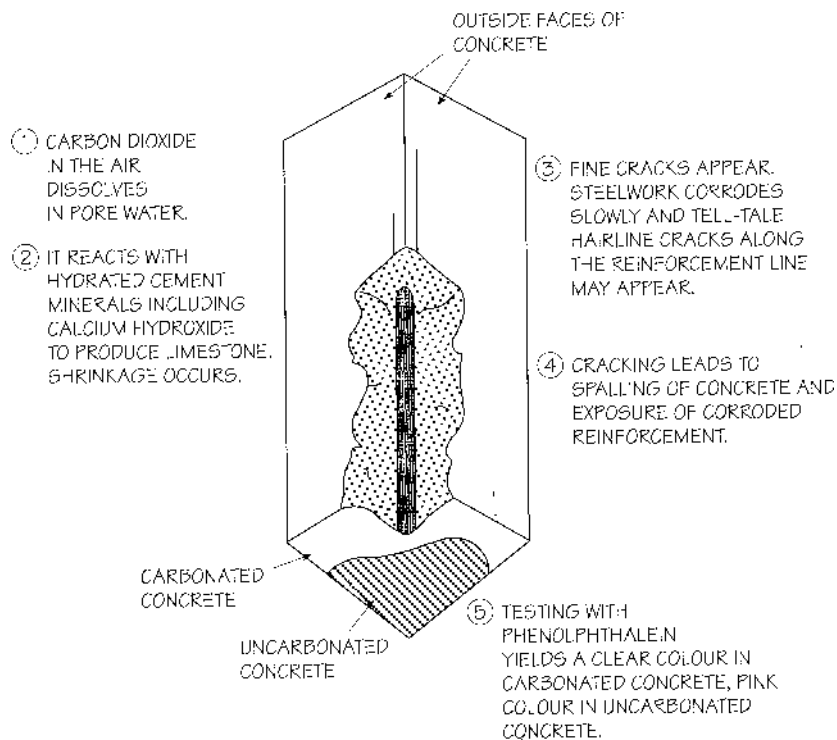
**Fig. 2.6.** The process of carbonation of concrete.

The reaction takes place near the surface in the pores of the concrete and produces two related problems. First, the carbonated concrete shrinks, which can further increase its porosity and hence its susceptibility to attack generally.

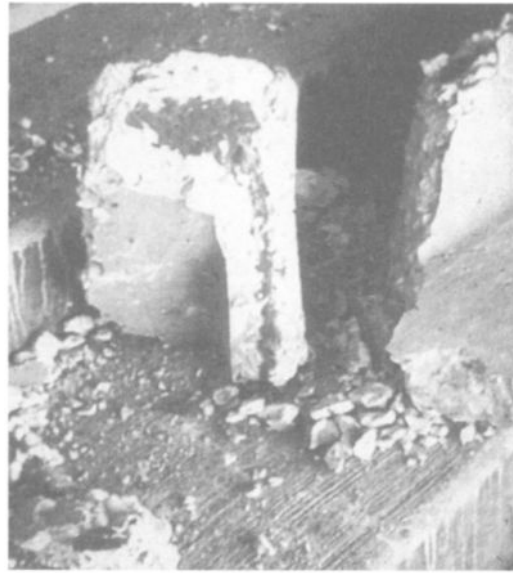
**Fig. 2.7.** The result of a phenolphthalein solution test on a fragment of concrete to establish the depth of carbonation.

The depth and extent of carbonation can be confirmed with a straightforward test using manganese hydroxide or phenolphthalein solution. The reaction of phenolphthalein with uncarbonated cement leaves a pink indicator. In contrast, carbonated cement does not respond and so remains clear. A cover meter will establish the reinforcement depth across any undamaged parts of the concrete.

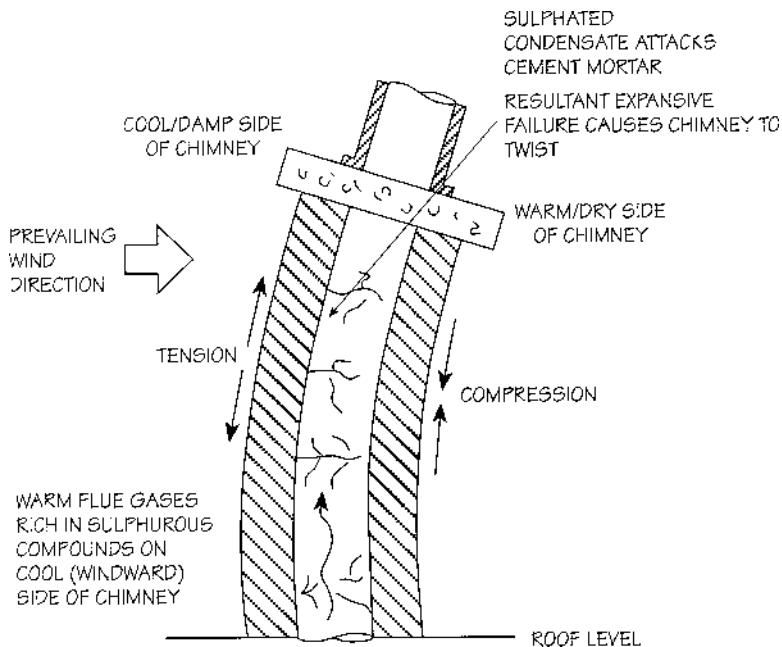
**Fig. 2.8.** Example of sulphate attack of a chimney.

If there is a high concentration of salts, and the presence of moisture, then sulphate attack of the mortar is likely to occur. The mortar is required to be wet for reasonably long periods if the reaction is to progress effectively, hence attack is usually limited to exposed details, such as parapets and chimneys. The sulphated solutions react with the tricalcium silicate compound in the cement mortar, producing calcium sulphoaluminate. Mortar may whiten and brickwork will swell, with individual bricks bursting.

Early symptoms include horizontal cracking in the joints between courses, as the expanding mortar creates an increase in the height of the wall. This will be reflected through any rendering, with vertical and (predominantly) horizontal cracking preceding detachment and allowing water retention, which will accelerate the sulphate attack. Total expansion may amount to 50 mm for a two-storey house, perhaps accompanied by oversailing at the corners of the building. In cavity walls the expansion

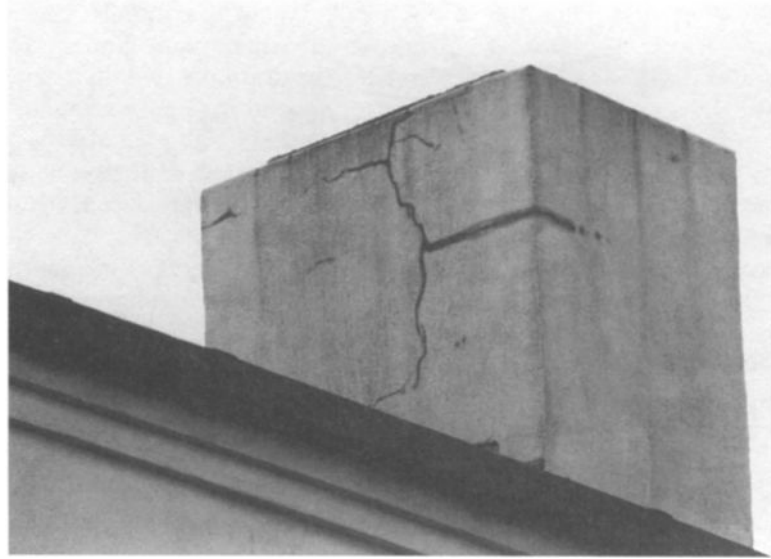
**Fig. 2.9.** Cracking of cement rendering around a chimney, which may indicate sulphate attack.

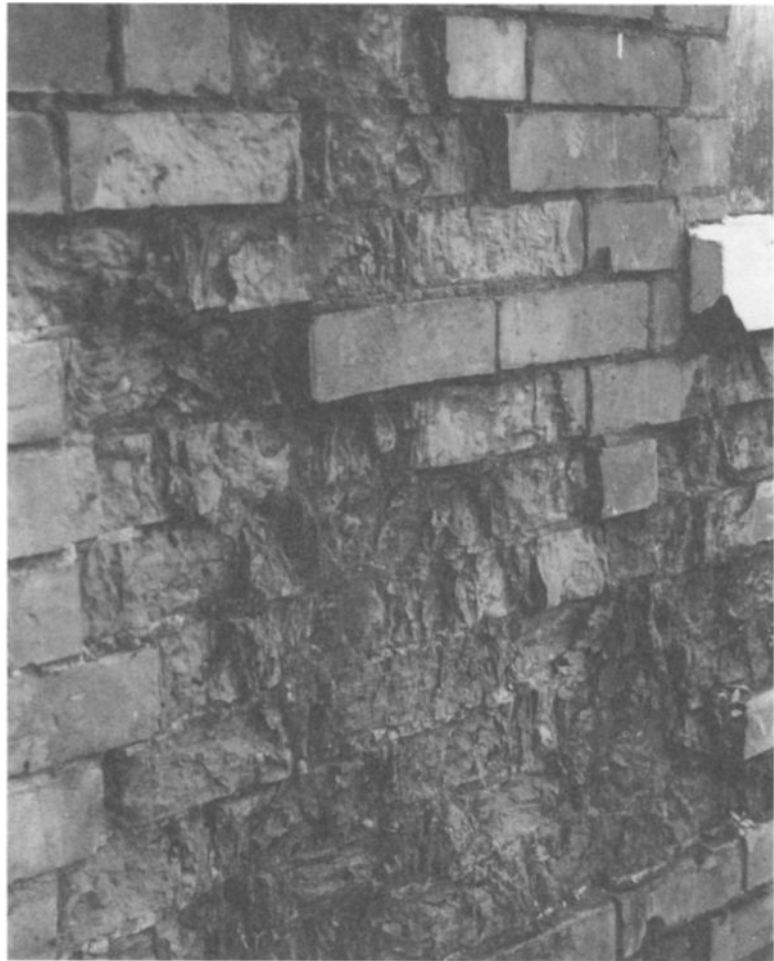
**Fig. 3.1.** Severe weathering and frost attack of brickwork. (Reproduced from G. Cook and J.Hinks, *Appraising Building Defects*; published by Addison Wesley Longman, 1992.)

Frost attack in brickwork is usually progressive, causing delamination as the bricks become friable and fail in tension under the build-up of stresses. There appears to be little quantifiable link between compressive strength and frost resistance, except in extreme instances, since the frost attack operates through tensile stresses.

In conjunction with its friability, frost-attacked brickwork may exhibit expansion of the joints and possibly the bricks also. Longitudinal and vertical expansion of the walling will occur, leading to oversailing or bulging under restraint.

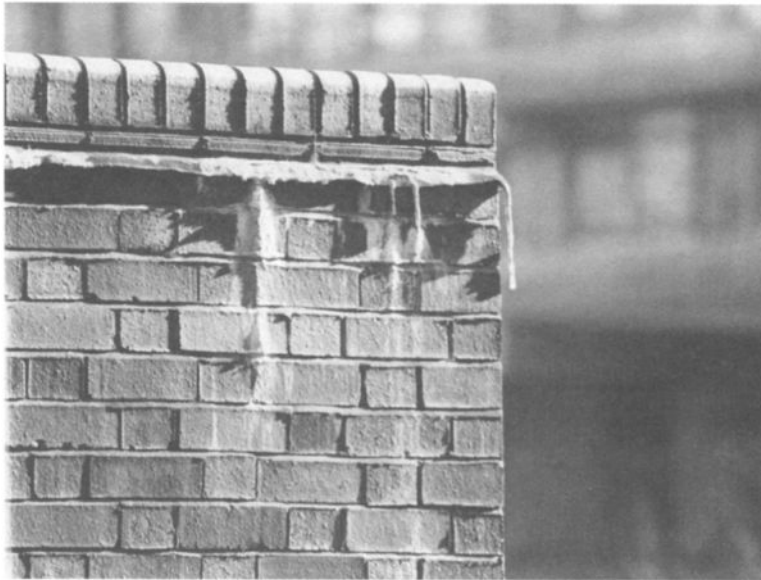
**Fig. 3.2.** The precipitation of soluble salts from brickwork at a DPC may even produce stalactite features.

Salt deposition within the material gradually blocks the pores. Since the process requires cyclic wetting and drying, its rate is controlled by the exposure of the detail. The crystallizing salts accumulate at the depth of wetting and create a back pressure which delaminates the material in a manner similar to frost attack. Delamination exposes pores previously behind the wetting zone to progressive attack.

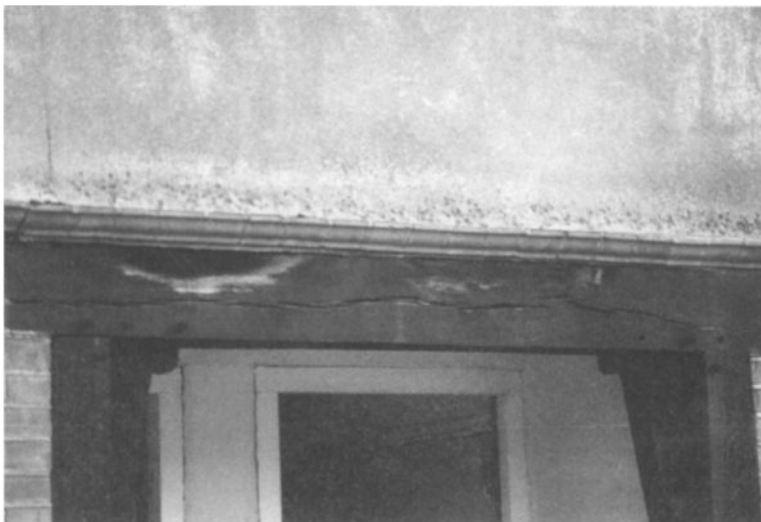
**Fig. 4.1.** External structural timber cracking along the grain. (University of Reading.)

Since a typical tensile strength of a softwood perpendicular to the grain can be  $3 \text{ N/mm}^2$ , and parallel to the grain  $138 \text{ N/mm}^2$ , it is clear that the slope of the grain has a considerable influence on structural performance. Even a  $10^\circ$  slope of grain in timber can cause a significant reduction in bonding strength.

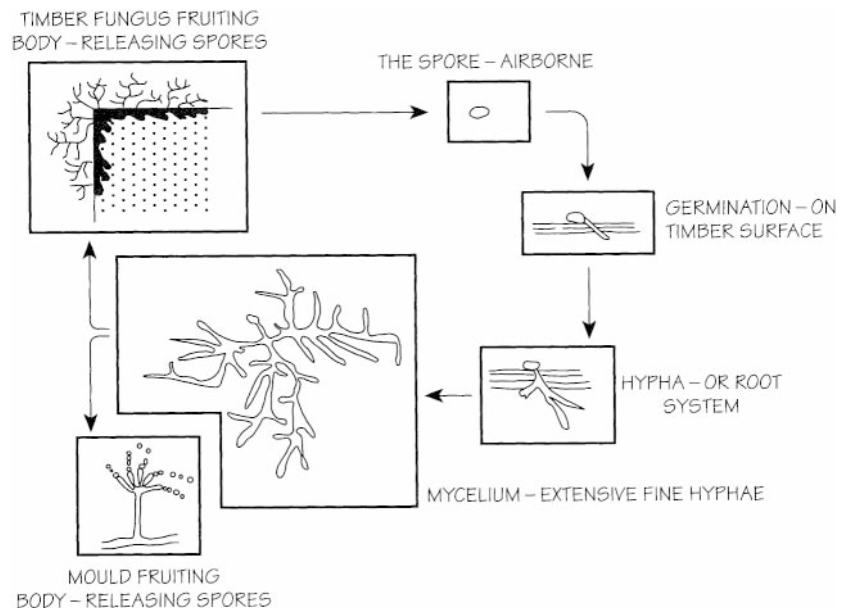
**Fig. 4.2.** The growth cycle of timber fungi.

Fungi usually attack untreated wood by developing extensive root systems (mycelium) to remove nutrients and oxygen from the cells, so destroying the chemical structure of the host timber. As the roots extend throughout the cellular structure, the timber disintegrates and becomes more susceptible to secondary damage such as insect attack. The presence of fungi may be indicative of a more critical dampness problem.

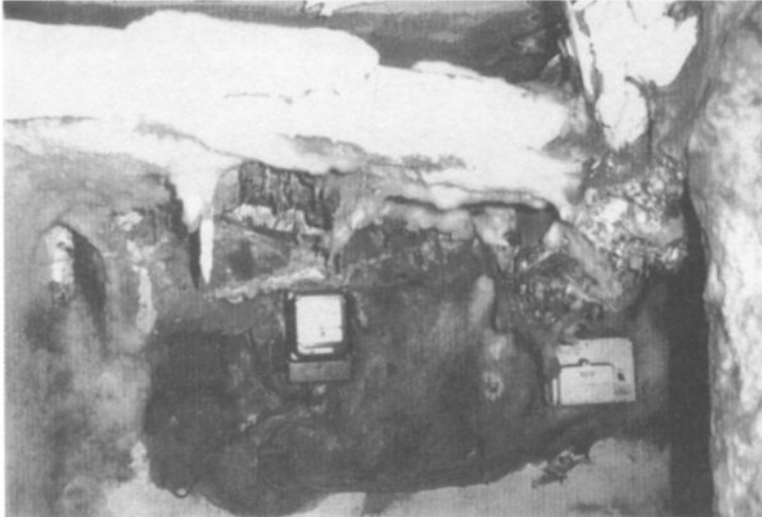
**Fig. 4.3.** Dampness and fungi can also affect building services. (S.D.McGlynn.)

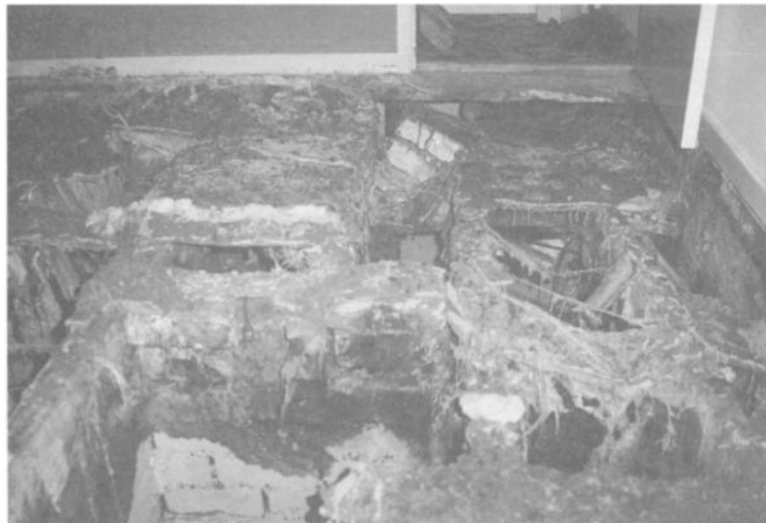
**Fig. 4.4.** General view of the failure, due to dry rot, of a suspended timber ground floor. (S.D.McGlynn.)

Dry rot is widely considered as the most serious of the wood rots, because of its structural significance and pervasiveness. Remedial works can be extensive and not limited to the brickwork. In dry conditions the surface appearance of the rot can be greyish, with bright yellow mycelium where there is light. Where the timber supply has been exhausted only the hollow strands used for moisture transport remain. These are called hyphae, and vary in size from 1 mm to 10 mm in diameter. They may cross or penetrate non-cellulosic materials in their path, leaving sites of dormant fungus.

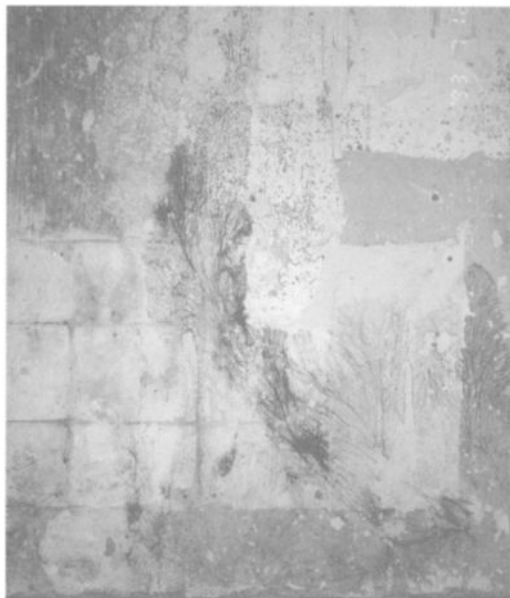
**Fig. 4.5.** Dry rot hyphae on the surface of a wall. (K.Bright.)

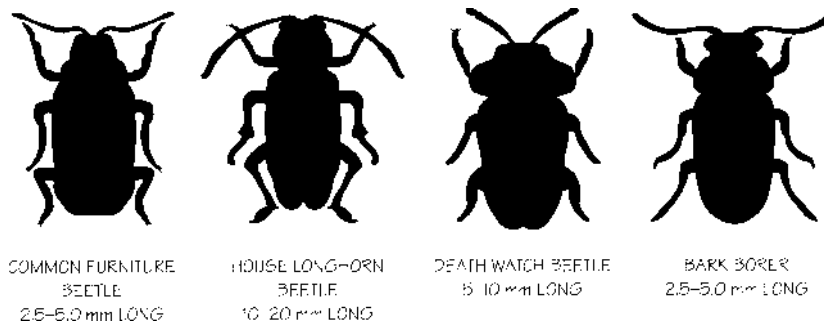
**Fig. 4.6** Insects which attack timber.

The common beetles causing damage in this country are the house longhorn beetle, the powder post beetle, the common furniture beetle and the death-watch beetle. Wood-boring weevils and bark borers may also be encountered.

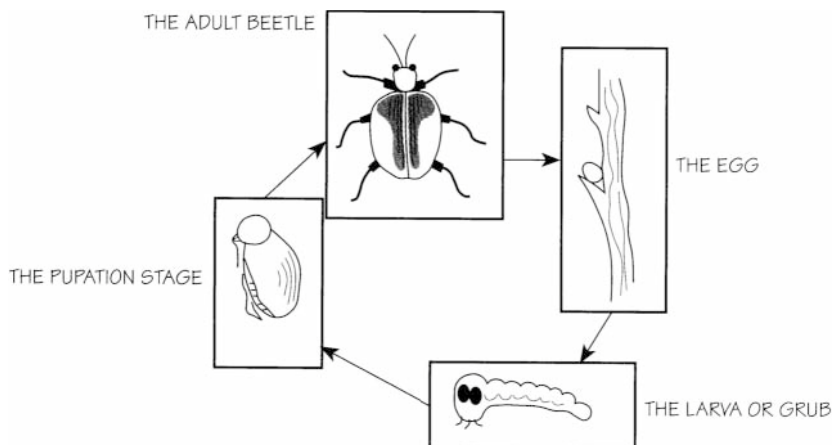
**Fig. 4.7.** Life cycle of timber insect.

The life cycle is long, commonly between five and seven years, so it is quite possible for infested timber to be apparently sound. Established attack may produce some surface bulging, and may be structurally serious enough to require replacement of members, in floors and particularly in roof spaces. It is important that all infected timber is cut back thoroughly.

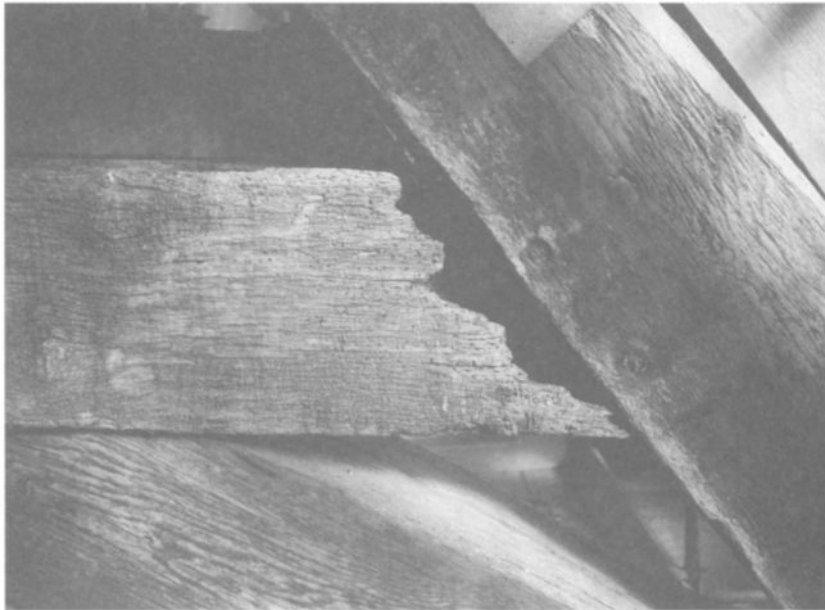
**Fig. 4.8.** This tie connection no longer exists, owing to a sustained insect attack.

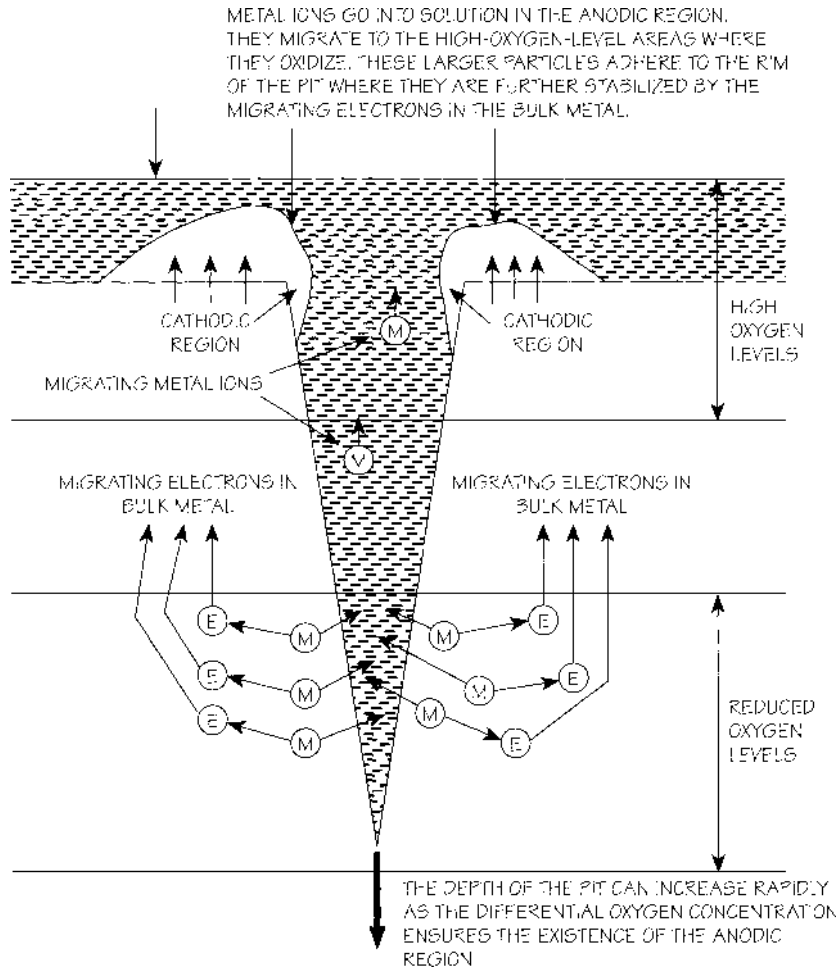
**Fig. 5.2.** The pitting corrosion of mild steel.

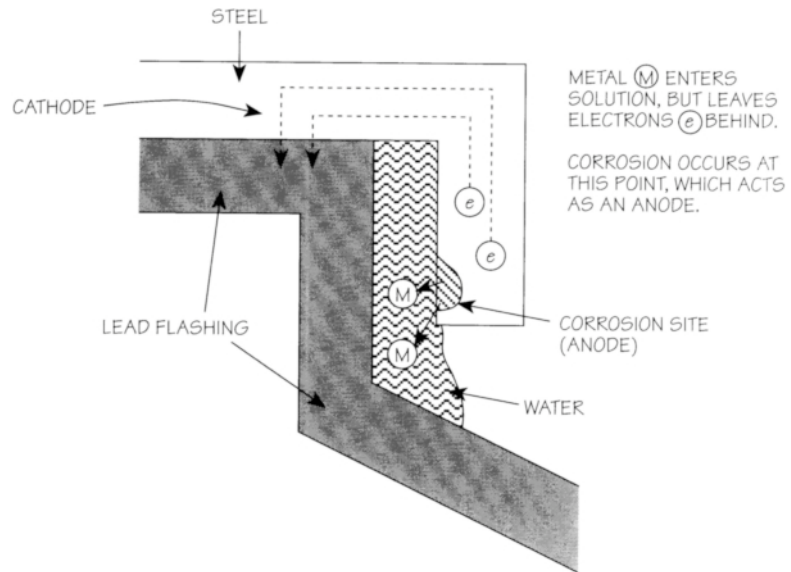
**Fig. 5.3.** Electrolytic corrosion.

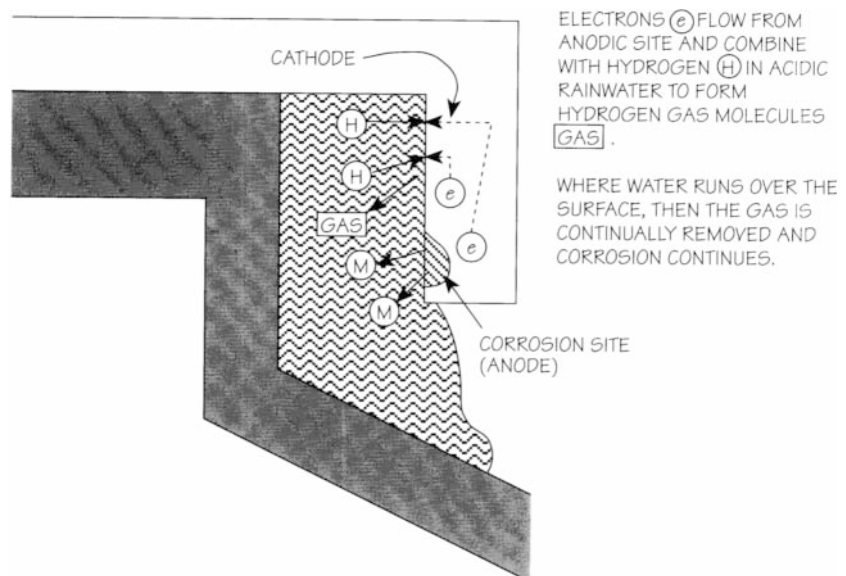
**Fig. 5.4.** Acidic corrosion.

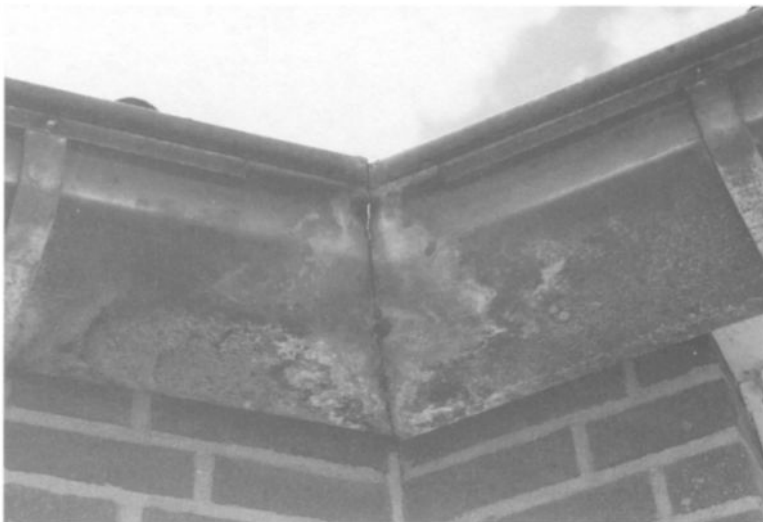
**Fig. 5.6.** Corrosion of external metalwork. Joints and other stressed regions are particularly vulnerable. (University of Reading.)

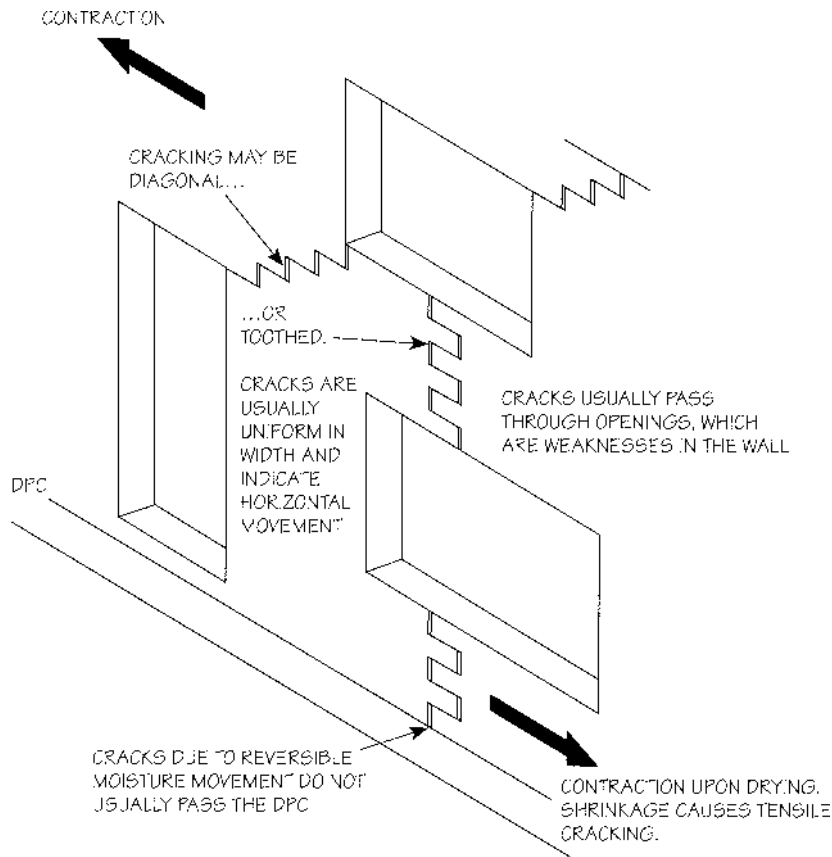
**Fig. 6.1.** Cracking due to moisture movement.

rate of moisture response in the material. In particular, the climatic variability in the UK may mean that components get out-of-phase with the climatic changes, as the drying-out period for materials may exceed the dry period between bouts of wet weather, leading to frequent cyclic moisture movement or chronic saturation associated with intrinsic stresses.

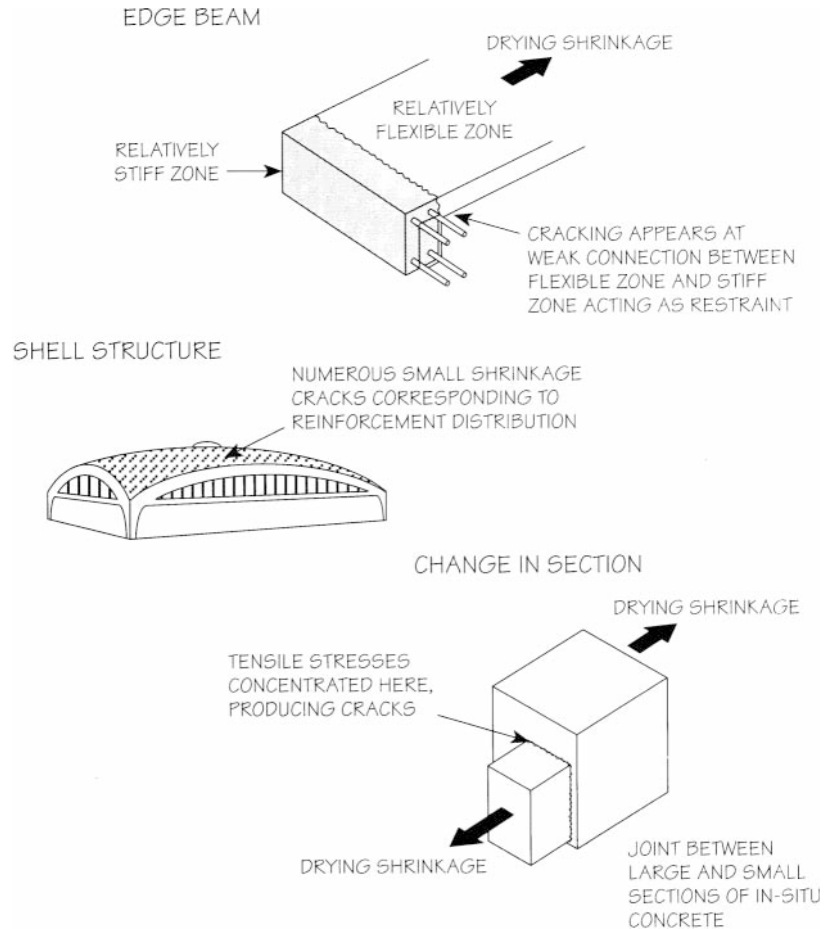
**Fig. 6.2.** Examples of drying shrinkage cracking to in-situ concrete frame.

of the brickwork coincided with irreversible drying shrinkage of the surrounding concrete frame. Inadequate movement allowances led to bulging in the brick panelling and/or cracking at the corners of the frame. This was further exacerbated by reversible thermal and moisture movement in the brick panelling.

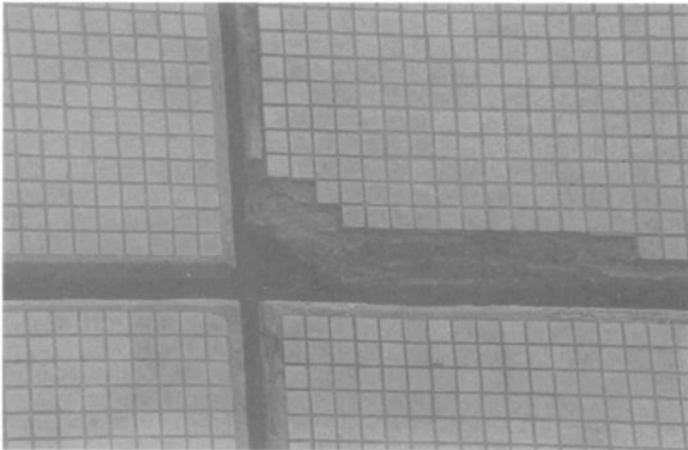
**Fig. 6.4.** Spalling of exposed edges of external mosaic adjacent to joints.

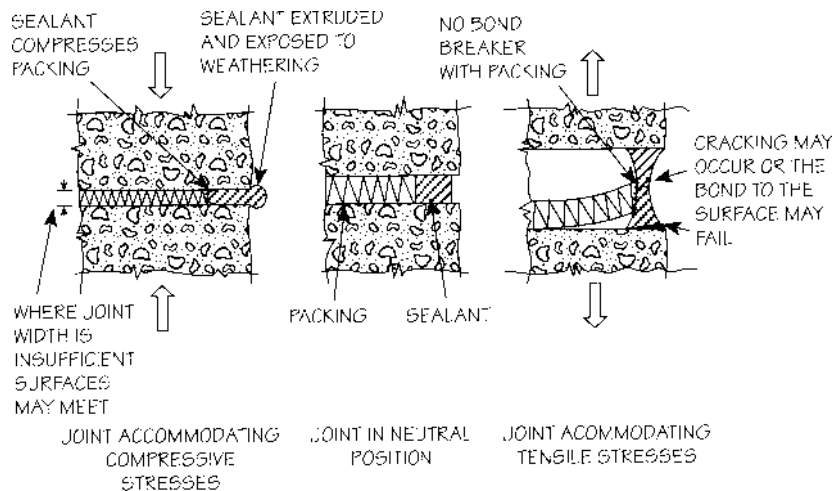
**Fig. 6.5.** Joints failing to accommodate movement.

Since all building materials have the potential for movement, a lack of movement accommodation can cause a range of defects. The movement can be due to changes in loading, thermal or moisture conditions of components or materials. Although it is possible to calculate the total range of movement to be accommodated, where this fails to include all of the factors which influence movement, then the joint may fail. Expansion joints may have insufficient width, contraction joints excessive width and general movement joints an inability to accommodate either.

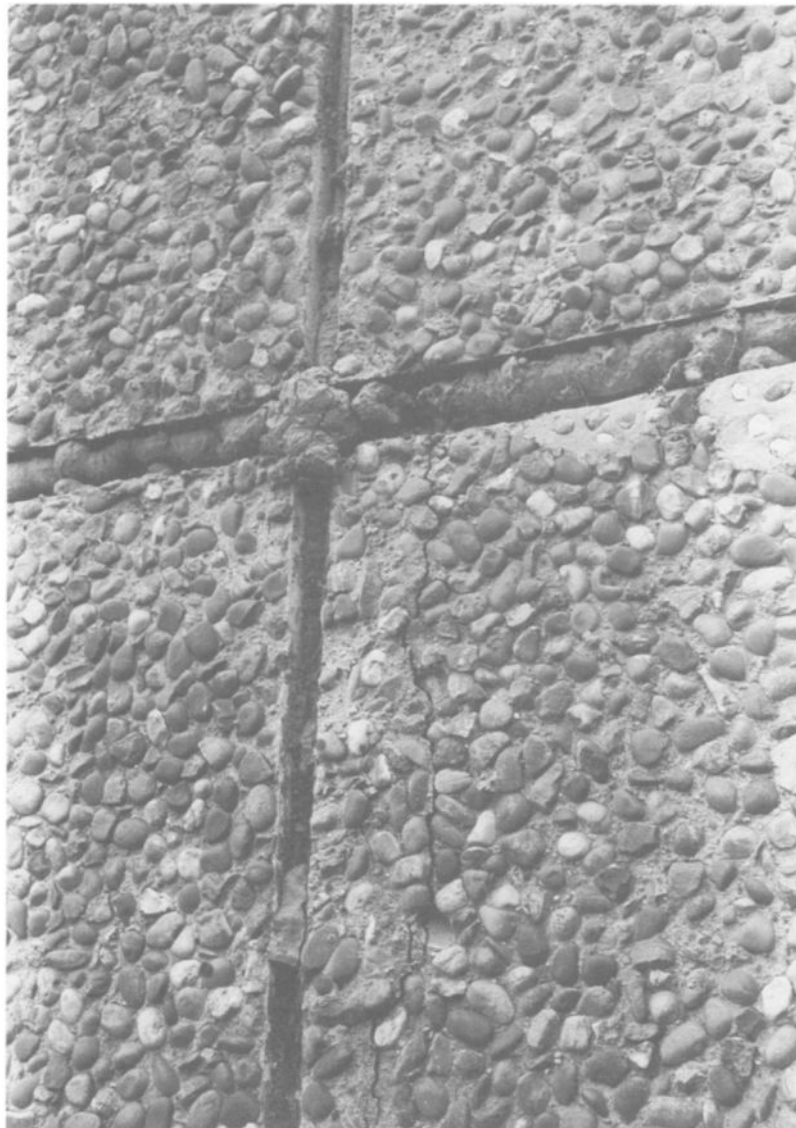
**Fig. 6.6.** The precast concrete panel joints are poorly aligned and of differing widths.

The joint width must be adequate to accommodate the required expansion and contraction of the element or component on either side of the joint. In order to account for the practical aspects of joint formation the tolerances of the structural element and the construction process must also be included. In general the tolerances for factory-made components are likely to be lower than those formed in situ. This enables a maximum and minimum joint width to be determined. The 'movement accommodation factor' expresses the movement as a percentage of minimum joint width; typically this value is 20%. With closed systems of construction the tolerances should apply to all elements and assist in joint design. The joints between in-situ and factory-made elements, since each may have different tolerances, are more problematic.

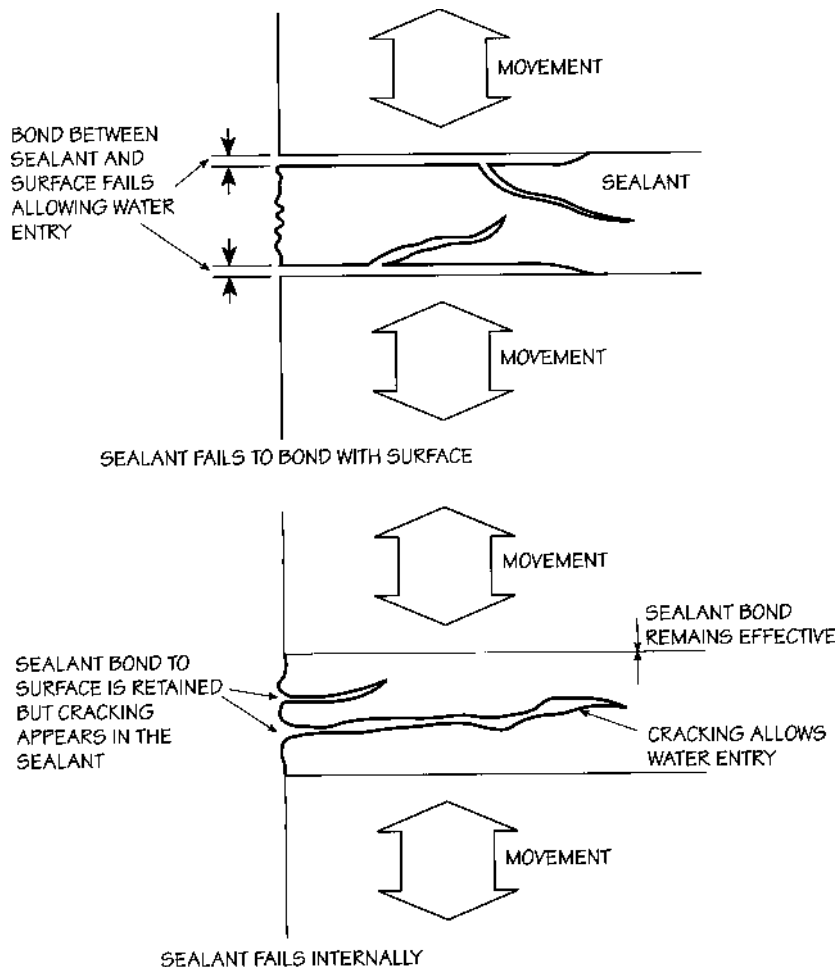
**Fig. 6.7.** Failure mechanisms of sealant. (Reproduced from G.Cook and A.J. Hinks. *Appraising Building Defects*, Addison Wesley Longman, 1992.)

Even where the movement range has been correctly assessed the joint may still fail because the sealant is subjected to either excessive tensile or excessive compressive stress. It is suggested that to avoid transfer of excessive compressive stress to the structure, compression joints 12–15 mm wide can be considered minima for brick or precast concrete cladding panels fixed to a reinforced concrete structural frame. Since the life of the sealant material is unlikely to exceed that of the materials, replacement is to be expected. A failure to appreciate the need for replacement can result in a defectively designed joint.

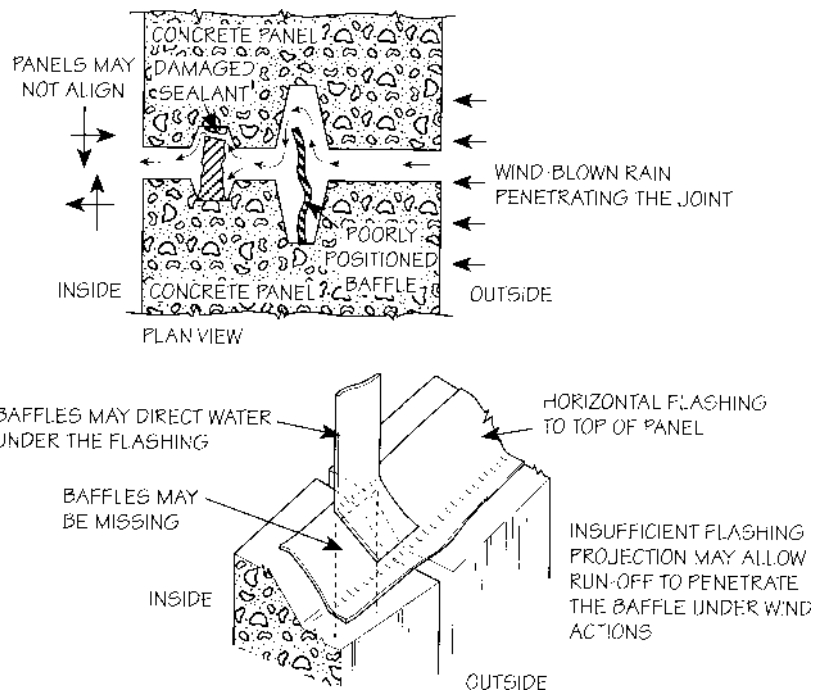
**Fig. 6.8.** The baffle-flashing joint.

The drained vertical joint used in precast concrete cladding panels incorporated a baffle which, although difficult to replace and occasionally missing altogether, relied on the integrity of the intersection with a horizontal flashing to provide weather resistance. Where the horizontal flashing was not dressed over the upstand of the lower panel, bringing the baffle to the

front of the panel, or did not provide adequate cover to the area behind the baffle, then it may fail. The sealant or gasket joint behind the baffle can fail, producing a joint which is no longer airtight and weather resistant. Sealants which are likely to be in contact with three surfaces can fail where a bond breaker has not been provided.

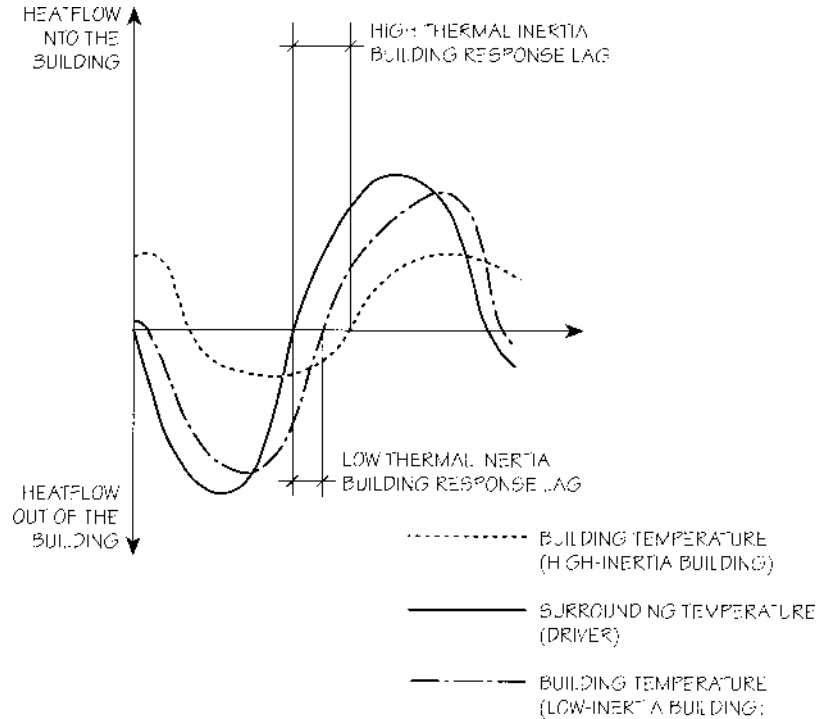
**Fig. 6.9.** Time lag and thermal inertia. Buildings with low thermal inertia exhibit less response lag than those with high thermal inertia.

Taken on a macro-scale, high-mass elements of buildings, which proportionately take a larger amount of energy to heat up than smaller-mass components of a similar material, will tend to take longer to adapt to changes in ambient temperature. The climatic variability in the UK is therefore a significant driver, and massive buildings with high thermal inertia can become out-of-phase with rapidly cycling ambient temperatures. This produces a time lag phenomenon in massive buildings, as they lag behind any relatively rapid climatic cycling. This phenomenon mostly appears in the older, heavyweight stock, but also includes the heavyweight concrete systems construction. Defects may occur in such buildings where the internal climate becomes out of phase with changes in the external climate and/or the building fabric, or alternatively with the cycles of usage. With intermittent use of such buildings, the consequence of relative changes of the internal humidity is frequently surface condensation. As occupiers return to a cold building and rapidly warm up the internal air with central heating, for instance, the structure lags behind and provides the cold region for the surface condensation of water vapour. Coupled with the occurrence of poor ventilation, the problem may become chronic.

Clearly there is also a profound relationship with thermal insulation levels. Modern lightly insulated buildings may be of low thermal inertia, and exhibit little or insignificant lag in responding to thermal change. They therefore respond better to intermittent usage. In such cases the building elements and components will be much more mobile. The building also provides a minimal buffering effect against changes in climate.

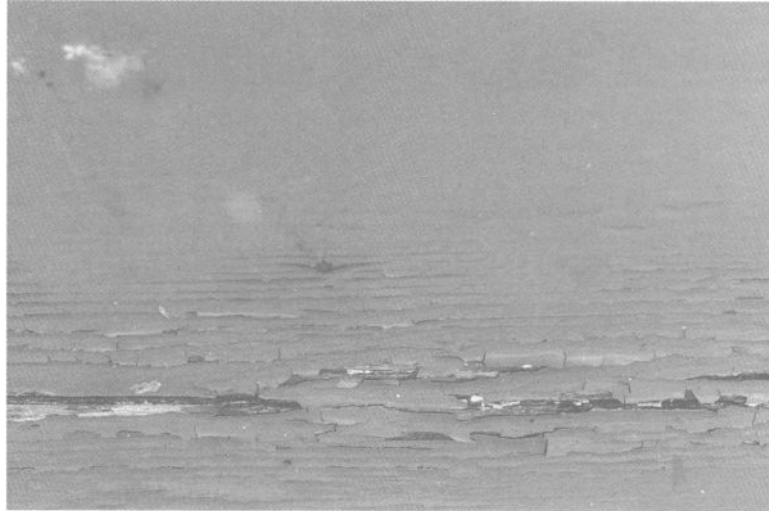
**Fig. 6.10.** Flaking and cracking of paint film following the grain of the timber background. (University of Reading.)

'Flaking' occurs with the loss of adhesion between the paint layer and substrate, so that small particles break away. Paints bond less effectively to non-porous surfaces, and some oily hardwoods such as teak are troublesome. Flaking and other bond-related faults occur more easily with such surfaces. All or some of the paint layers may be affected. Flaking is usually an external problem, which tends to arise with hard-drying paint types, or any paint applied to a friable surface. Timber backgrounds can also promote early flaking of paint because of trapped moisture, and this problem is particularly likely at the joints which will experience the greatest movement.

Timber that is highly grained or well weathered is likely to produce an unstable background. As differential movement occurs across the grain or within the weathered timber this will set up surface stresses which destroy the integrity of the painted surface. Layers may flake off following the pattern of the grain, so illustrating the nature of the stresses. Clearly this vulnerability in the background will lead to rapid deterioration if unattended.

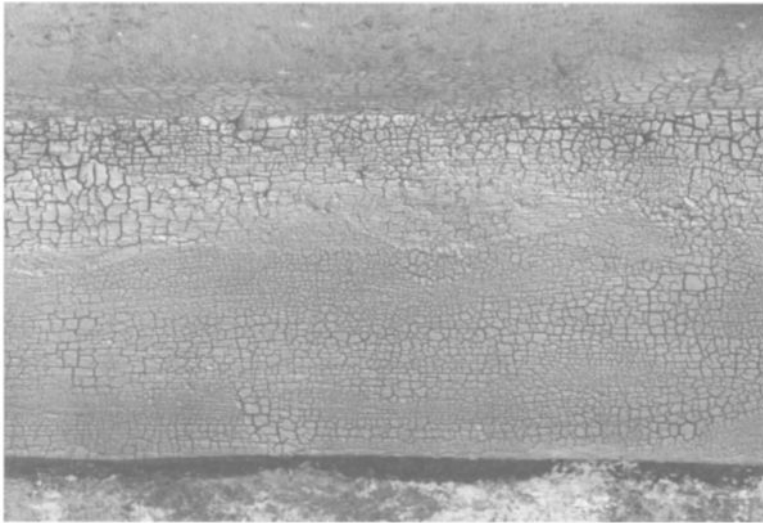
**Fig. 6.11.**  
'Alligating' of a  
paint film. (University  
of Reading.)

Poor-quality paints may develop 'checking' in the form of 'V' or 'crows-feet'—shaped cracking. These cracks are very fine and whilst these do not immediately threaten the protective properties of the film, if left unattended will lead to 'crazing' (or 'alligatoring'). Crazing defects arise most frequently with paints based on or containing bitumen. They occur when hard coatings are applied to soft backgrounds. As these dry they shrink and distort the background. Adding excessive driers can produce the same effect. Patterned cracks form in the dried paint but the defect does not always penetrate the

film completely. The cracks are raised above the surface producing an alligator-skin effect.
