# THE TECHNOLOGY OF BUILDING DEFECTS

John Hinks  
Geoff Cook

# Defects with materials

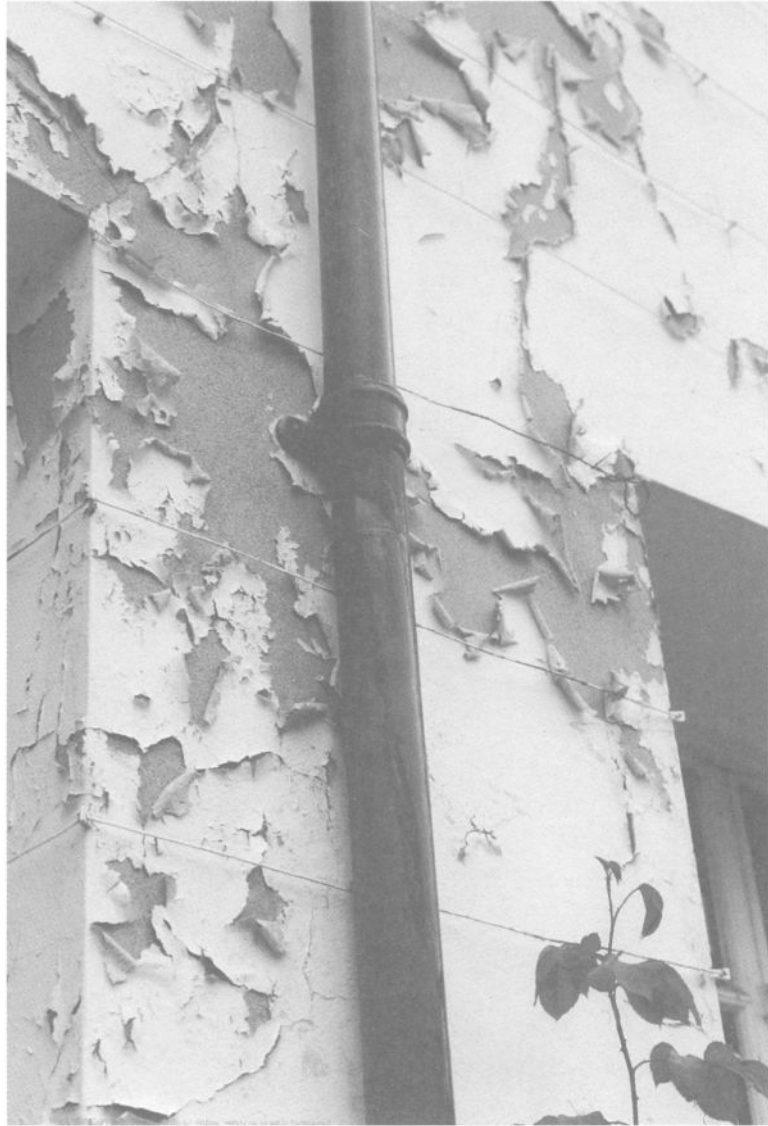
**Fig. 6.12.** Peeling paintwork on a rendered wall. The leakage from the downpipe may have contributed to the paintwork failure. (K.Bright.)

Overpainting existing coatings rather than removing them can produce a range of problems—incompatibility, poor base surface quality or integrity, cleanliness or extent of preparation. Different types of paint may cause differential stresses, and the additional weight of the new coating may

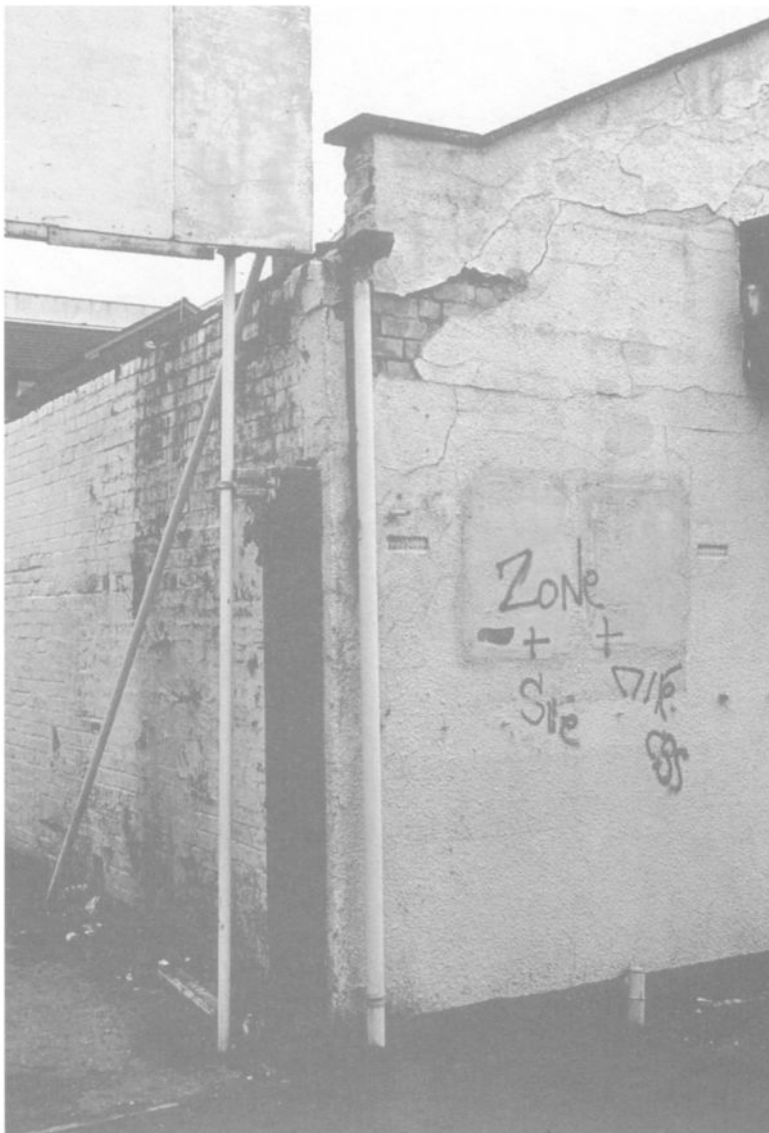
**Fig. 6.13.** The banded cracking and detachment of the render is most marked where the gable parapet is exposed at the eaves.

Defects may also arise in the background or as a result of incompatibilities between the render and the background. The mechanical bond between the two may have failed, owing to chemical or physical incompatibility. Movement (both temperature- and moisture-induced) as well as the irreversible inherent shrinkage that takes place in cementitious materials may combine to stress the interface bond. Renders which have a very high cement content will tend to exhibit abnormal shrinkage problems. Faults in the line and level of the background (which may be seen through some of the thinner-coated rendering systems) can produce attachment problems.

Loss of adhesion may also be due to renderings being applied to saturated walls or an incompatibility between the render and the background. The cause of this may lie with the render specification or the background stability. Frost and cold weather can also cause weakening of the rendered coat. Dashing

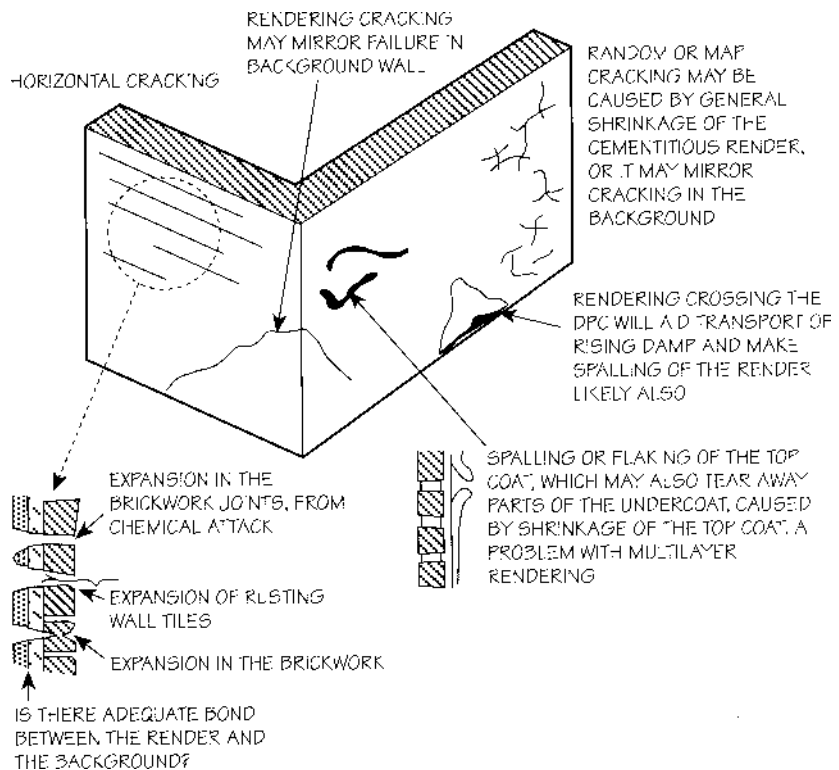
**Fig. 6.14.** Cracking patterns in rendering.

Cracking in rendering may be associated with the breaking away of sections of the render. Breaking away increases the risk of rain penetration into the structure. By allowing the rain admittance to the back of the intact render

Shrinkage cracks occur with the hydration of cementitious material, and are particularly marked where a rich mix has been used (1:3 or richer). Uneven concentrations of cement in mixed batches can create areas of render with high cement concentrations, and therefore differential shrinkage characteristics. Over-trowelling of the render can cause the cement matrix to rise to the surface, further increasing the risk of shrinkage. This form of failure is exhibited as map cracking.

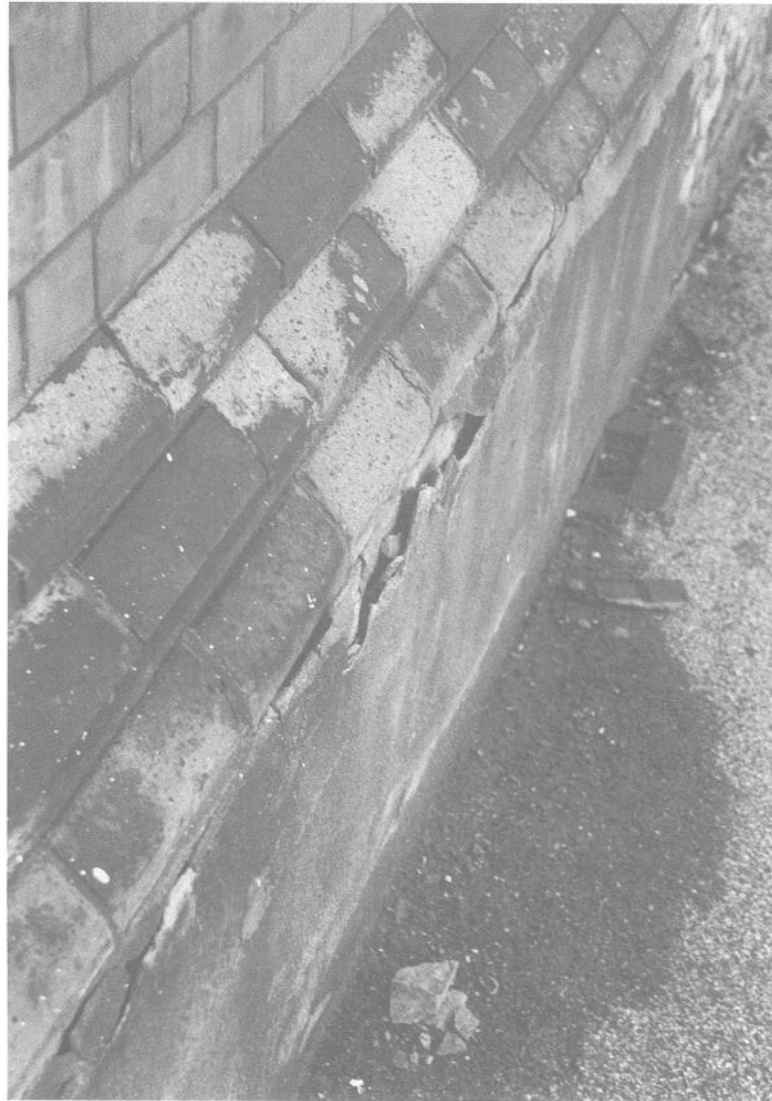
**Fig. 6.15.** The rendering may or may not be bridging the brick DPC. The run-off water from the wall and general weathering have started to detach the rendering from the wall.

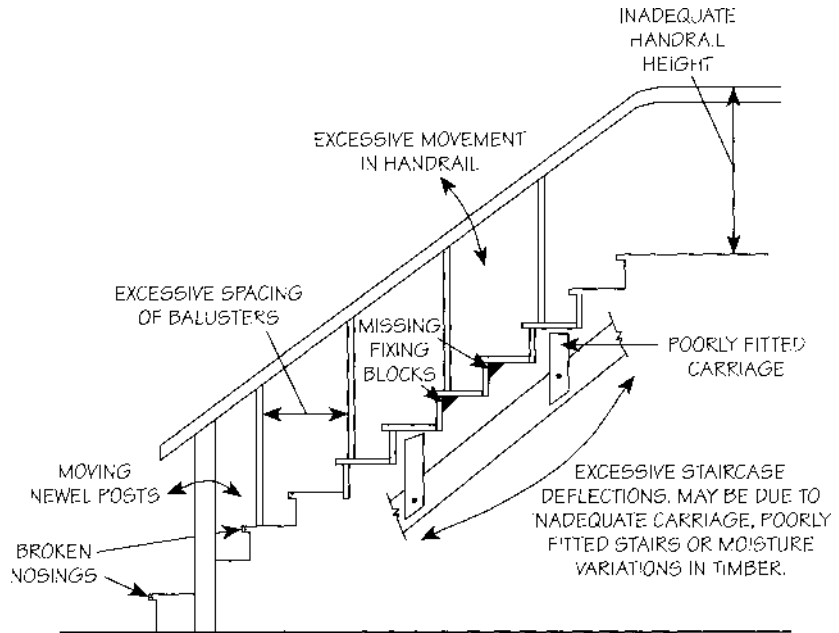
**Fig. 6.16.** General defects of timber stairs.

Older stairs may creak. This may be due to the seasonal variations in the moisture content of the timber or movement in the joint between tread and riser. Where triangular fixing blocks have been omitted or poorly fixed there

may be movement of the tread against the riser. This can result in cracking of the treads.

The whole flight of stairs may distort under normal load, causing wholesale differential movement of the stair components. The fixings between the carriage and the treads may be defective. Distortion of the tread under load may also cause movement in the joint between tread and string.

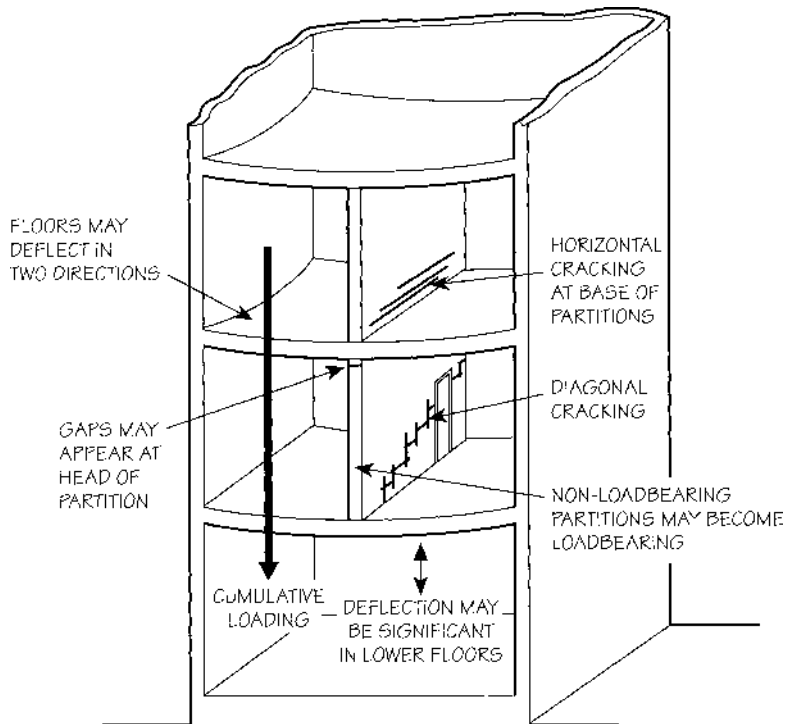
**Fig. 6.17.** Possible failure mechanisms of partitions.

Ground floor timber partitions may be distorted owing to the settlement of fill or the expansion of shales under the concrete ground floor slab. Distortion can also occur where suspended floors deflect under load. Shrinkable aggregates in concrete floors can cause this deflection.

Non-loadbearing partitions in upper storeys may rest on timber floor joists. Since the partitions may not be directly over the ground floor partitions, deflection of the floor can occur. This may create twisting, leaning and deflection of the partition walls.

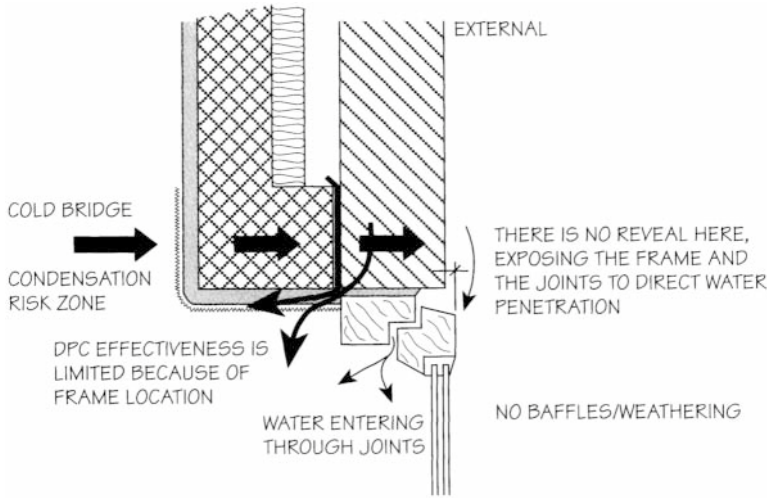
**Fig. 7.1.** Poor design and/or construction detailing at head of window.

Joints between the timber frame and opening construction can be defective. The setting-in of the frame must not allow water access to the back of the frame, although the provision of priming to concealed surfaces offers some protection.

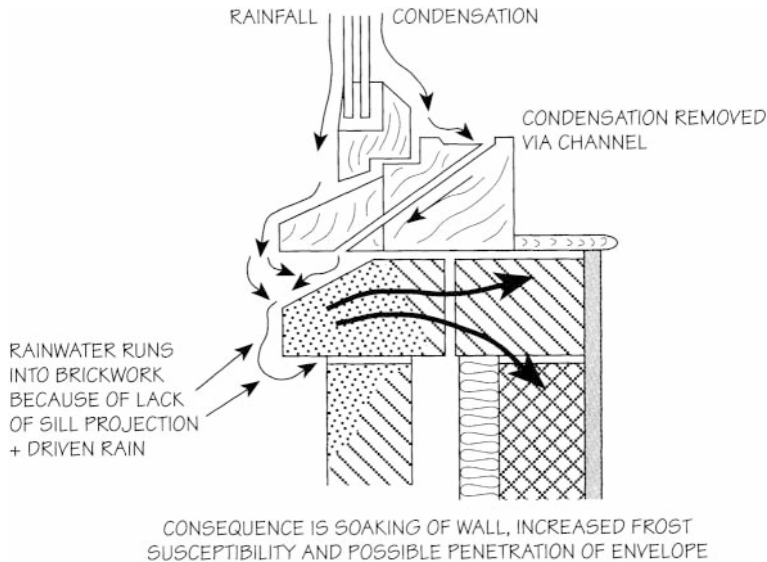
**Fig. 7.2.** Inadequacy in sill projection/ weathering leading to wall dampness.

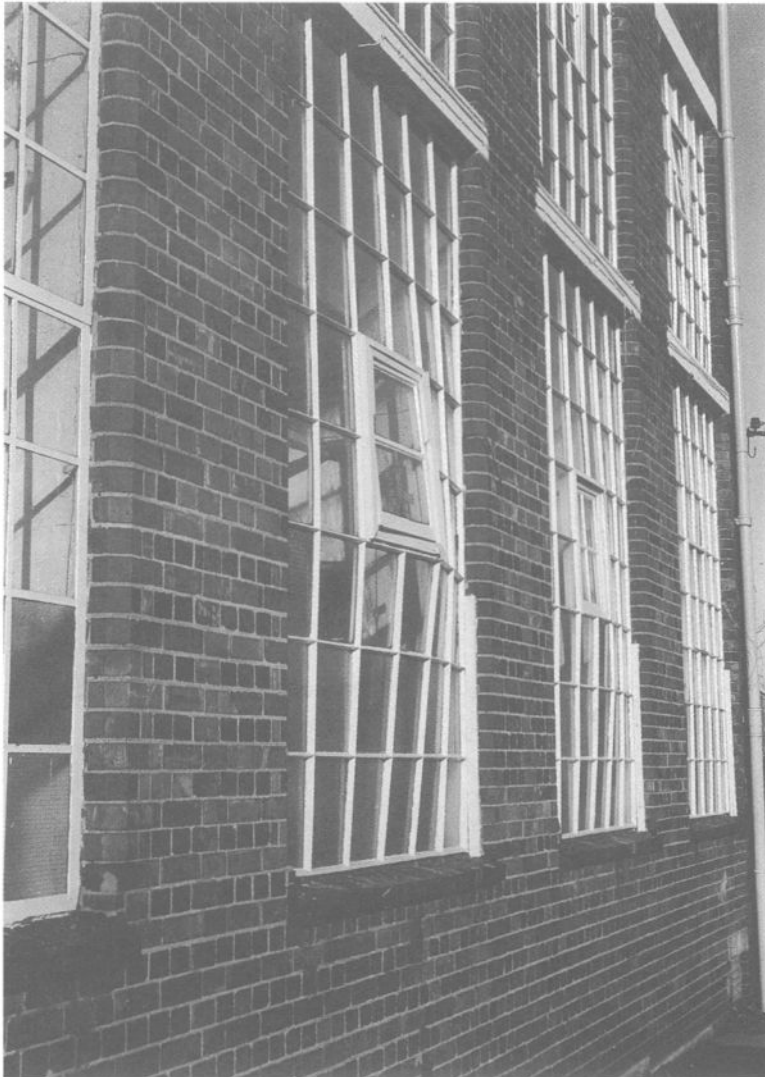
**Fig. 7.3.** Buckling of metal windows due to expansive effect of corrosion.

When in contact with water, the metallic atoms which are characteristic of the particular metal dissolve at different rates. As the atoms dissolve they tend to leave behind some electrons which can flow from one metal to another via the surrounding water. This transport of electrons to other metals causes the original metal to continue to dissolve. This cycle depletes the metal and reduces its strength. This is problematic where different metals are connected directly or by water, but it is also possible for differences to exist within the same metal which can cause the same process to occur. It is therefore possible for metals in solution to set up an electrolytic cell if there is variation in the metal composition. This produces rust which is then deposited on the metal surface. The deposits are commonly found close to the regions of depletion and are therefore a visual indication of corrosion attack.

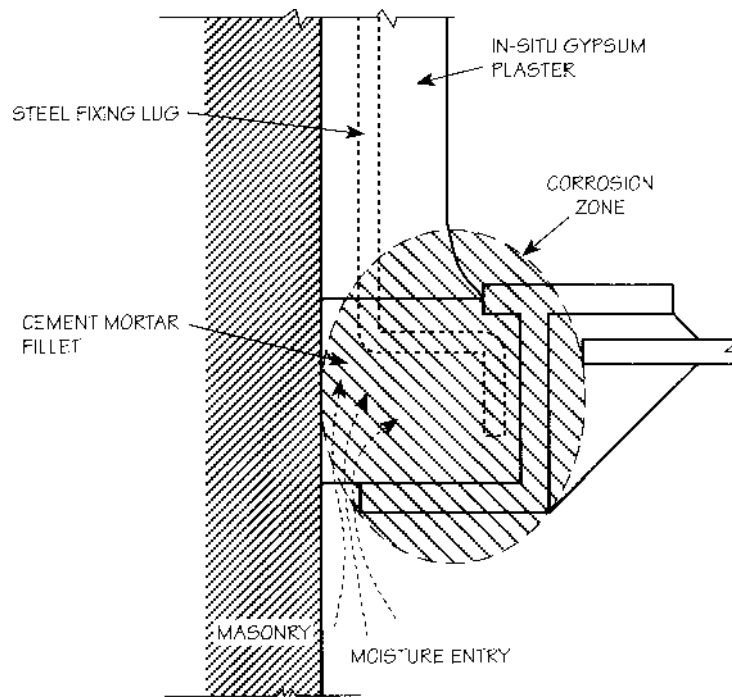
**Fig. 7.4.** Corrosion at steel window frame/wall junction.

The metal sections are regions of high thermal transmittance; this can create a series of cold bridges across and around the edge of the window. These in turn will increase the incidence of condensation at just the place where it should be avoided, since the condensate will drain into the back putty areas or any abutting plaster where it will lie, slowly acting upon unprotected metal and also creating a site for mould growth. Metal casement putty is essential. Where the casement putty has been applied to damp surfaces, the adhesion can be permanently lost, which will increase the number of cracks and crevices within which such corrosion and water entry can occur. Although the amount of retained water is small, this process can continue for an extended period and produce serious deterioration. Kitchens and bathrooms are at particular risk. Owing to the necessarily complex shape of the metal window section, there are usually a range of potential corrosion sites.

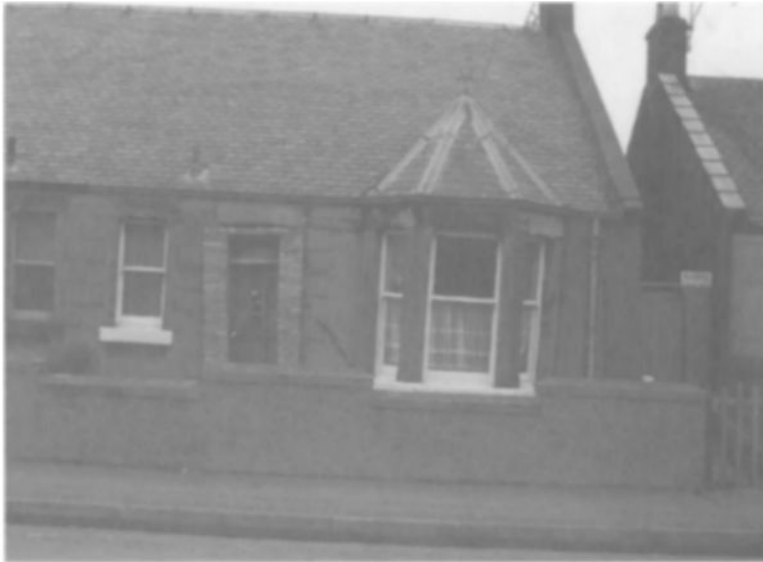
**Fig. 8.1.** Mining subsidence can affect buildings and their general vicinity. In this view the door pillars are vertical.

Where differential settlement occurs, the structure may tilt or fracture. Since buildings usually fail in tension or twisting, the cracking patterns may assist in identifying the location(s) of settlement (and/or heave conversely). However, since the failure in the building is a composite of its own structural nature and orientation with the advancing subsidence face (which will also vary in intensity), the cracking may be of a complex nature. The structural integrity of the building should be assessed.

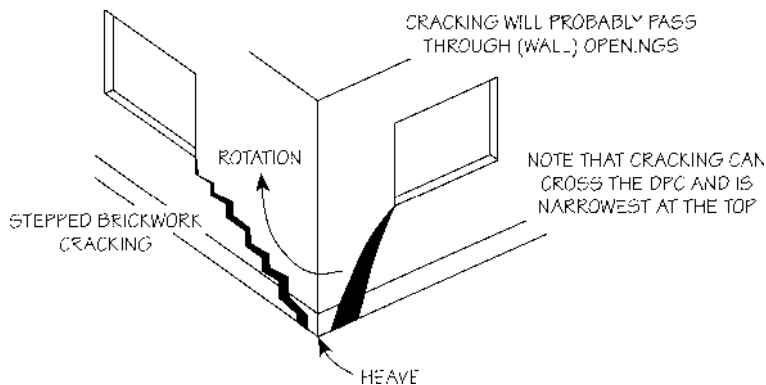
**Fig. 8.2.** Clay heave cracking symptoms at the corner of a building.

Clay soil will exhibit heave with increases in moisture content (rehydration), which can cause lifting at the corners of buildings. Heave is possible where established trees are removed, and the water-table rises as it adjusts to the reduced demand for water from the surrounding vegetation. This can be particularly complicated to diagnose or predict. The centre of the building may also be disrupted in drought conditions as the central plug of soil protected

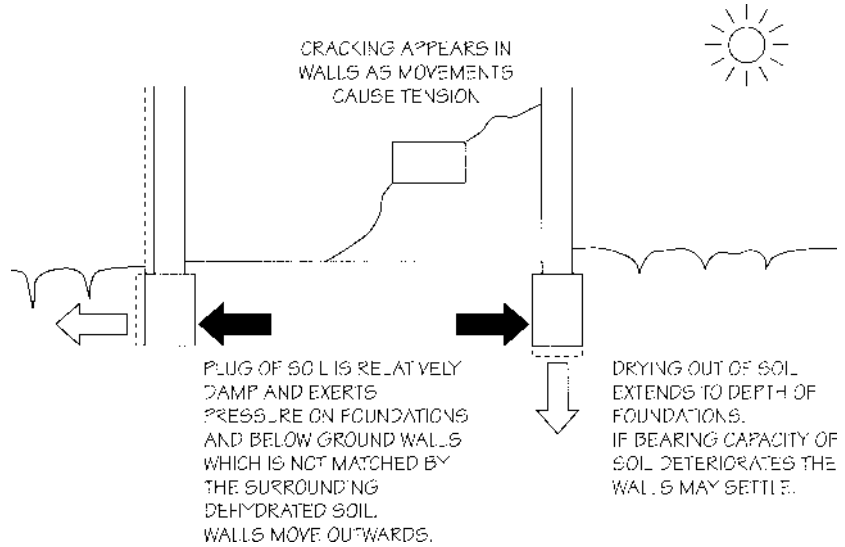
**Fig. 8.3.** Movement of clay soil under buildings.

by the building retains moisture whilst surrounding soil dries out. This is termed 'hogging'. Desiccation is a common cause of subsidence damage to buildings.

The symptoms of central hogging include vertical (tensile) cracking of the building, which increases in width across the height of the building. Such cracks usually bridge the DPC, and may be accompanied by spreading of roof coverings under tension also. The cracking may be duplicated in the opposing elevation and extend across floors and also affect internal walls.

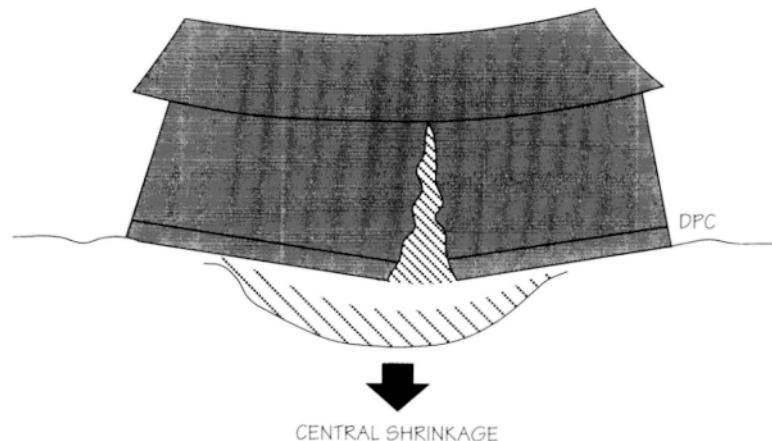
**Fig. 8.4.** Drying-out of central clay soil produces tensile cracking in the structure and substructure as it is placed in tension.

Centralized drying out, perhaps due to tree roots or the presence of substantial vegetation, will produce reciprocal symptoms as the lower section of the building spans across a void caused by the shrinking support soil, placing the foundations and lower walls in tension. This is sagging failure. Cracking symptoms in such cases will be wider at the base, and will pass through the DPC. Similar symptoms may occur with localized weak points in other soils. In instances of desiccation of clay soils it is common for the soil

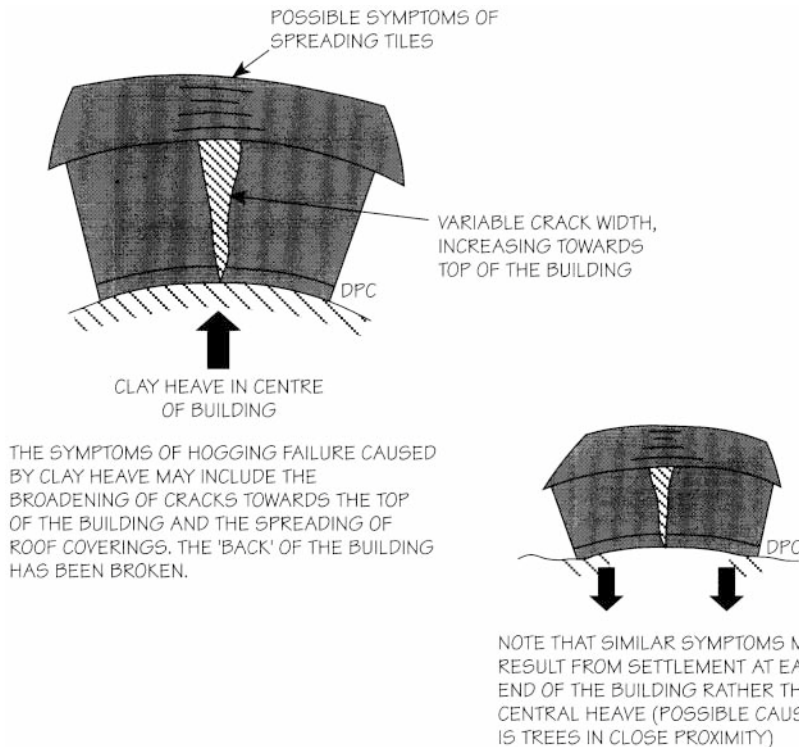
**Fig. 8.5.** The symptom similarity between clay heave and shrinkage. In both cases the severity of cracking may be seasonally variable. Monitoring may be appropriate.

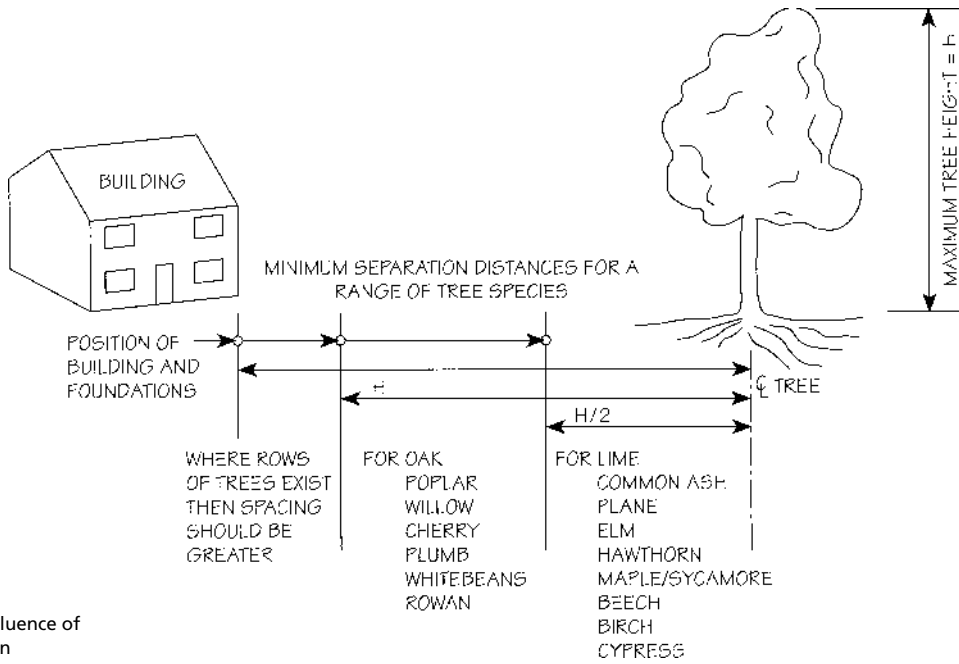
**Fig. 8.6.** Influence of tree species on separation distance.

The proximity of trees (or other substantial vegetation) to buildings may cause significant soil shrinkage due to drying. This is a seasonal effect usually, and is most dramatic in clay soils. The root radii of trees vary and can be especially significant for poplar, willow and oak. It is common for tree-related foundation defects to occur within a radius similar to the height of the tree (or less). This may increase to 1.5 times the radius for groups of trees, with mature heights of 20–30 m in ideal conditions for trees such as oak, sycamore, lime and beech trees. This is reduced when grown in heavy clay.

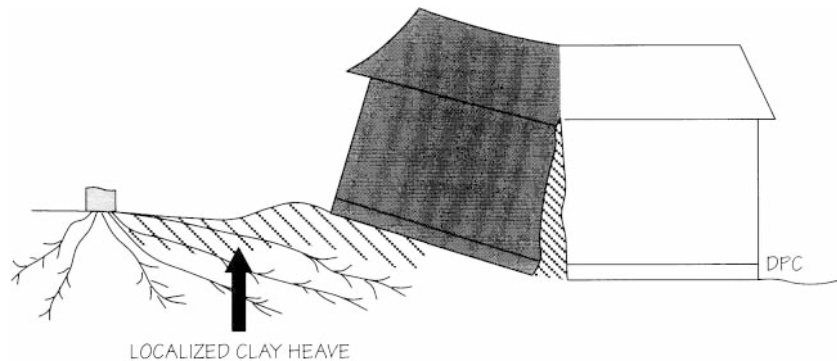
**Fig. 8.7.** Expansion at corner of building causes lifting. This may be caused by removal of tree(s) leading to localized increase in water-table level.

It is important to appreciate the phenomenon of soil recovery, which occurs after trees have been removed. The removal of water will cease and the water-table level will increase locally, producing heave failure. Clearly this type of causal factor may be difficult for the surveyor to identify if there is no residual evidence of the trees. This effect can also occur over a long period (25 year movement has been recorded).

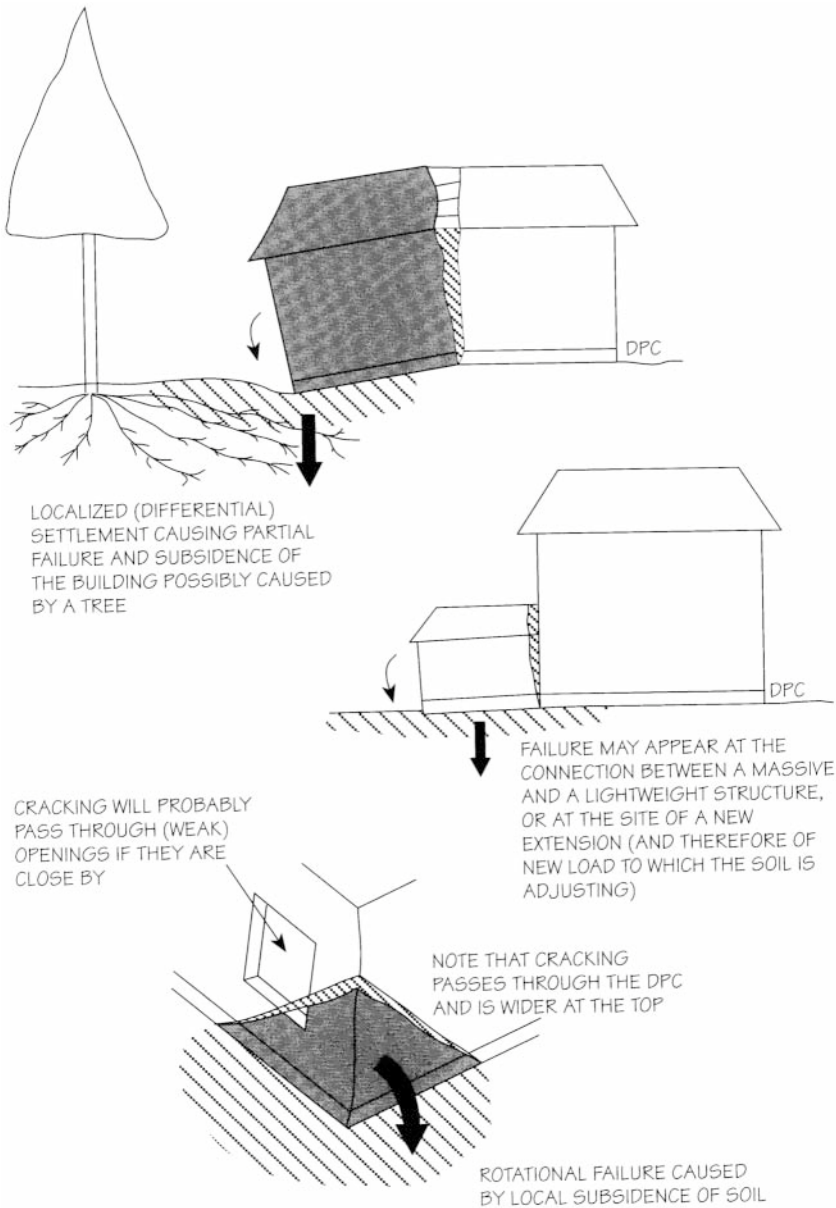
**Fig. 8.8.** Localized (partial) subsidence and settlement cracking in domestic buildings.

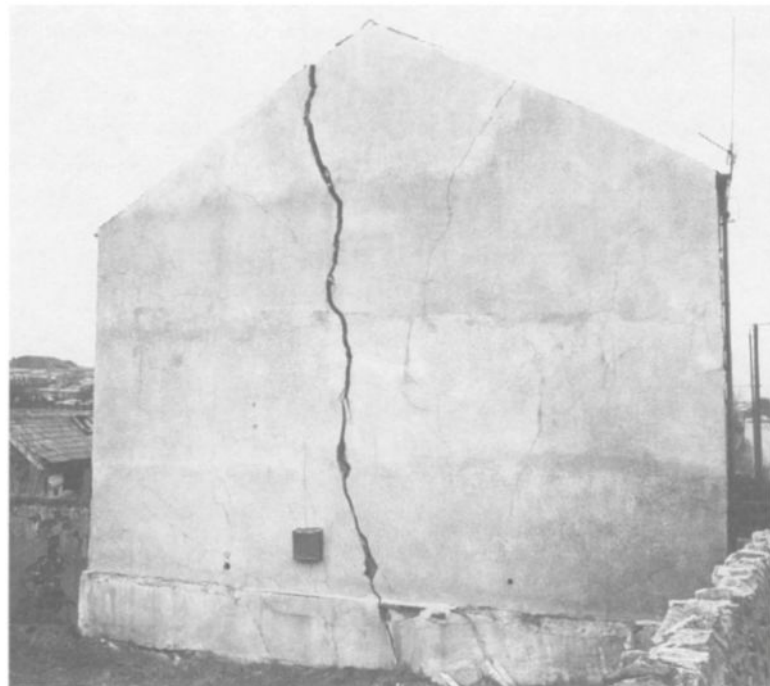
**Fig. 8.10.** Severe gable end cracking. The crack width increases with height indicating a movement of the lower left-hand corner of the wall.

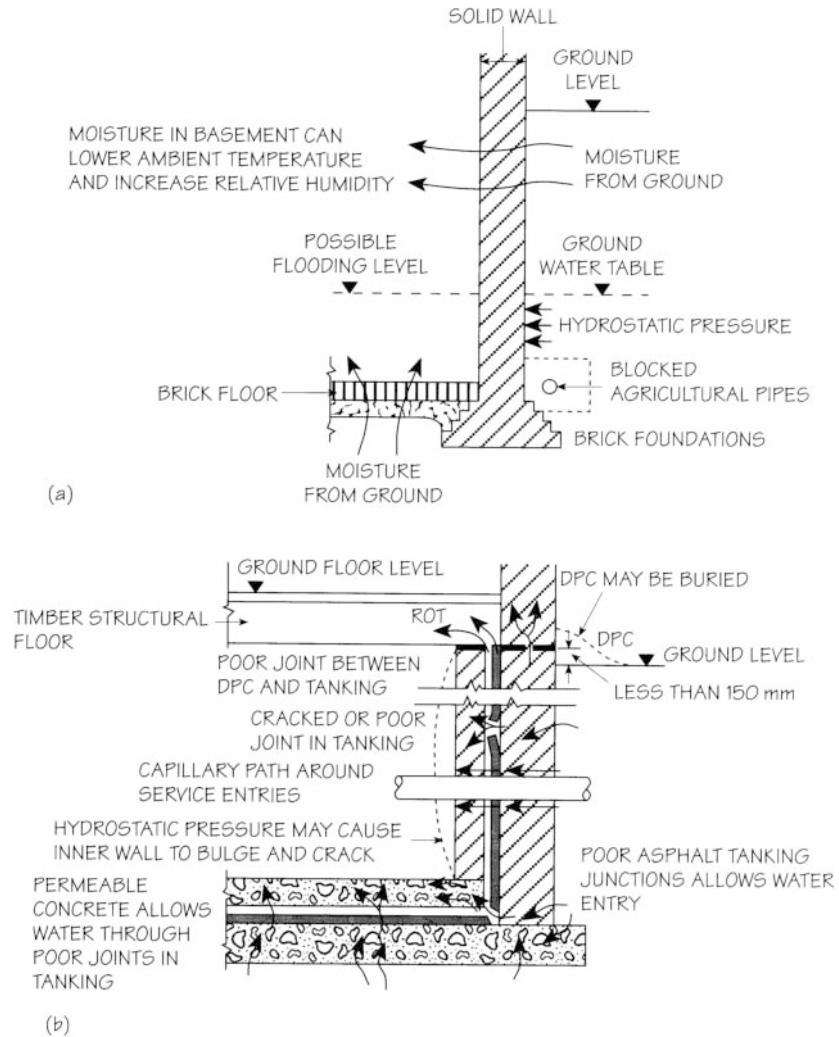
**Fig. 8.12.** (a) Older basement construction—failure mechanisms; (b) newer basement construction—failure mechanisms.

1. An incomplete water barrier due to failure of the tanking or an inadequate and incomplete link with the ground floor DPC. This may produce dampness around service entry points. Differential movement of the building may produce cracking. In addition, cracks may appear near structural, constructional or movement joints in walls and floors. The junction between floor and wall is particularly vulnerable.

2. The inability of the tanking to resist the hydrostatic pressure caused by water in the ground. Waterproof renders applied internally may be sufficiently impermeable but fail owing to a lack of bonding to the basement wall. Tanking within the basement wall can fail where the inner wall is unable to resist the hydrostatic pressure. This will increase with depth, unlike the applied load from soil. The ground drainage pipes commonly laid in the ground in front of the basement wall may become

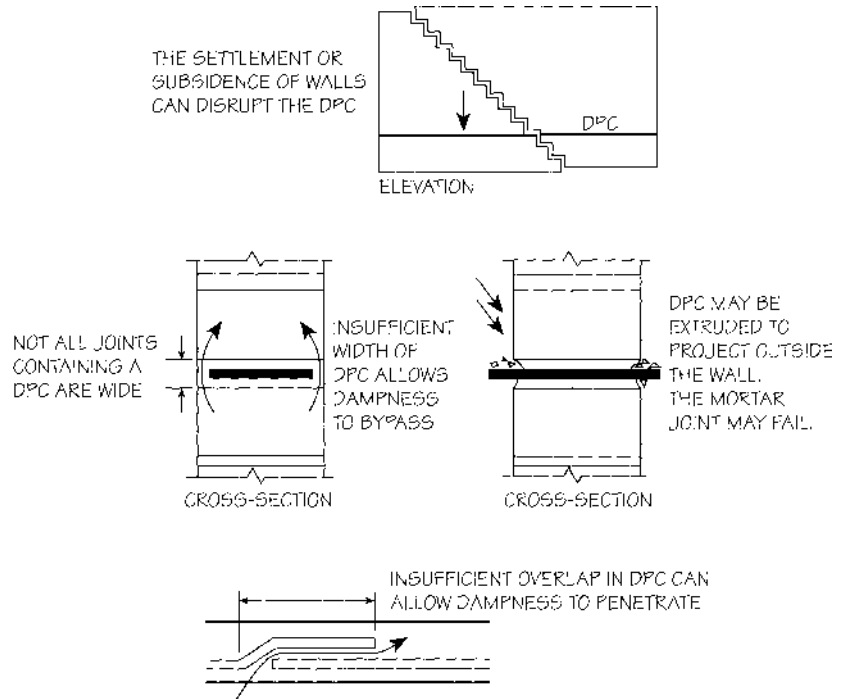
**Fig. 9.1.** General defects with DPCs.

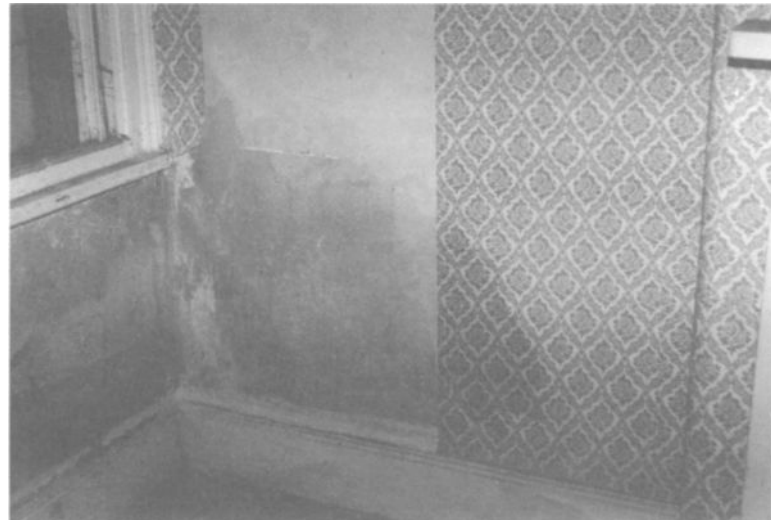
**Fig. 9.2.** Symptoms of dampness within a building. The general shape and height of the staining suggests that this may be due to rising dampness. (K.Bright.)

Rising dampness can be identified by a generally horizontal although irregular pattern of dampness. This is commonly associated with the discoloration of inner surfaces, which may rise to >600 mm above ground floor level.

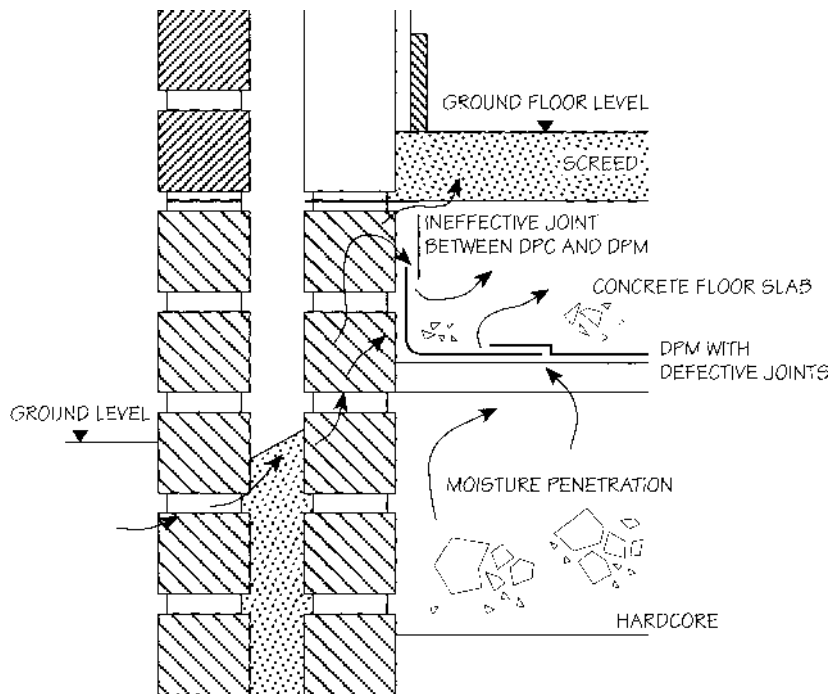
**Fig. 9.3.** Dampness penetration through ineffective joint between DPC and DPM.

This may be due to a difference in level between a concrete floor slab and a brick course. Because DPCs and DPMs are commonly different materials, with different characteristics, they may fail at their junction. Where the DPC is above the DPM then dampness may migrate to a region behind the skirting board. Where the DPC is below the DPM dampness can migrate through the floor construction and into the wall. Where the DPM is formed by brushing on waterproof emulsions it may fail owing to inadequate thickness or general failures in workmanship. Polyethylene sheets of inadequate thickness, typically <math><0.25\text{ mm}</math>, can be punctured because of site conditions and allow dampness to enter. This can also occur where there is insufficient overlap and jointing of the polyethylene sheets.

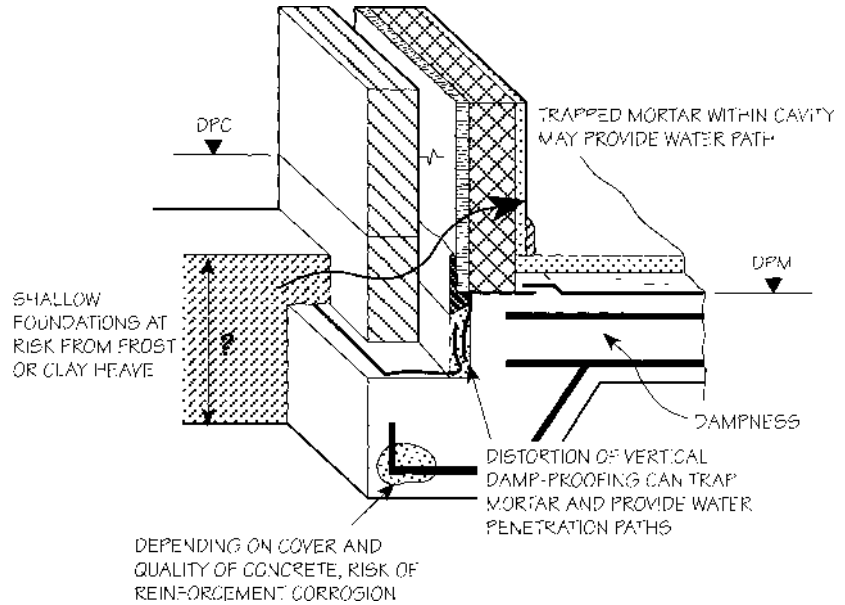
**Fig. 9.5.** Water penetration routes through raft foundation junction with walling.

or other measures, this may not occur in practice. Accumulations of mortar which extend above the DPC level can act as a conduit for rising dampness. Where DPCs are stepped between the outside and inside leaves of a cavity wall the cavity in this region is relatively small and therefore more easily filled with mortar droppings. A similar problem can occur with a concrete raft foundation.

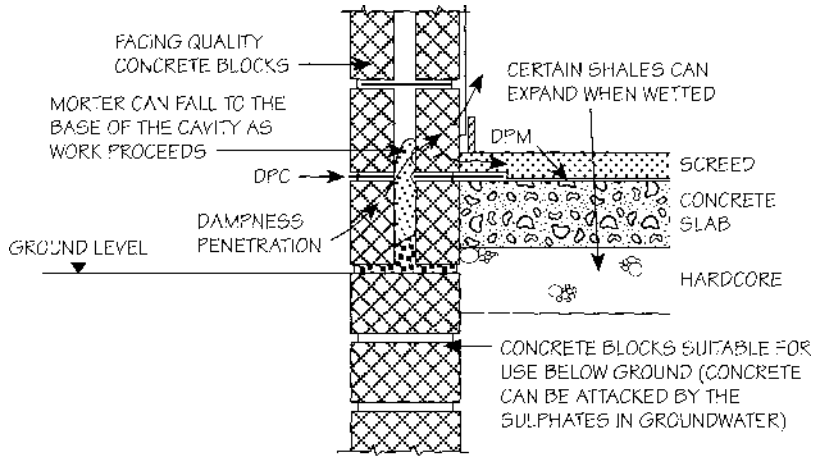
**Fig. 9.6.** Dampness penetration through mortar droppings at the base of the cavity.

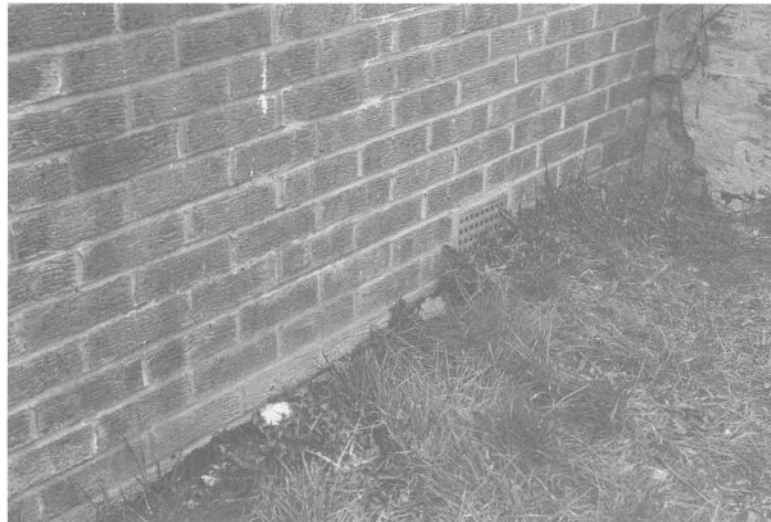
**Fig. 9.8.** The partially buried air brick suggests that the DPC is also close to ground level.  
(K.Bright.)

The 150 mm minimum distance between ground and DPC level may disappear owing to gardening activities or pavings. Providing an effective DPC at door thresholds can be problematic.

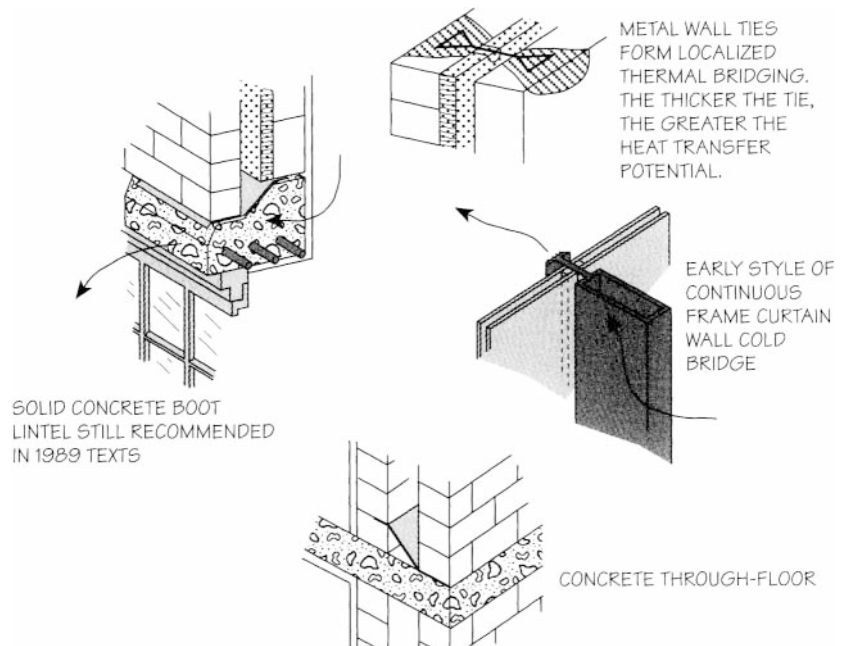
**Fig. 9.9.** Simple forms of cold bridge.

for condensation. This may be due to a variety of factors, including mortar droppings on wall ties in cavity walls, concrete lintels and columns. The areas around the edges of concrete ground- and upper-floor slabs can also act as cold bridges. The presence of moisture will be intermittent, compared to a loss of integrity between the DPM and DPC.

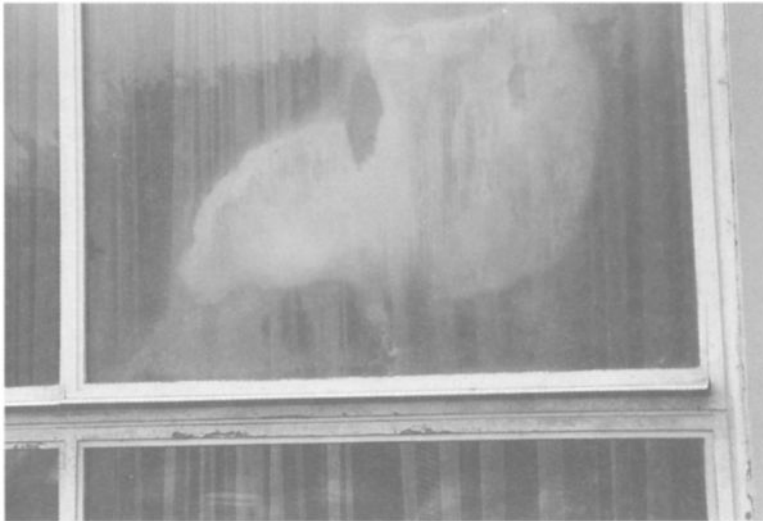
**Fig. 9.10.** Incidence of condensation within a double-glazed window.

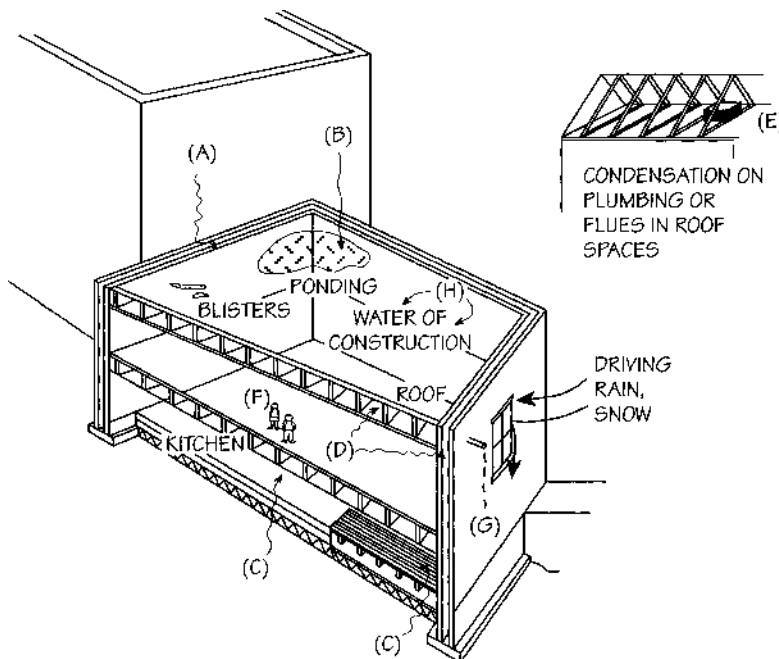
**Fig. 9.11.** Moisture in buildings: sources and problems. Extrinsic sources and routes: (A) permeating dampness from adjacent buildings; (B) leakage of roofs; (C) soils. Internal sources and routes: (D) interstitial condensation; (E) condensation within spaces; (F) people. Intrinsic sources and routes: (G) plumbing overflow—runback; (H) entrapped moisture.

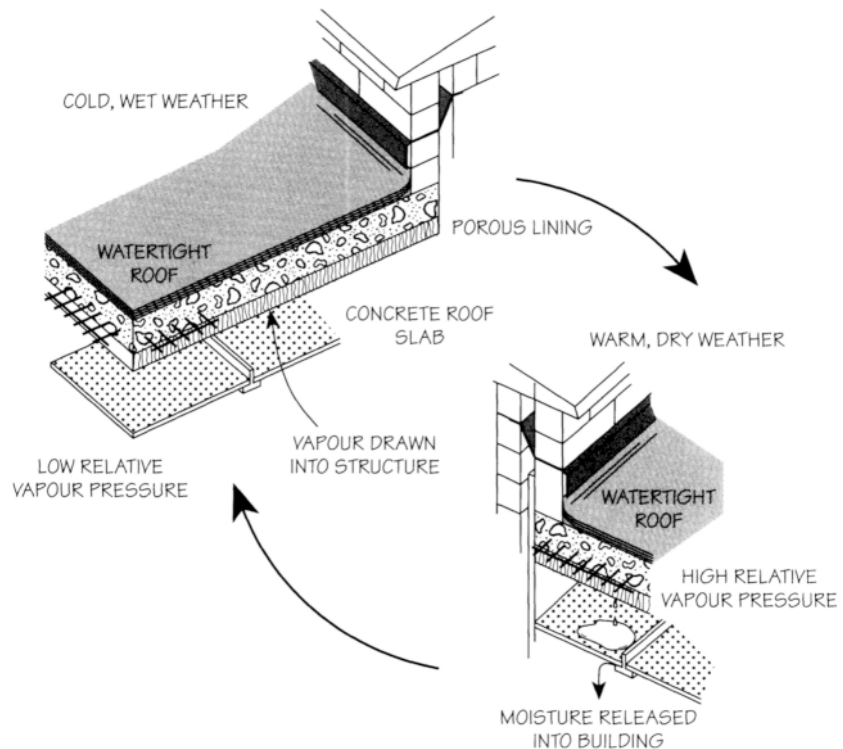
**Fig. 9.12.** Thermal pumping mechanism. (W.A.Allen.)

This is a term devised by Dr W.Allen and is caused by the changes of the external temperature and the difference between it and the internal temperature within the building. During cold or wet weather, the roof or walls of the building become cold. Consequently there can be a lower

vapour pressure in the external envelope thickness than inside the building. Moisture can be drawn into the layers of the external envelope from the inside of the building, and held there. Humid atmospheres are a particular risk.

During warm weather the roof slab or external envelope can substantially increase in temperature, particularly so where it is insulated at the rear. This increases the vapour pressure of the trapped moisture, and where it exceeds the internal vapour pressure, moisture is forced back out into the interior of the building. Moisture then appears, perhaps as drips from a ceiling, at times when conventional leakage is unlikely.

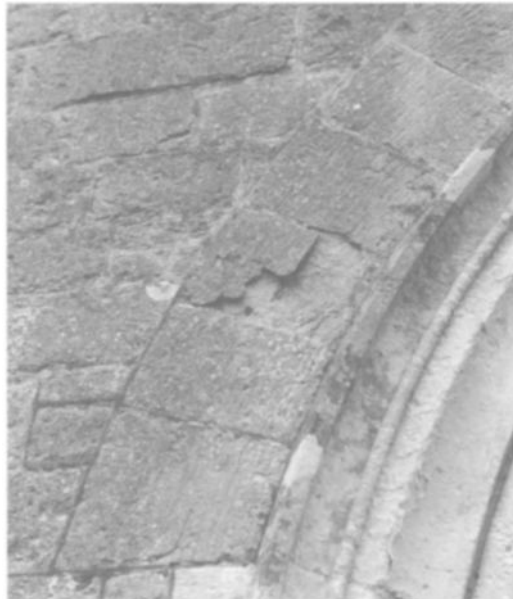
**Fig. 9.13.** Delamination of stone surface. The initial, developing and advanced stages are clearly shown. (K.Bright.)

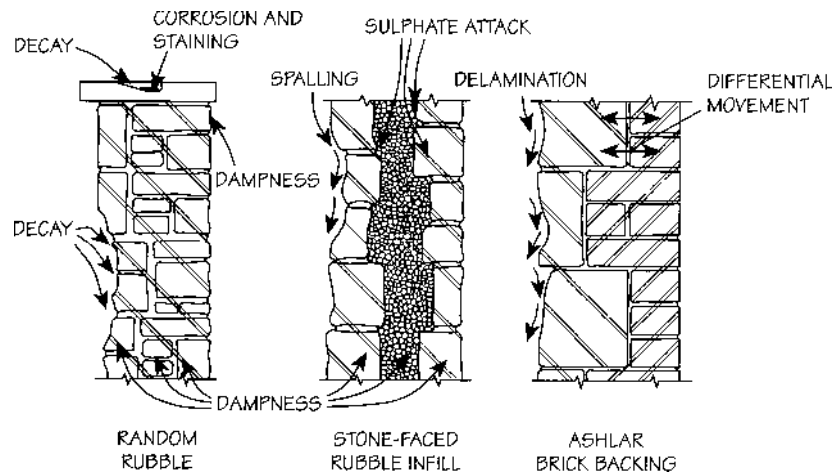
**Fig. 9.14.** Defects in stone walls.

The most widespread problem arises from the crystallization of soluble salts (the mechanisms of which are dealt with in the 'Materials' part of this book). This can cause sufficient pressures to build up behind the face of the stonework to fragment the stone, leading to localized splitting or spalling at its surface.

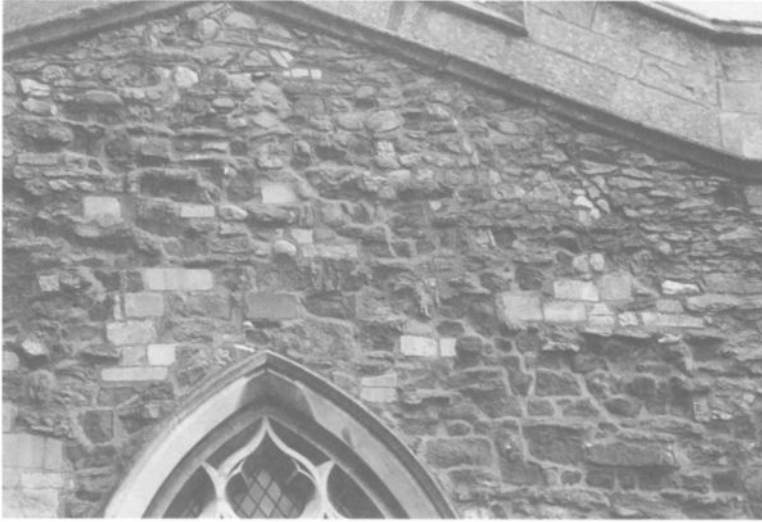
**Fig. 9.15.** General weathering of stone wall. The pattern of attack has been influenced by the position of replacement stone. (K.Bright.)
