# THE TECHNOLOGY OF BUILDING DEFECTS

John Hinks  
Geoff Cook

# Defects with materials

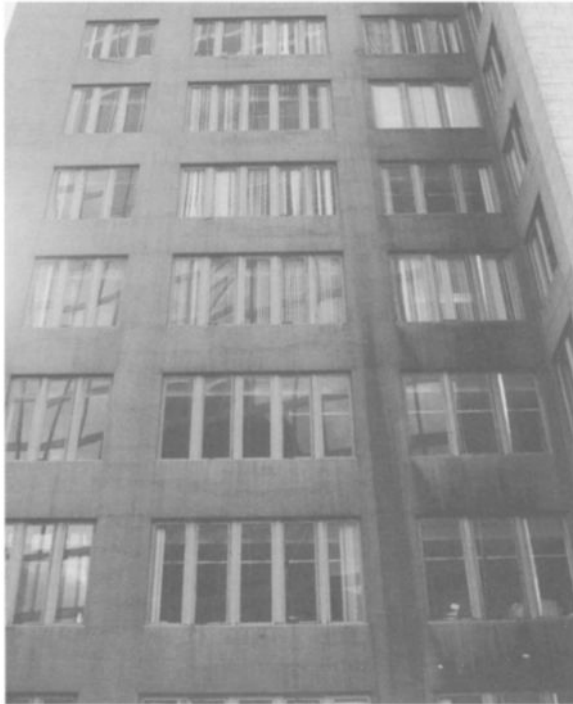
**Fig. 9.16.** The staining of this external façade is more pronounced in the internal corner, where the effect of rain washing is less marked.

It is common for this mechanism to cause gradual erosion, such as in limestones, aided by the washing of rainwater. The sedimentary deposition of stones can exacerbate such problems, as will details which expose the stone to run-off. The rainwater run-off on stone buildings may produce staining as it leads to the transportation of salts to other locations, leading in turn to secondary attack on other materials. Drying out of the stonework can itself be destructive, more so if a dense and relatively impermeable mortar leads to most of the evaporation (and therefore moisture-transport-related erosion) occurring from the stone surface.

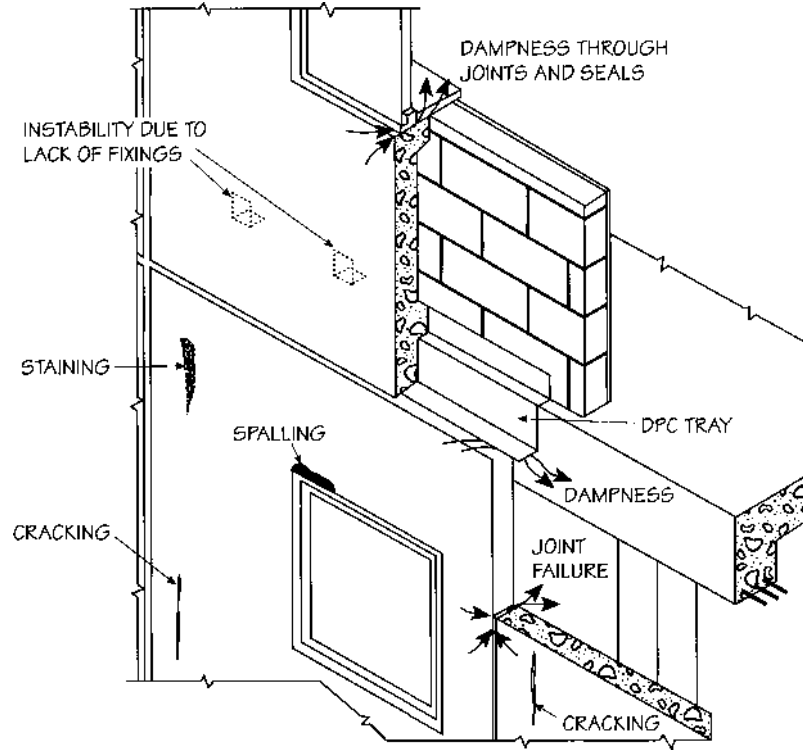
**Fig. 9.18.** Schematic view of characteristic defects in pre-cast concrete walls.

There are distinctions between the function and operation of top-hinge and base-support fixings which should be borne in mind when assessing the deficiency or otherwise of fixing. However, the appearance of movement symptoms due to localized over-attachment coupled with movement stresses is likely to appear at the points of least fixity. Hence base-supported panels are likely to exhibit movement at their head. Heavily fixed units will exhibit their movement at their joints (imposing loads on the sealants and

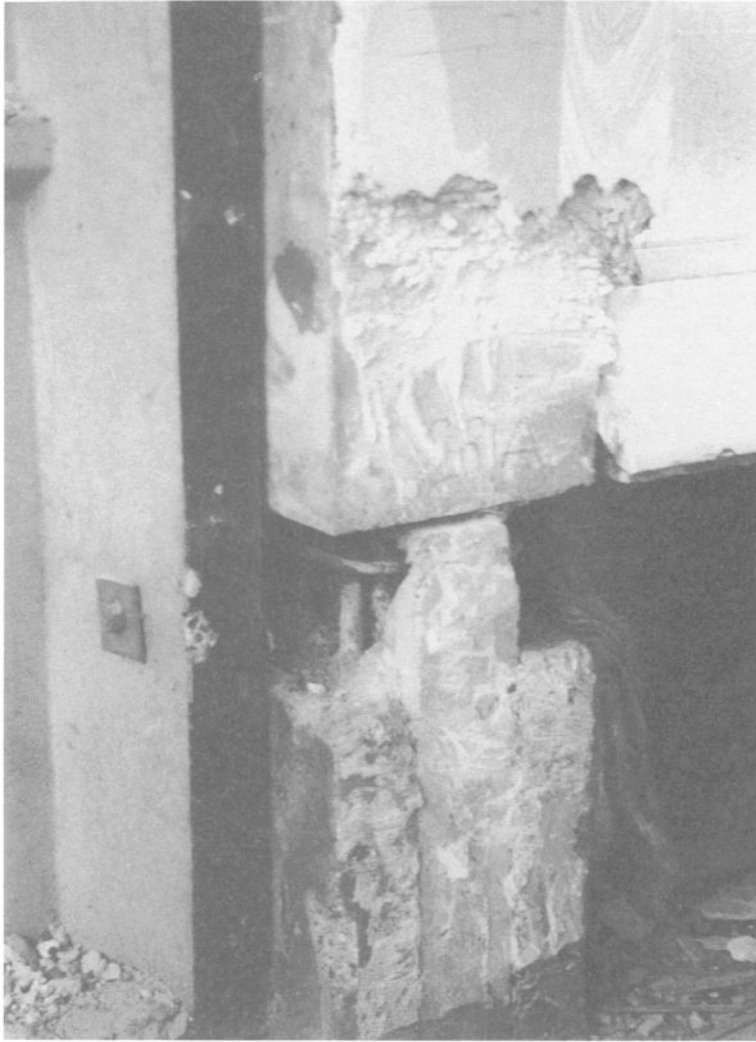
**Fig. 9.19.** The exposure of poor or non-existent continuity of reinforcement between precast concrete column sections.

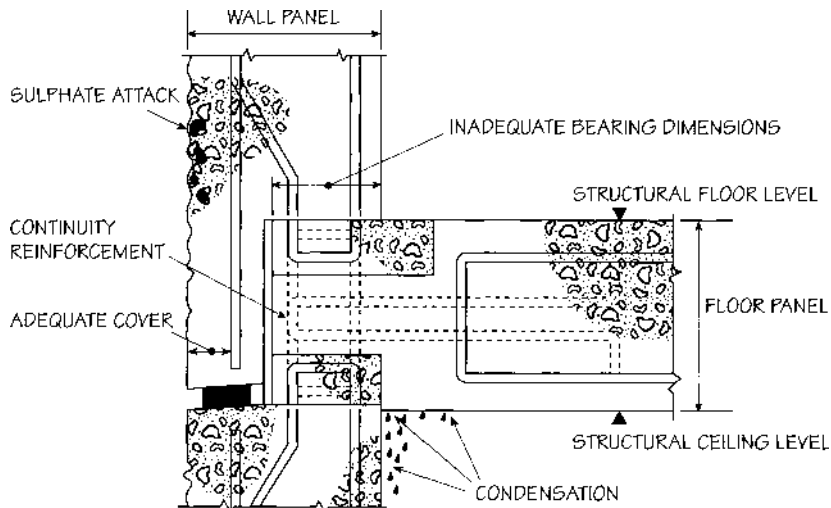
**Fig. 9.20.** Precast concrete walls—problems at external wall-to-floor junction.

In addition to the problems with fixings, there can also be defects arising from the bearings upon which panels rest. These may occur in terms of the accuracy of fit of panels and any adjustment made to accommodate this vertical inaccuracy during construction (such as hacking off the floor surface or addition of packing material). Horizontal inaccuracy can mean that in some cases the bearing may be reduced by cumulative inaccuracy to very small dimensions—leaving the support of the panel as inadequate and vulnerable to any movement in the structure. In fires the hogging which occurs as a result of the temperature build-up can cause a reduction in bearing greater than some reduced residual bearing sizes.

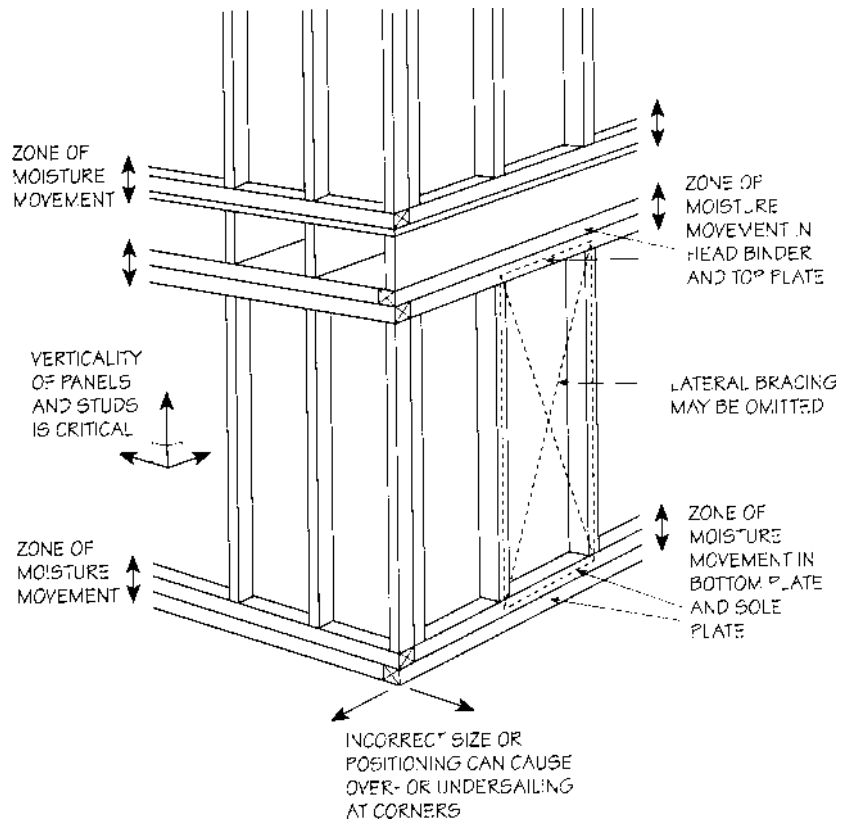
**Fig. 9.21.** Timber frame—movement problems.

Since the moisture movement of timber across the grain can be significant, timber panels are likely to expand and contract in the vertical direction. The initial drying out of the panels may produce a 5 mm reduction in height and where this and a possible 3 mm expansion of the clay brickwork used as an external cladding cannot be accommodated, distortion and cracking may occur. Although the amount of movement may

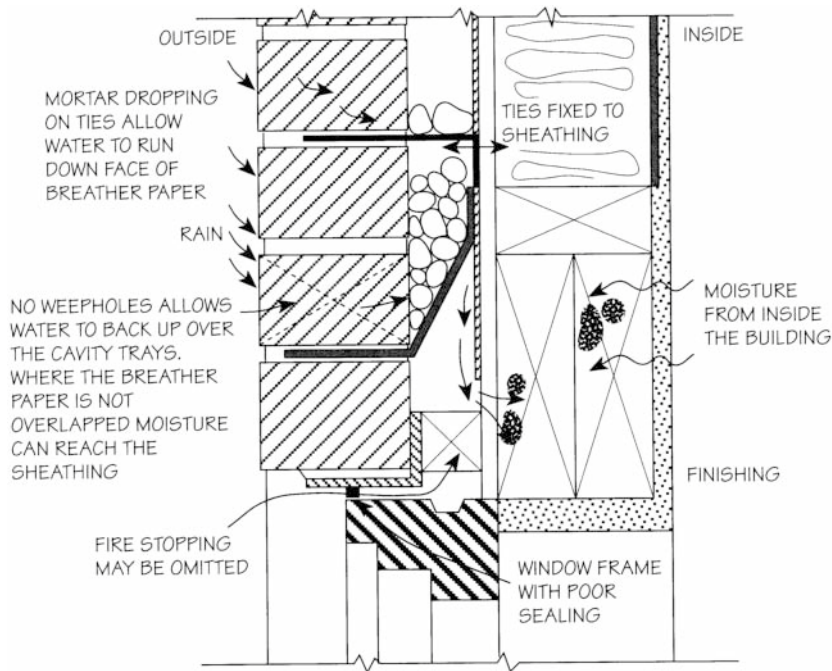
**Fig. 9.23.** Timber frame—general defects at window head.

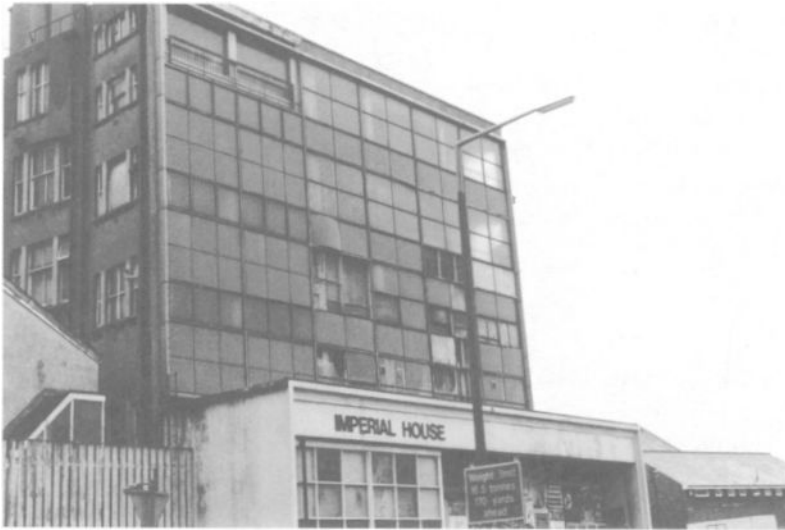
**Fig. 9.26.** Lightweight cladding—intolerance of differential movement between panel and frame. (K.Bright.)

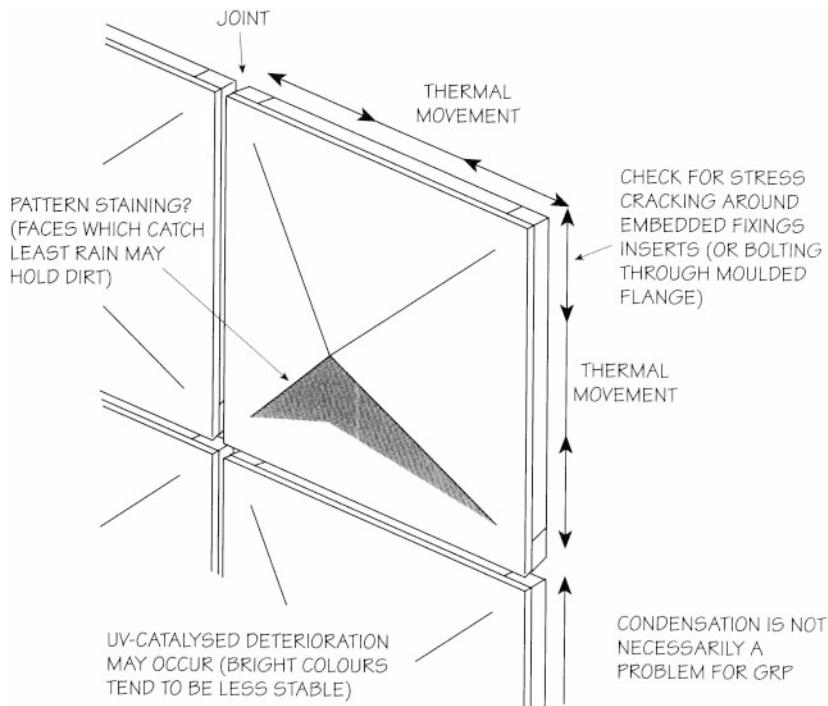
**Fig. 9.27.** Check details for glass reinforced plastic cladding panels.

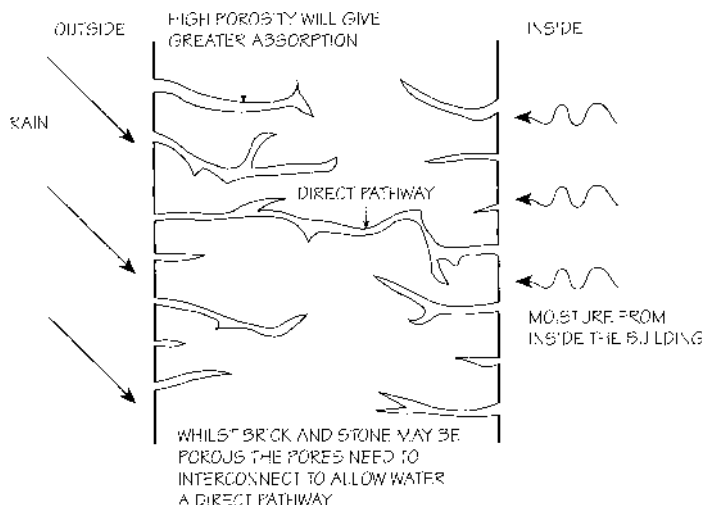
**Fig. 9.29.** Porosity problems with clay bricks.

Rain may pass through a solid wall through the small cracks within the mortar, or between mortar and brick. Exposed locations are particularly vulnerable. The perpends are particularly reliant on adequate workmanship to be effectively filled with mortar and where this does not occur alternative routes for rain penetration are provided. Poor-quality mortar may reduce the weather resistance of large areas of solid wall. Recessed pointing may provide ledges and crevices where rain can

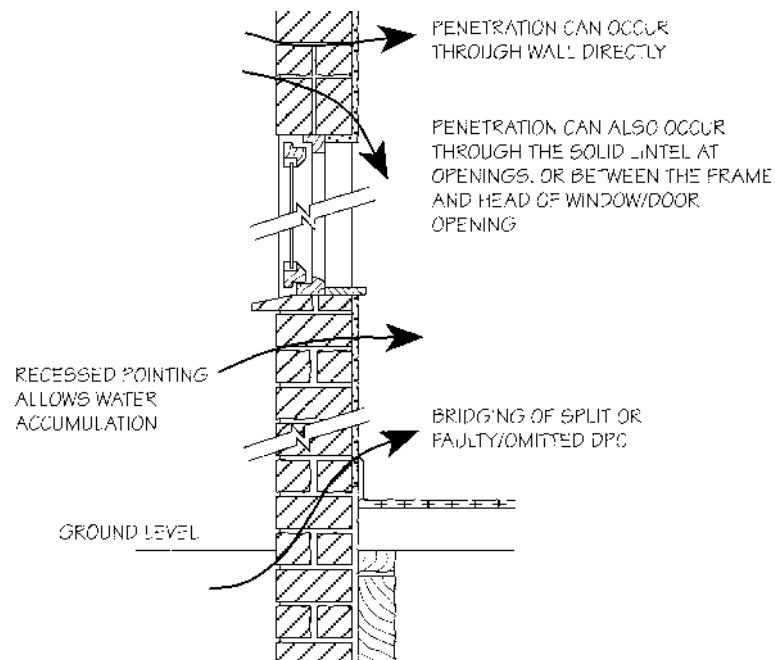
**Fig. 9.30.** Water penetration routes through solid masonry walling.

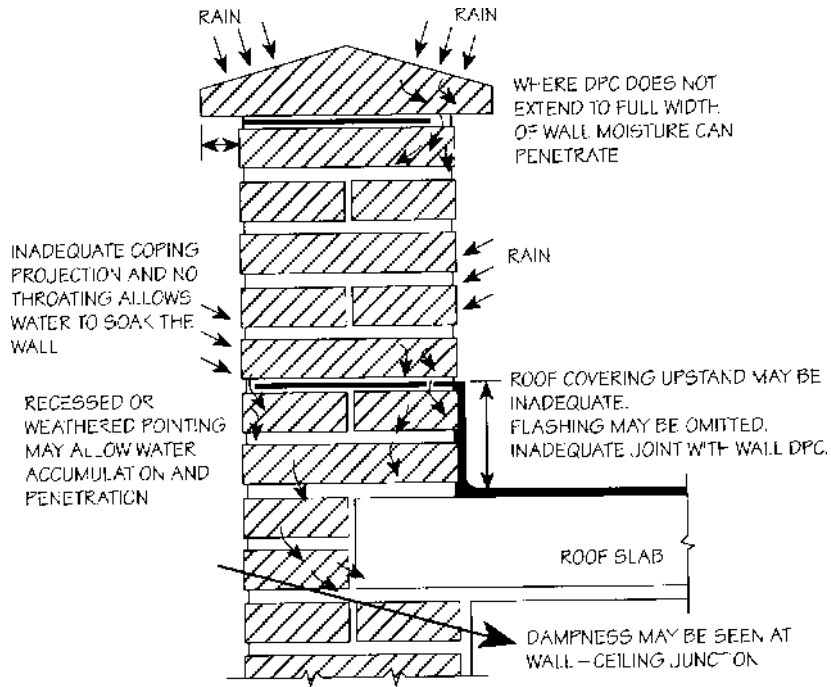
**Fig. 9.31.** Solid parapet wall: failure to resist dampness penetration.

Where a DPC is not provided at the base of the parapet wall there can be no continuity with the roof covering or flashing, and a pathway for rain penetration can exist. Even when a DPC is provided, where it does not pass through the entire thickness of the wall, rain may still enter the wall. This may produce damp patches on the ceilings near outside walls of upper rooms. For timber roofs then dampness in this region may also affect the durability of structural timbers around the parapet gutter.

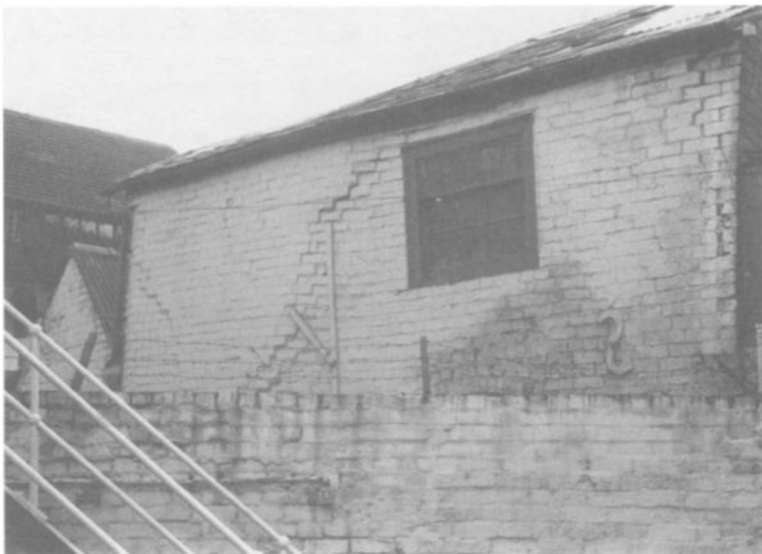
**Fig. 9.32.** Severe diagonal cracking of a solid wall. The external supports appear to be ineffective, although they are evidence of a long-term problem.

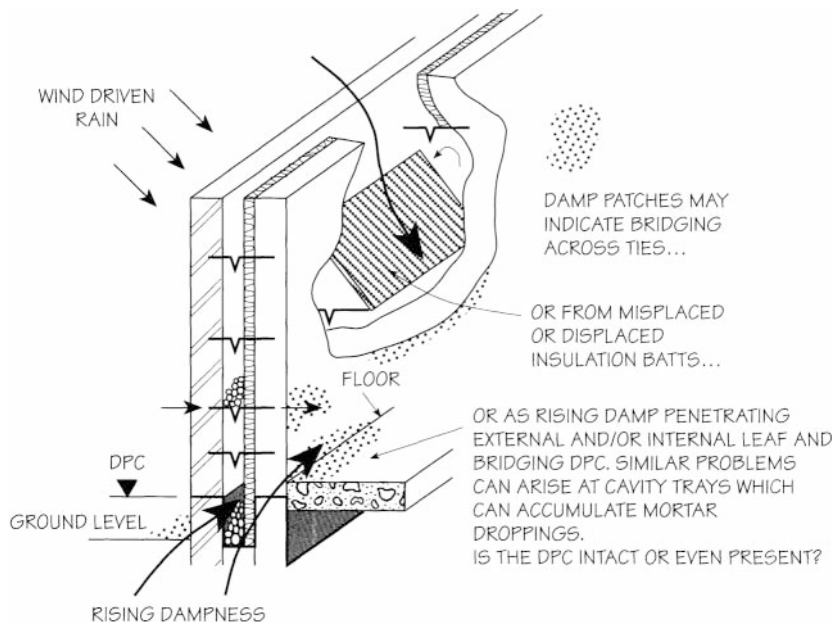
**Fig. 9.33.** Schematic representation of water penetration paths in cavity walls.

Damp can penetrate the cavity wall via a faulty or omitted DPC, which should be used to protect the wall 150 mm above ground level and around openings to the wall. There may also be direct penetration of the wall fabric, or directed penetration of rainwater caused by obstacles in the cavity such as ties coated with trapped mortar or unattached (and therefore inclined) partial cavity insulation creating bridges. It is important to appreciate in considering such potential defects that the cavity zone can remain damp for large portions of the year, and that in driving rain conditions it has been demonstrated that

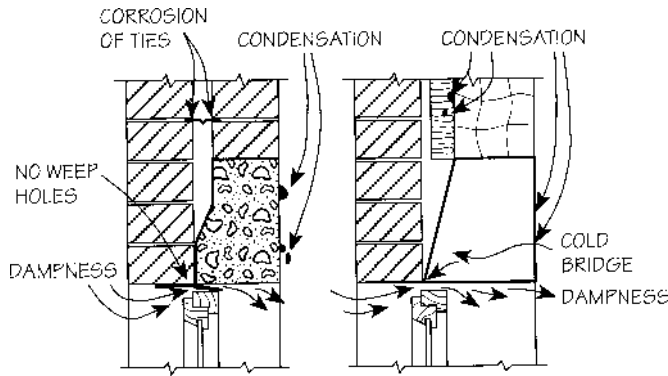
**Fig. 9.34.** Possible water penetration routes at openings in cavity walls.

- Other problems with water penetration could lie in the detailing of components and/or openings in the walls, and of connections between elements. Hence poor overhangs and/or weathering of parapet copings, soffits, window cills and external door steps may provide routes for

water penetration. Windows and doors may provide poor direct weatherproofing, but can also contribute to water penetration at their perimeter connections, especially if such joints are not adequately sealed. Check such dampness carefully to ascertain whether it is water penetration or condensation occurring at a cold bridge. The pattern of occurrence may assist in such a diagnosis.

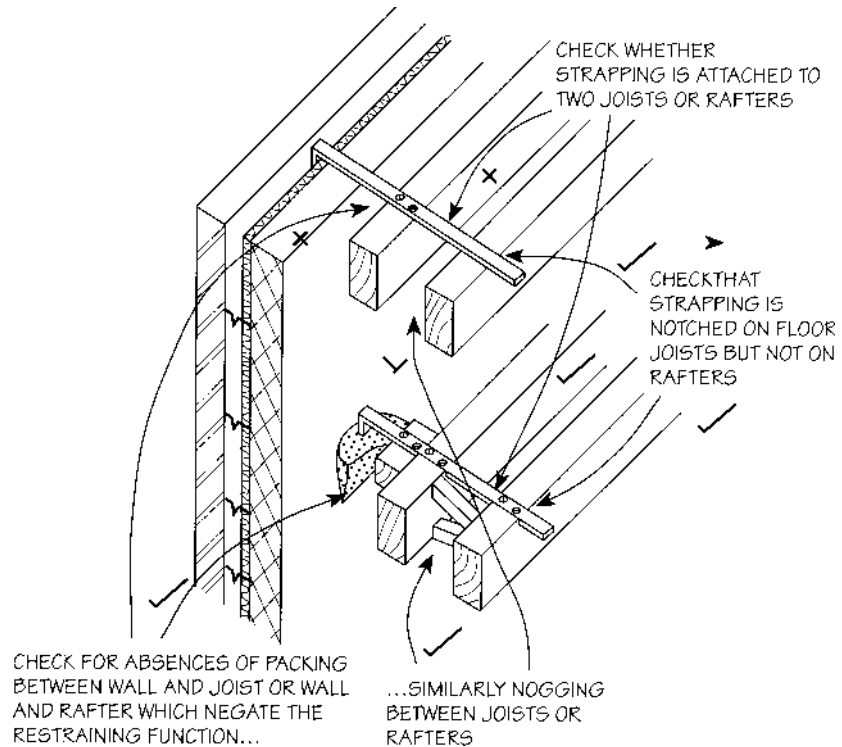
**Fig. 9.35.** Schematic contrast of sound and unsound lateral restraint provision to walls by floors and roof.

Walls are buttressed by the floors and roof to which they are connected, turning the structure of the building into a 3D box rather than a collection of 2D elements. Hence the connectivity between the floors (and roof) and the walls is critical also, and strapping should be checked for a number of potential deficiencies which can render the restraint minimal (Figure 9.35). Such defects can be the result of poor design/specification or workmanship. Note that this means conversely that overloading or failures in the floors or roof will result in extra imposed loads on the walls, which may be eccentric or unbalanced, thereby causing potentially serious secondary defects in the wall.

- Connections with floors and roofs are critical to provide lateral restraint to the wall. A number of installation defects can arise with such connections, including the omission of packing between floor joists (or roof timbers) running parallel to the wall and the wall which they should be stabilizing, the omission of packing between the outermost pair of joists (or rafters) used for lateral restraint and the absence or improper attachment and notching of the strapping to the joists (or rafters) and/or wall.

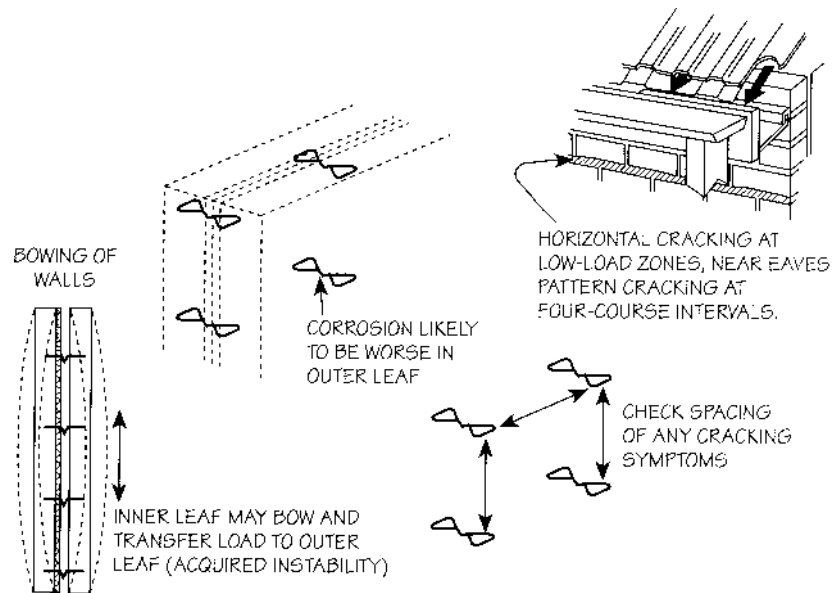
**Fig. 9.36.** Symptoms of wall tie corrosion.

The effect on the wall of wall tie failure will be horizontal pattern cracking corresponding to the location of the wall ties (usually every four courses and approximately 5 mm wide). There may also be vertical and/or diagonal cracking. The horizontal cracking is most likely to occur where the resistance against uplift is least, such as near eaves.

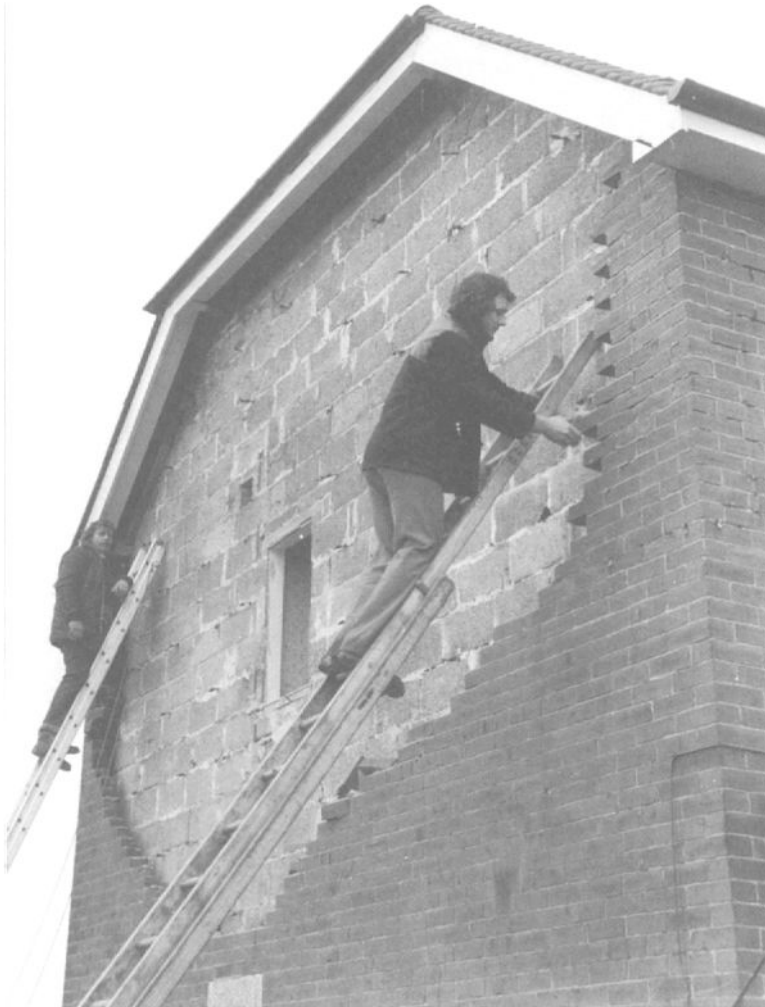
**Fig. 9.37.** Wind damage to a cavity wall forming the gable end of a domestic building. Significant negative pressure on the face of the wall has detached it from the inner leaf, overcoming any resistance of the wall ties. (Reproduced from the *Kentish Gazette*.)

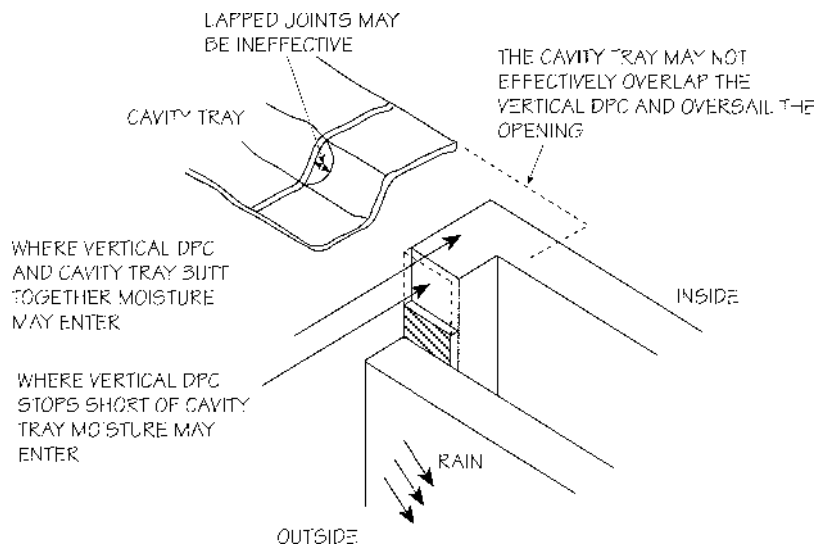
**Fig. 9.38.** General defects—cavity tray and vertical DPC junctions.

Inadequate overlap of the cavity tray and the vertical DPC to the jamb of the opening may allow rain to penetrate.

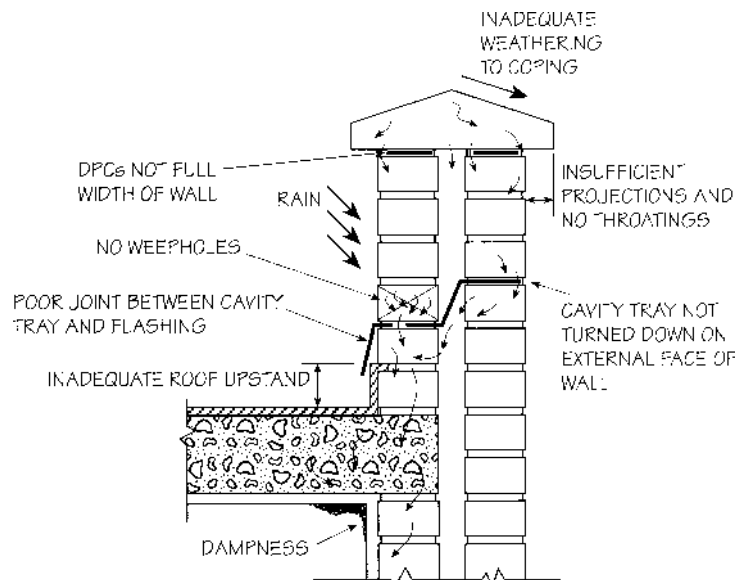
**Fig. 9.39.** Parapet wall—cavity tray problems.

The cavity tray at the base of the parapet wall may fail to stop dampness where it does not extend through the full thickness of the external skin of the cavity wall. The cavity tray may not overlap the flashing to the roof covering. Flashings may not penetrate the full thickness of the inner leaf and therefore offer little resistance to damp penetration. Where flashings are chased into the same bed joint as the cavity tray, any joint between the two may fail to resist penetrating dampness.

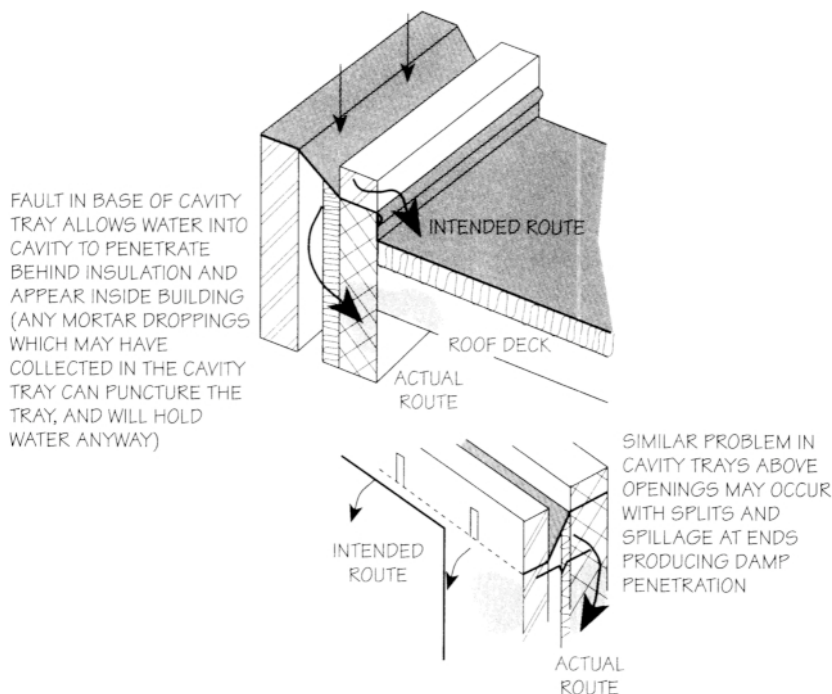
**Fig. 9.40.** Possible defect path for water penetration to insulation: cavity tray failure.

Where insulation boards are inadequately fixed to the outside surfaces of the inner leaf of cavity walls, they may fall and bridge the cavity. Mortar extrusions from the outer leaf may partially bridge the cavity, allowing water to drip onto poorly fixed or distorted insulation boards. Where the cavity is filled with insulation batts the mortar extrusions can compress the insulation material and any water entering the batts may follow the compression layers towards the inner leaf of the wall.

Insulated cavities may block or close weepholes, rendering them partially or completely ineffective. Where insulation prevents water from draining freely from the cavity this will influence the effectiveness of the

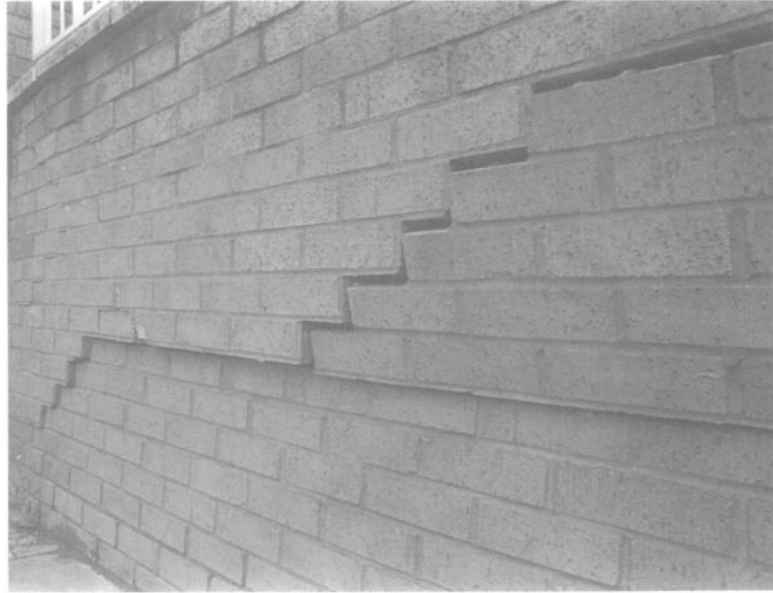
**Fig. 10.1.** Diagonal cracking and displacement of a brick retaining wall due to differential movement between the base and the top of the wall.

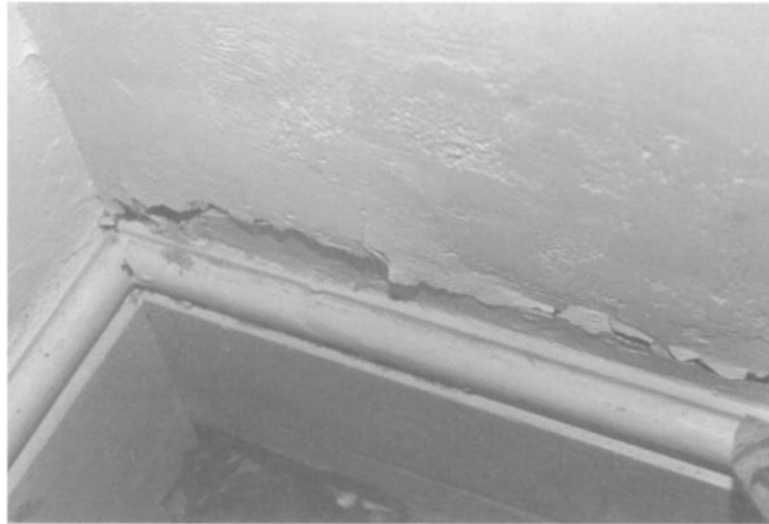
**Fig. 10.2.** Movement of the structure which can occur at DPC level may also be visible internally.

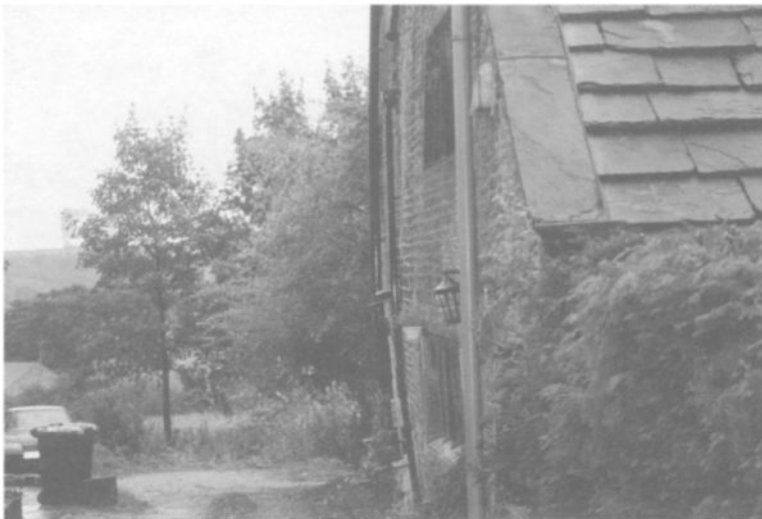
**Fig. 10.3.** Ballooning of the gable end of a stone building. The downpipe acts as a visual reference line. (University of Reading.)

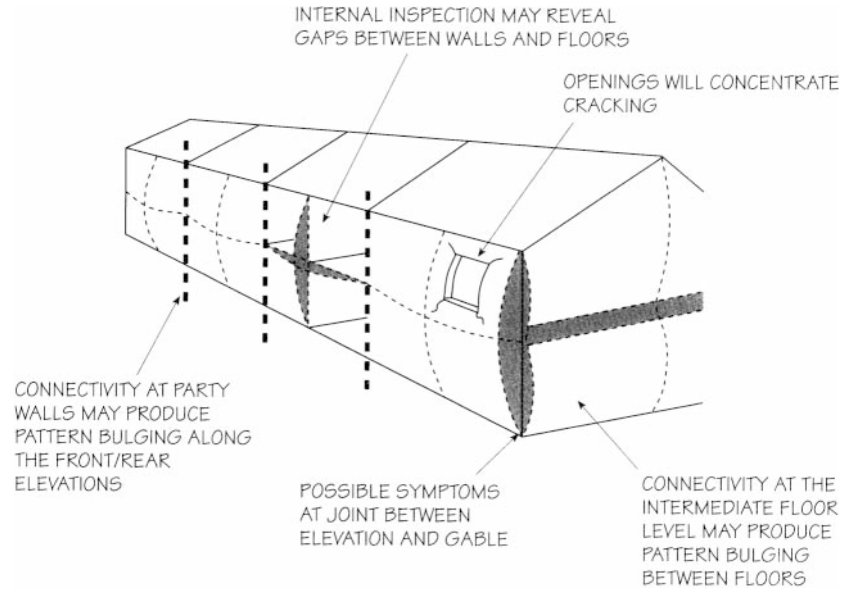
**Fig. 10.4.** Ballooning in terraced housing.

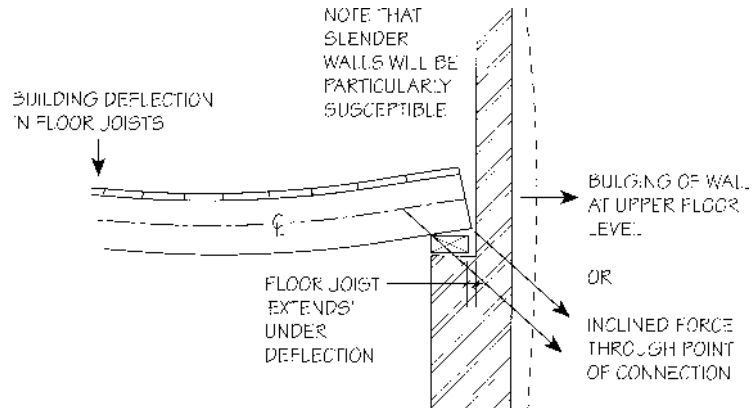
**Fig. 10.5.** Side forces from bending timber joist or beam causing wall to bulge.

Bulging or ballooning in walls can be caused by overloading of floors which transmit these loads under deflection as inclined forces on the walls. Bulging may also be exacerbated by a lack of restraint from the floor structure if the appropriate corrections to parallel joists are missing. The effect in both cases may be a full-height bulging of the wall—the cause of which will require investigation for positive identification. Note that a wall which is bulging may pull the parallel connected floor joists into deflection also.

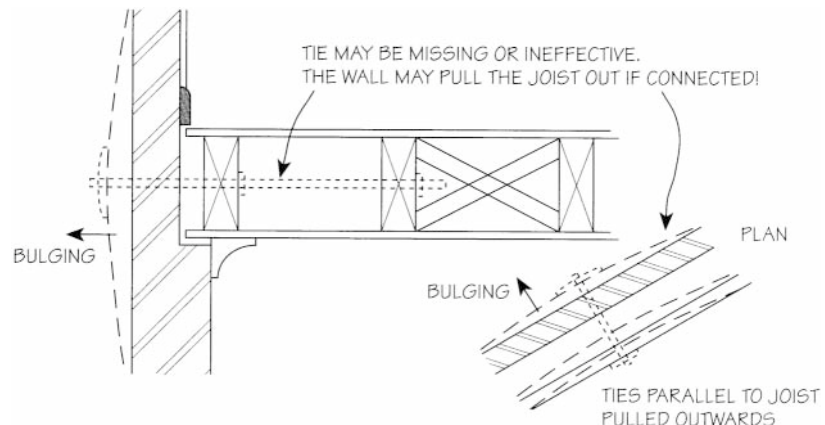
**Fig. 10.6.** Lack of support from parallel joists allows bulging of wall.

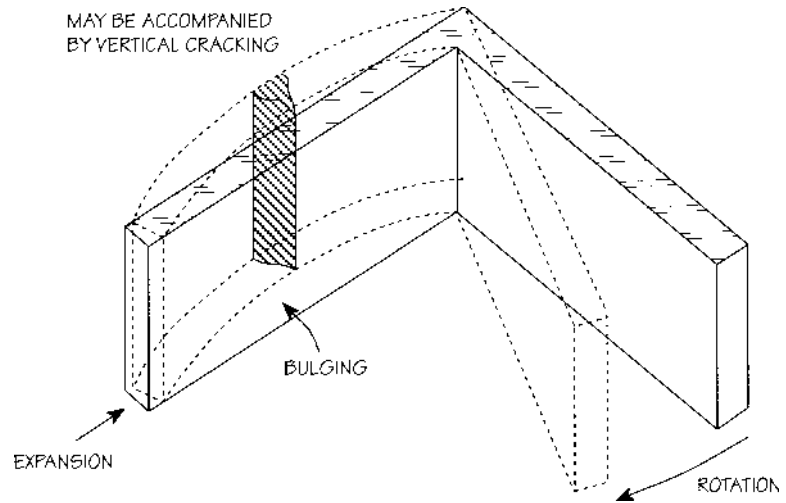
**Fig. 10.7.** Rotation and cracking in walls: bulging of wall attempting expansion against restraint. This phenomenon may occur with ballooning in elevations and gables.

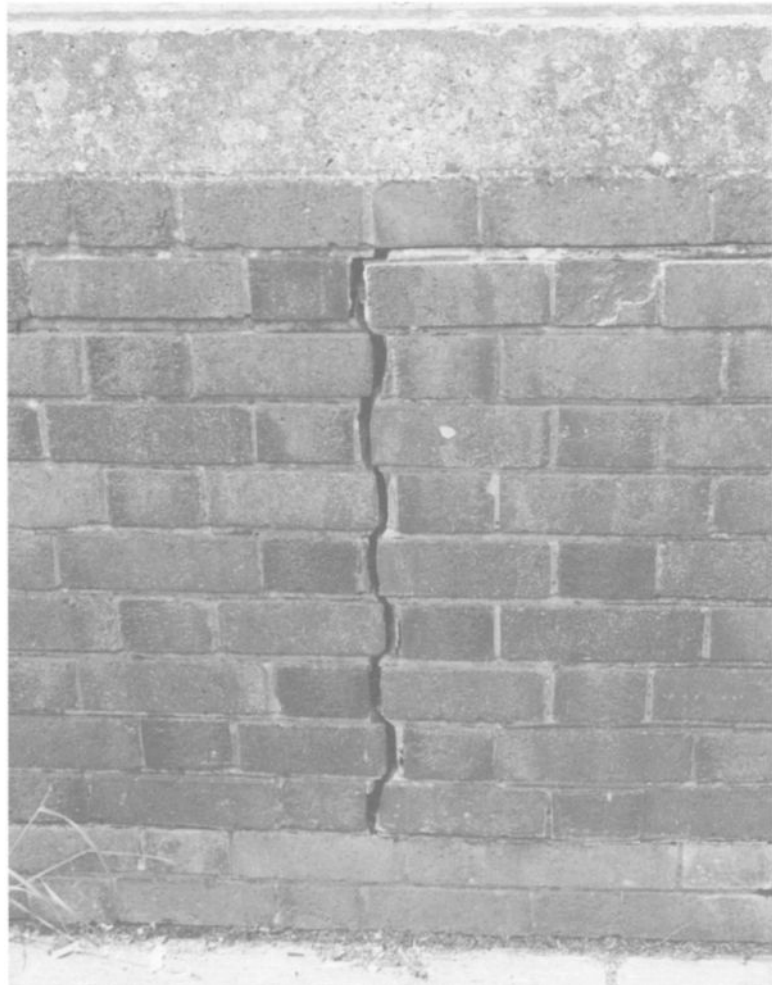
**Fig. 10.8.** Tensile cracking—even through bricks where a high mortar strength is present. (K.Bright.)

The tensile capacity of brickwork is usually relatively low. It is also normal for the mortar to have a lower tensile capacity than the brickwork, and therefore to exhibit the cracking. In cases of brickwork with very strong mortar the cracking may pass through the bricks.

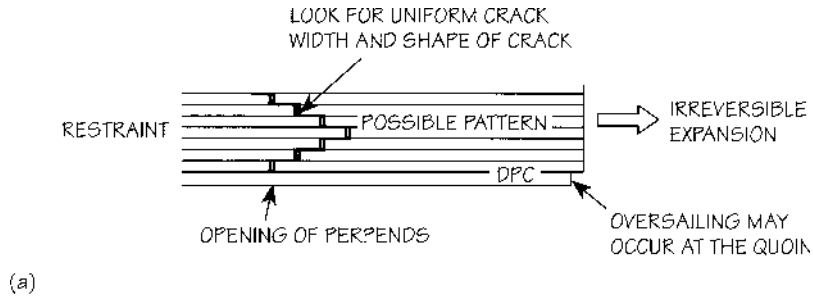
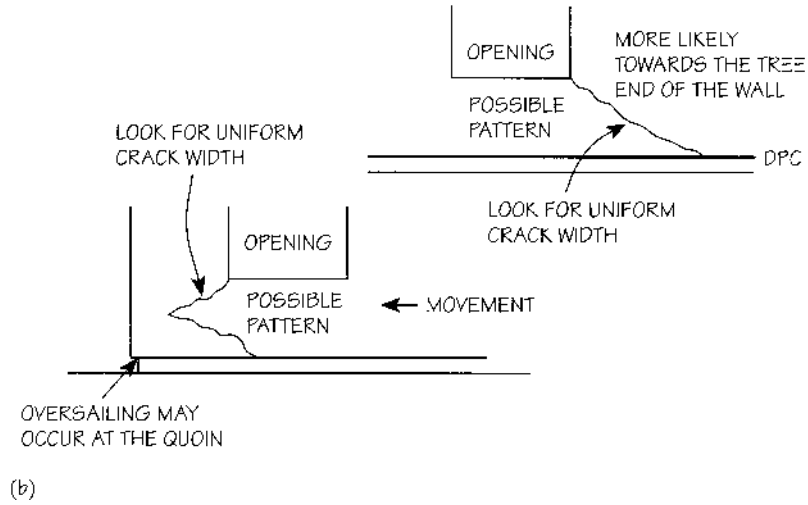
**Fig. 10.9.** Moisture and thermal expansion cracking in clay brickwork: (a) irreversible; (b) reversible. Note that cracking will not usually cross the DPC, and that irreversible and reversible movements may occur coincidentally.

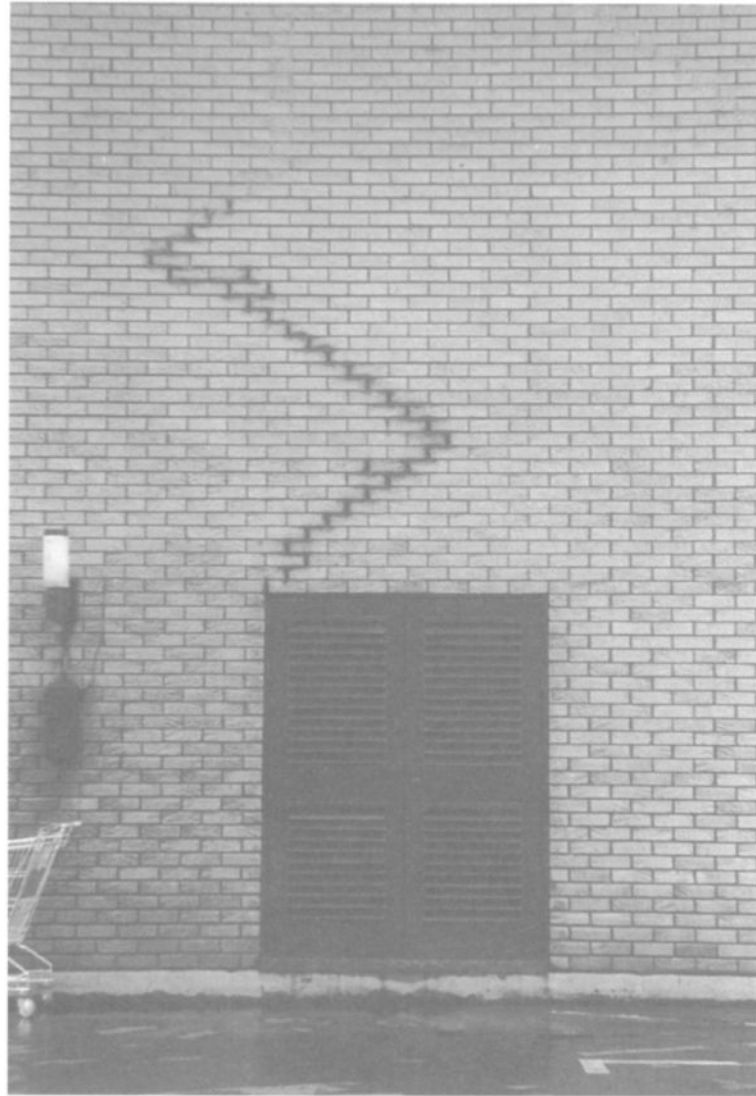
**Fig. 10.10.** Diagonal tensile cracking through mortar joints.

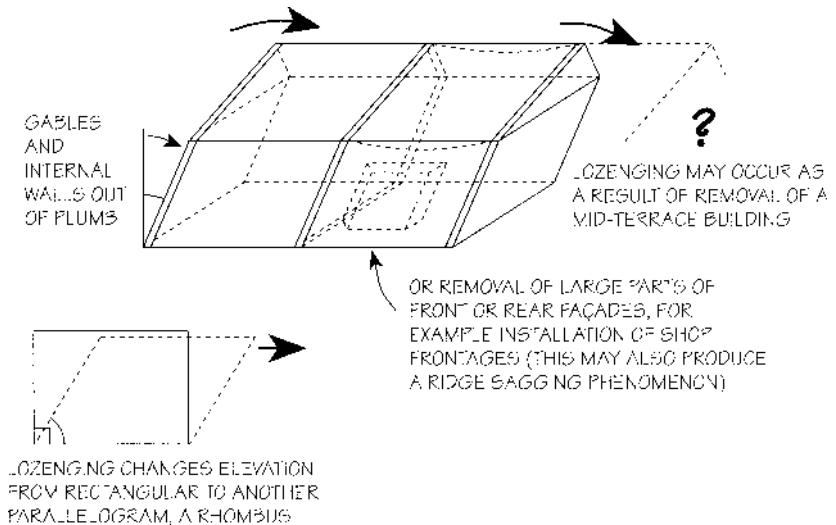
**Fig. 10.13.** Lozenging in buildings.

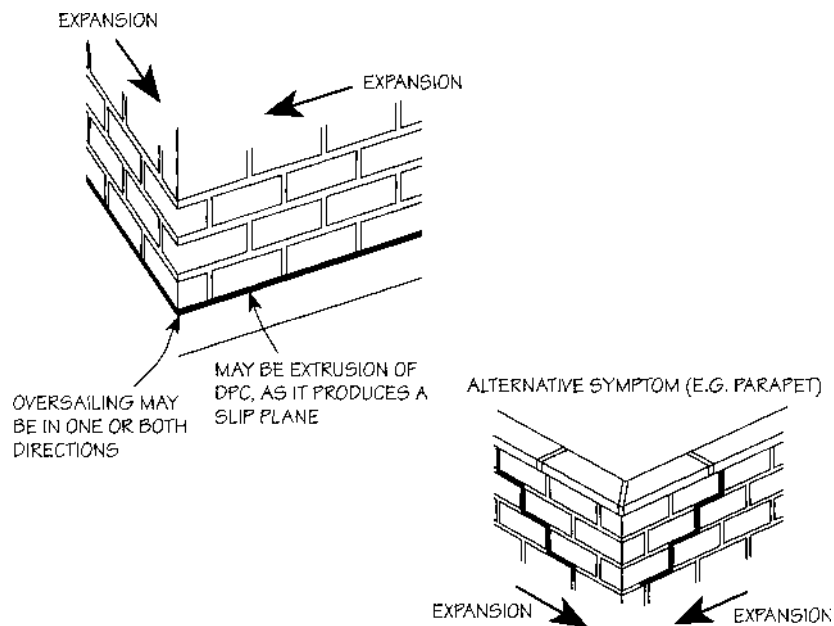
**Fig. 10.14.** Oversailing of walling at corners caused by expansion of long runs of brickwork.

Oversailing is a phenomenon that occurs at the corners of buildings, usually at the DPC level, where the DPC creates a slip plane and dislocates the wall experiencing stresses from wall below the DPC, or at other locations in the building where a relatively unrestrained element is in contact with a restrained or restraining element—for example, a parapet wall above a concrete roof deck.

In the former case, expansion in one or both walls meeting at a corner results in the wall slipping across the DPC during expansion, but not withdrawing upon contraction. The forces under expansion are sufficient to push the wall, whereas the forces under contraction, coupled with the relatively low tensile strength of brickwork walls, are insufficient to pull the wall. The defect appears as a progressive overhanging of the wall or parapet in one or two directions. Any DPC in contact with the wall may be extruded also. The extent of overhang is related to the coefficient of expansion and the extent of reversible or irreversible movement. Usual causes are thermal and moisture-related movements.

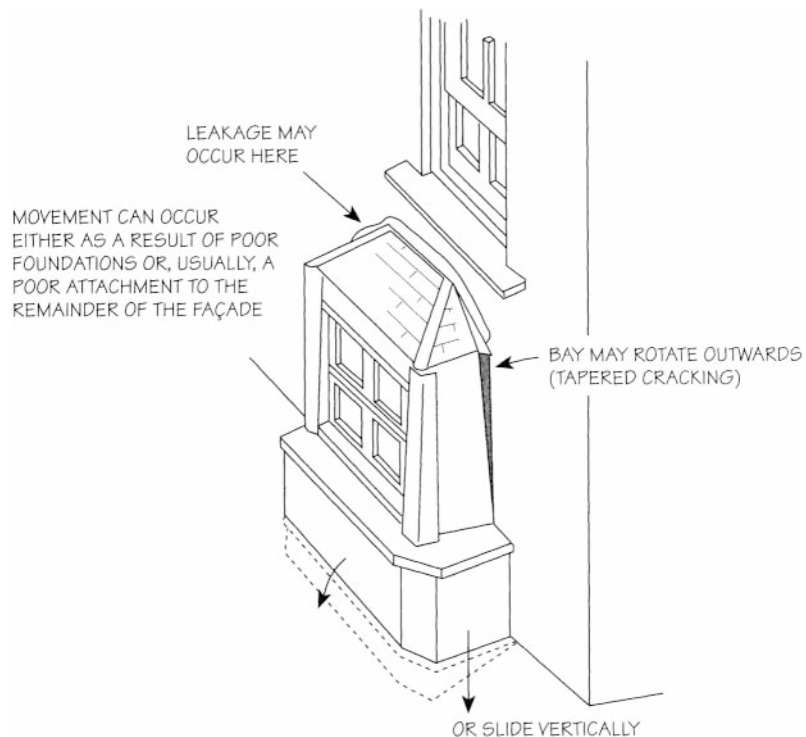
**Fig. 10.15.** Instability in bay window: vertical sliding or rotational settlement with tapered cracking.

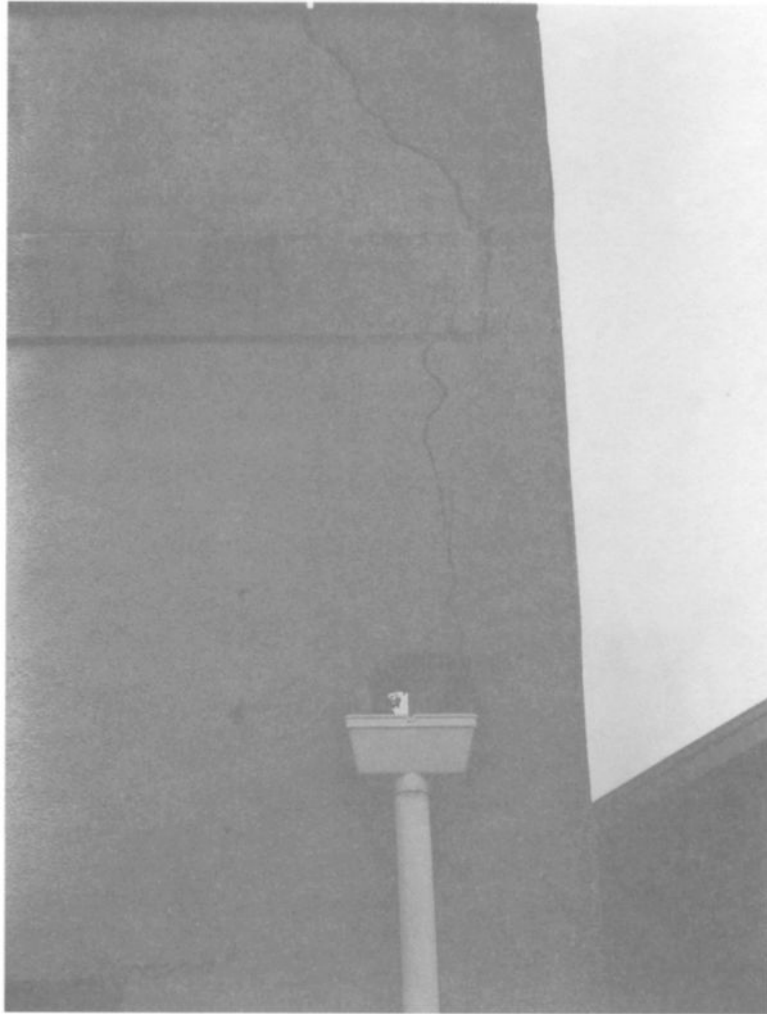
**Fig. 10.16.** External cracking to corner of parapet wall originating at corner of rainwater opening. Expansive effects evident from increase of crack width with height.

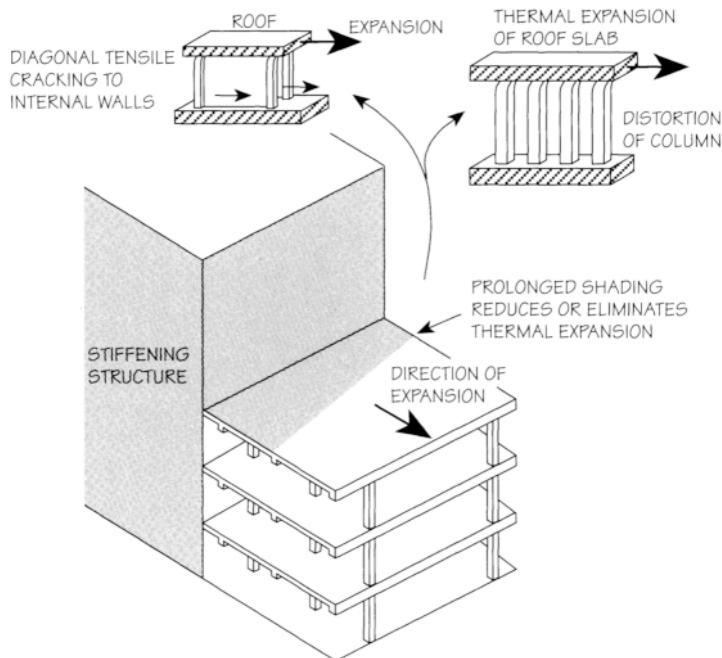
**Fig. 10.18.** Concrete roof slab thermal expansion in framed buildings.

The mechanism usually operates through differential movement in one element of the structure which causes tension at its connections with the remainder of the structure. A possible scenario is that of a flat roof exposed to sunlight and therefore undergoing cyclic thermal movement. In a free-standing and broadly symmetrical building plan and structure the forces will tend to be distributed evenly in all directions. In uneven structures, or plan layout (or alternatively, where the building is attached to a stiff structure), the movement may be concentrated in one direction only (away from the point of restraint). With large elements and/or large temperature (or moisture) changes, the resultant movement may produce significant distortion at connections. This may appear as relief cracking in internal walls or distortion of columns.

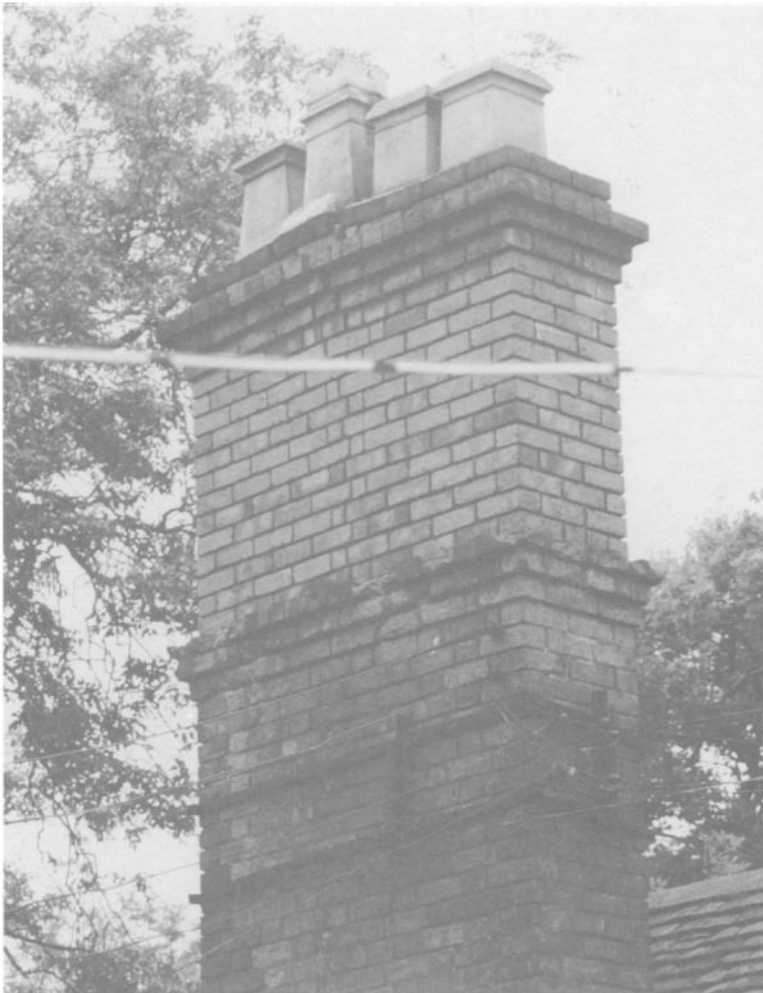
**Fig. 10.22.** Failure of chimney stack. Possible sulphate attack of upper section of stack and weathering damage to the brick corbelling.
