# THE TECHNOLOGY OF BUILDING DEFECTS

John Hinks  
Geoff Cook

# Defects with materials

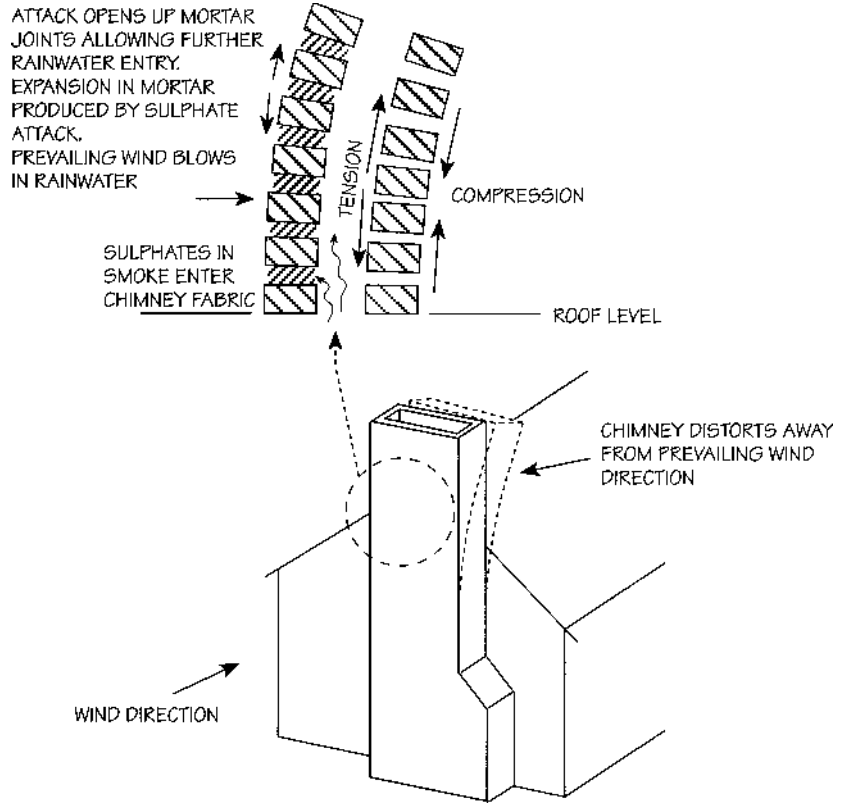
**Fig. 10.23.** Sulphate attack in unlined chimney.

Sulphates in smoke passing through early unlined chimneys pass into the fabric of the chimney. The expansive reactions associated with sulphate attack occur in the mortar in the presence of moisture. For chimneys the exposure is usually related to wind direction, being greatest on the side facing into the predominant wind direction. This side is exposed to moisture more than the others and a differential sulphate attack expansion occurs, producing a characteristic bend in the chimney away from the penetrating winds. This may pull over the attached gable. The bending opens up the exposed mortar joints, which accelerates the process.

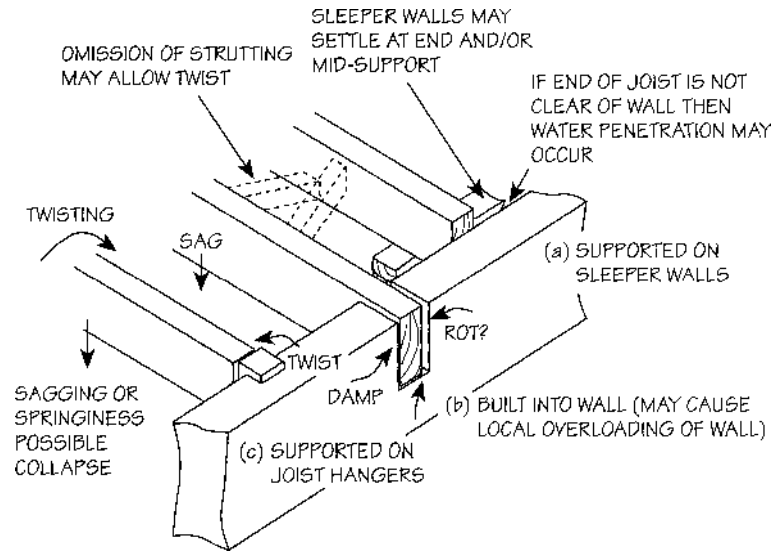
**Fig. 11.1.** Composite schematic diagram of bearing problems in flooring. Sagging may be caused by overloading, or collapse/dislocation end bearing.

The end support/connections for timber flooring joists can be achieved in a number of ways, and deficiency will produce a range of characteristic symptoms including sagging of the floor at edges or particular weak locations, springiness (which may be due to displaced or rotating joist hangers) and local collapse, perhaps due to rot in the bearing ends of the joists or local failure of the support wall.

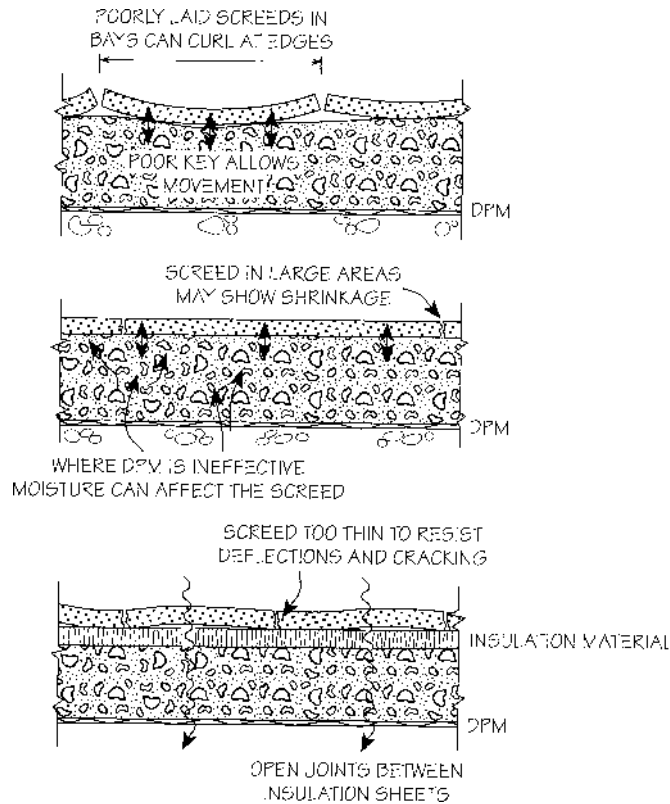
**Fig. 12.1.** Screeds—typical defects.

- Too much time between casting base concrete and laying screed and a poor texture of concrete base. These factors are related to the time between casting and laying the screed. The base concrete may not be swept clean of site debris. Where the time between laying concrete and screed to get monolithic construction is  $>3$  hours then the screed and concrete may shrink differentially. Where the screed is laid within 3 hours of the base concrete but exceeds 25 mm thickness or contains aggregate  $>10$  mm then differential shrinkage can occur. Where the screed is laid on mature concrete it may fail if there is inadequate mechanical key, formed by hacking or scarifying, with the concrete base.

Surface laitance may not have been removed or the surface adequately wetted before laying the screed. There may be bonding problems with screed < 40 mm thick. Screeds laid over a DPM may fail where they are < 50 mm thick.

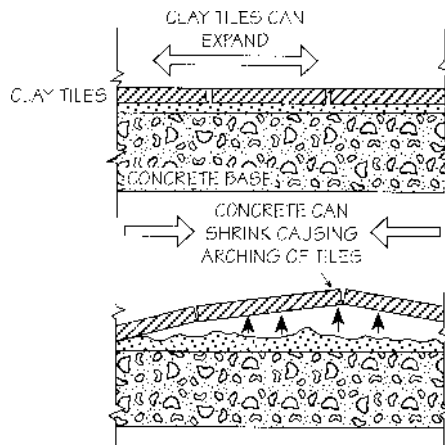
**Fig. 12.2.** Clay tiles—typical defects.

Thermal expansion coefficient differences may exist. When the floor becomes cold the screed may contract more than the clay tiles and they can become detached.

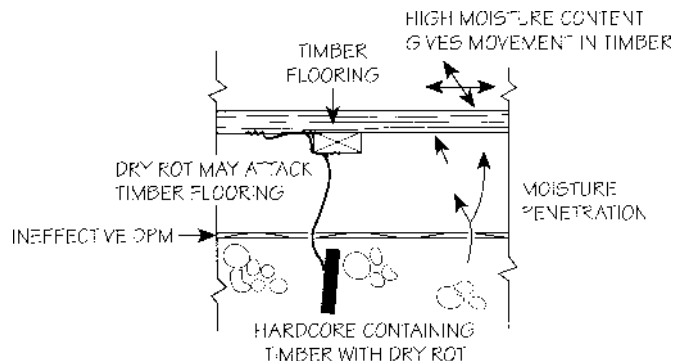
**Fig. 12.3.** Timber flooring—typical defects.

Where moisture movement is not accommodated then expansion can cause arching and lifting. This is a particular problem with wood block flooring. Problems may occur when wood blocks are laid at a moisture content which they would not experience in service. Then when on site to condition to the general humidity, timber may absorb water to above that required in service. When the timber is subsequently fixed it may shrink. Using a high-moisture-movement timber will increase the potential for movement.

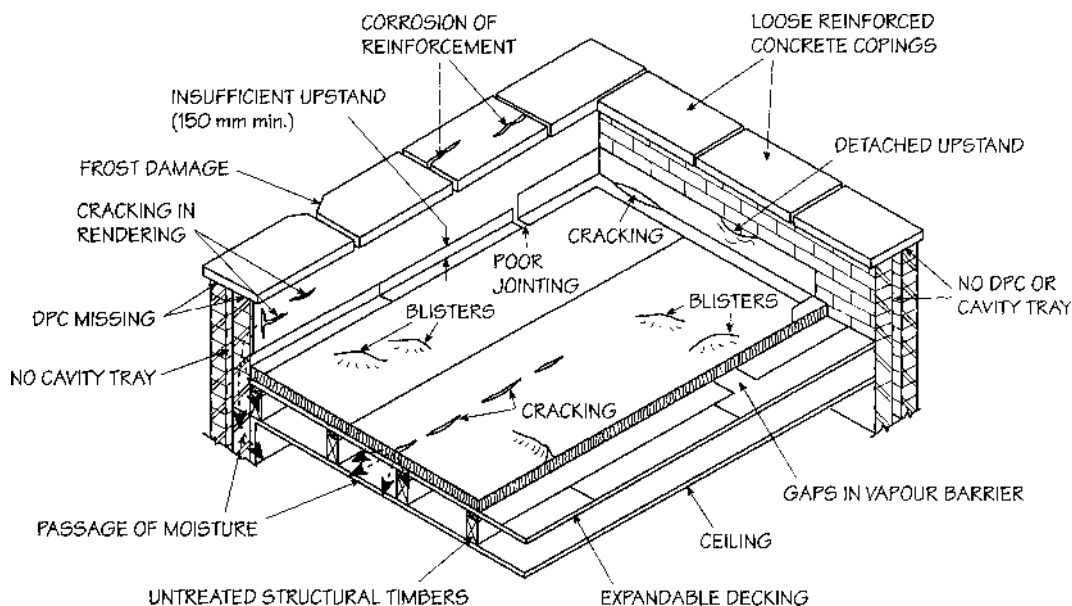
**Fig. 13.1.** Felted roofs: schematic diagram of failure mechanisms.

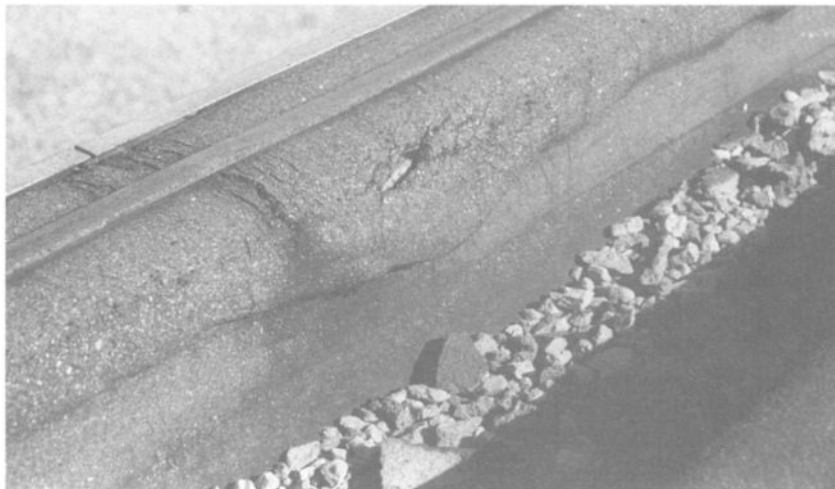
**Fig. 13.2.** Asphalt failure due to thermal distortion and movement cracking. The roof covering has failed plastically over the upstand and exposed the sub-base. (Reproduced from G.Cook and J.Hinks, *Appraising Building Defects*; published by Addison Wesley Longman, 1992.)

where deckings expand and contract, compressive stresses can be imposed on the covering. Deckings with high coefficient of linear expansion will produce the greatest degree of movement/and the greatest problems.

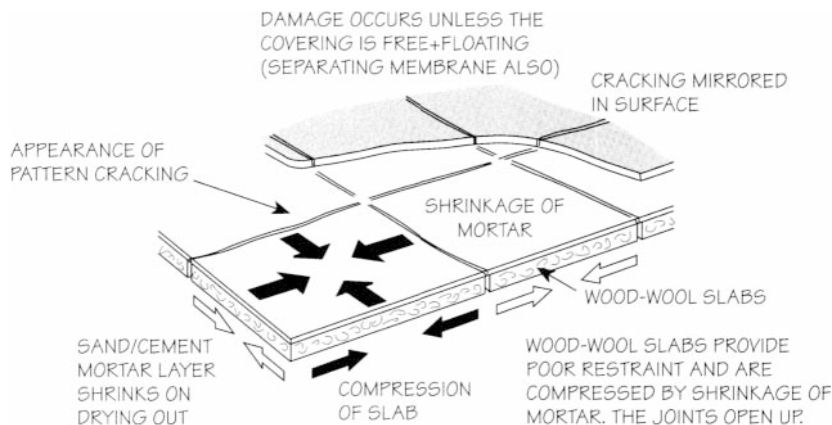
**Fig. 13.3.** Dimensional instability in roofs.

Expansion ridges can occur around isolated fixed points such as pipes and parapets. Their causes may be traced back to defects associated with

concave and convex angles formed in the mastic asphalt. These high-stress points are generally vulnerable, since they operate as the stopping and starting points of thermal and moisture movements. The high temperatures associated with warm roofs may initially assist the asphalt in enabling it to flow plastically. This may be a short-term gain since the material may reduce in thickness, thereby increasing the shear stresses operating during the next movement cycle. This can be further complicated if the separating membrane is omitted.

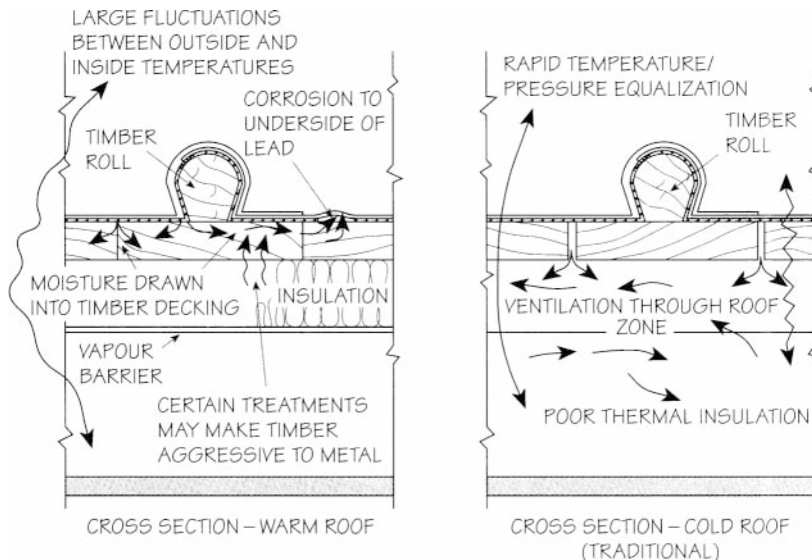
**Fig. 13.5.** Effect of roof type on potential defects.

The general acceptance that 'warm' roofs are superior to other construction forms has meant that where remedial treatment to existing roofs has been carried out, their features have been incorporated. Sealing of the traditional 'cold' roof ventilation path suggests that the incidence of condensation will increase at, or under, the covering and cause corrosion. Where outside temperatures fluctuate greatly, the isolation of the covering from the main building can result in water being drawn through joints owing to the reduction in pressure caused by the differences between inside and outside temperature. Once the corrosion area has become established, it will penetrate the covering. It is driven through a variety of mechanisms—low CO<sub>2</sub> concentrations, chemicals in the timber (e.g. preservatives and flame retardants) and variable oxygen levels.

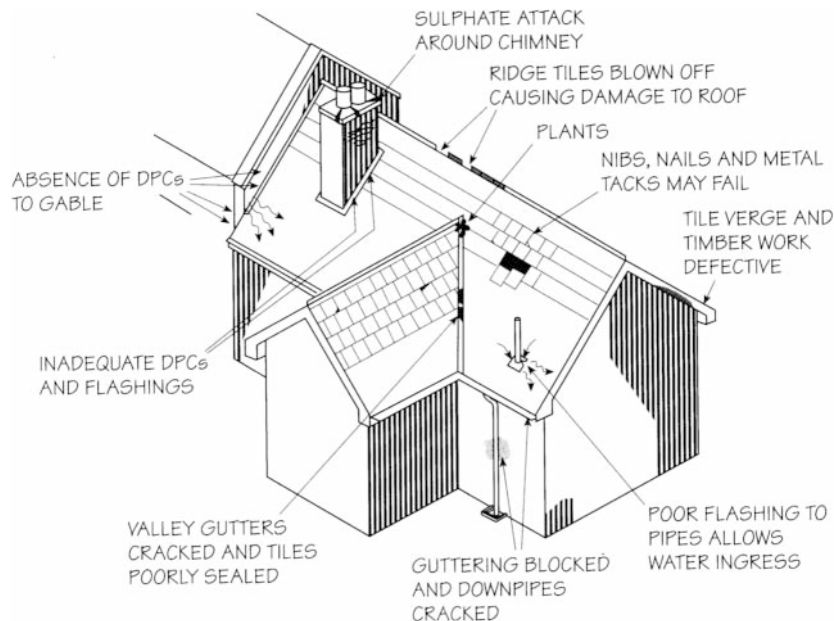
**Fig. 13.6.** Location and nature of pitched roof defects.

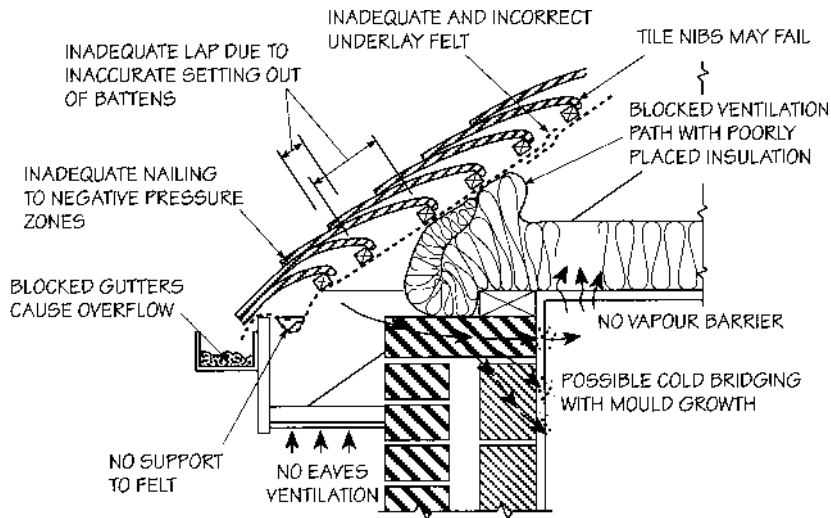
**Fig. 13.7.** Potential defects at eaves of pitched roofs.

Condensation creates conditions suitable for fungal attack and corrosion of metal fixings and so weakens the roof timbers. Where ventilation has been provided, this can become blocked by insulation or stored items. Masonry carried up to the underside of the roofing felt causes the same effect.

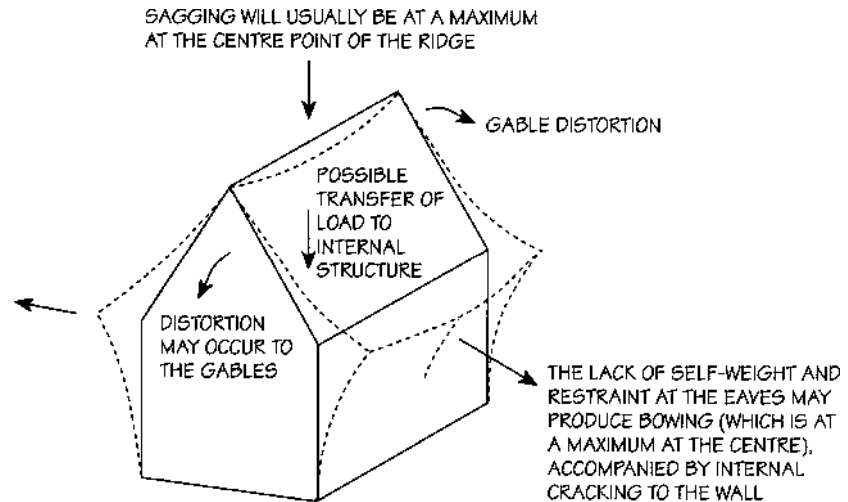
**Fig. 13.8.** Tent-like sagging in pitched roof structure.

Sagging in roofs tends to be brought on by failure of the tensile stiffening in roofs, either the ceiling joists or ties in braced trusses. Sagging may also be simply due to overloading, via a mechanism similar to bulging in walls due to floor deflection and load transfer.

Externally, the symptoms will be a tent-like bowing of the ridge coupled with outward deflection of the eaves, particularly near the mid-point. The response of the gables will depend on the strength and stiffness of the wall, which will be carrying increased load including side forces. Symptoms similar to those caused by racking may occur in the gable(s).

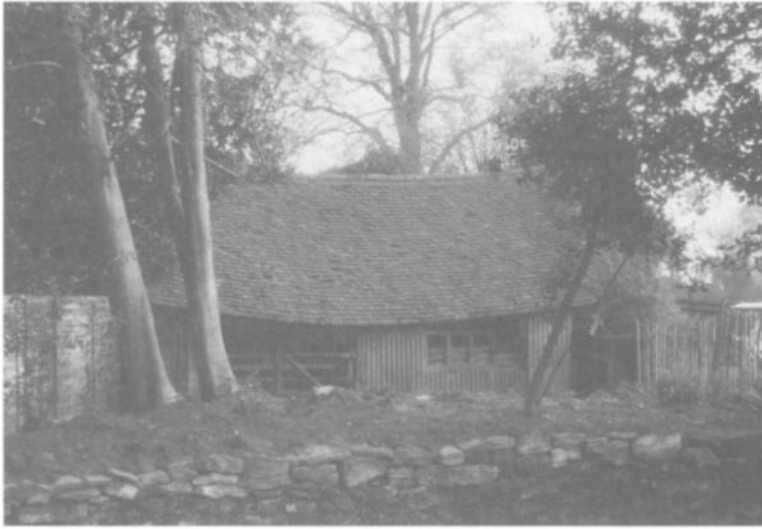
**Fig. 13.9.** General sagging and distortion of a roof structure. This may be due to overloading or failure of the structure. (K.Bright.)

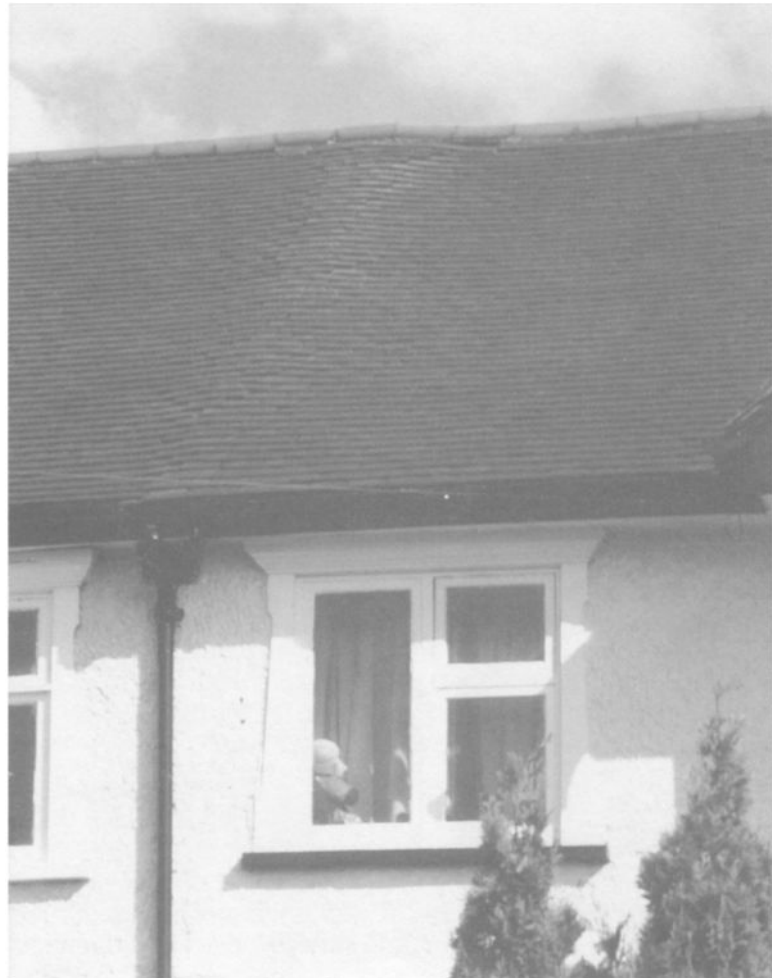
**Fig. 13.10.** Distortion of roof coverings over a party wall caused by differential movement of the main roof areas. (K.Bright).

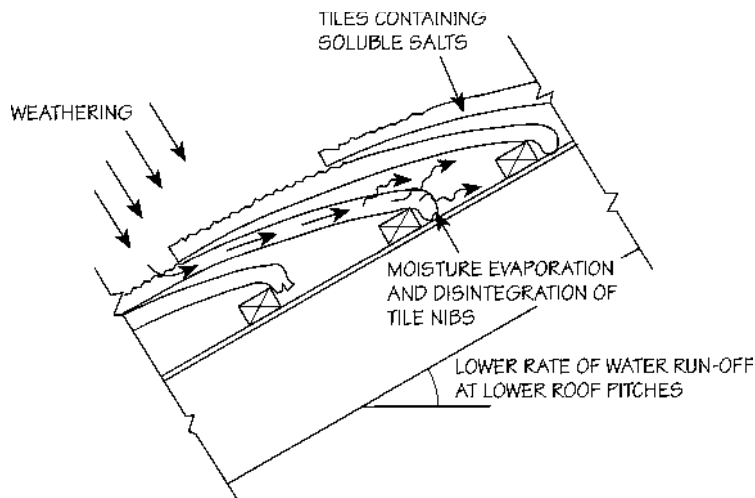
**Fig. 13.11.**  
Disintegration of tile nibs.

and lowering the frost resistance. This leaching out can occur in that part of the tile which is protected by overlapping tiles. Although normally a deficiency of relatively few tiles in a batch, this can cause the disintegration of tile nibs.

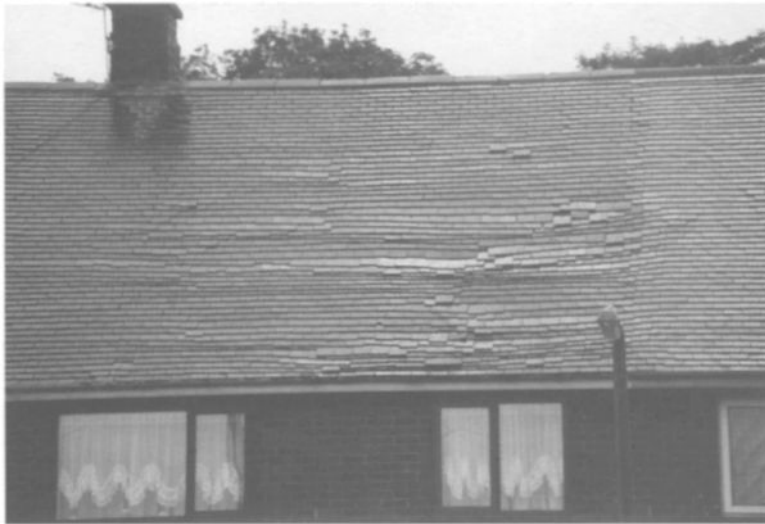
**Fig. 13.12.** General slippage of roof tiles due to nib and nail failure. (D.McGlynn.)

Tiles and slates can be blown off roofs when not nailed. This can also occur where there is a reliance on the tile nib over the batten to retain the tile. The nibs on clay and concrete tiles can crack off where the clay is brittle owing to ageing. A small tile or slate lap will mean that there is less mass to resist the effects of wind action. Since laps are generally smaller on steeply pitched roofs, and more of the roof surface is likely to be in regions of negative pressure under wind action, this is more likely to occur on steeply pitched roofs.

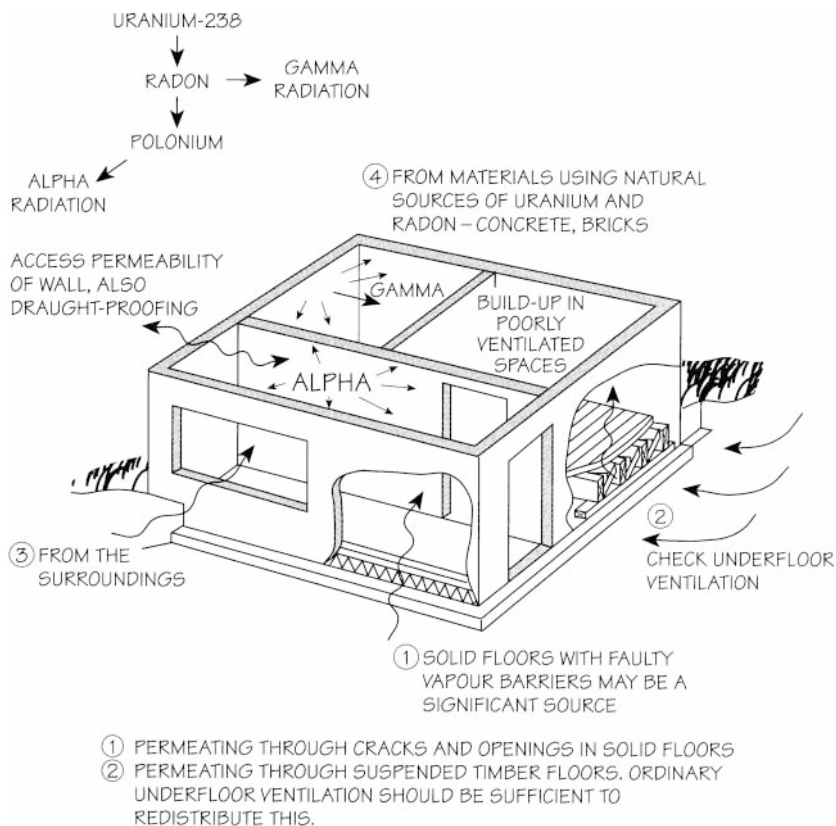
Factors which will increase the risk are floors to houses which have no barrier to the radon gas, exacerbated by any features of design or use that minimize

**Fig. 14.1.** Sources of radon.

the ventilation rate. Common examples include insulated walls, which have a reduced permeability, and also draught-proofed openings or double glazing. Dense concrete floors with a low vapour permeability or floors with effective vapour barriers should be of minimal agency to radon transmission, but this will be affected by any cracks and openings in the floor slab. Consequently, it can become the biggest single source. The external background levels in the air will also mean that some gas will be introduced into houses which themselves are not contributory sources.

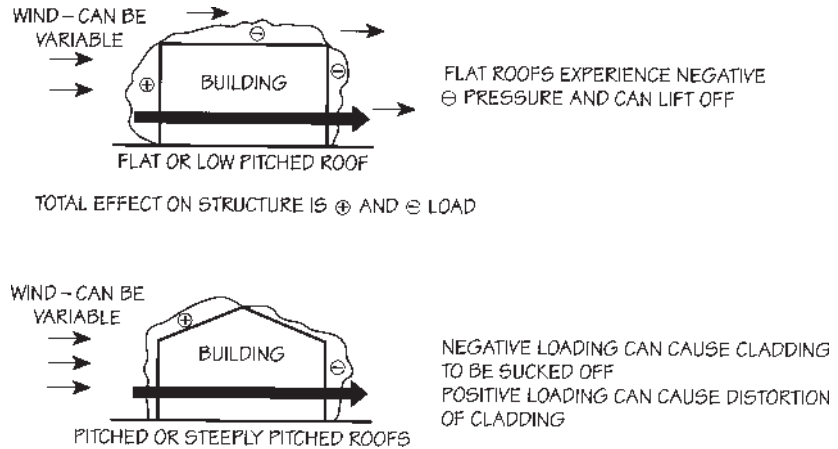
The prevailing wind is from a south-westerly direction, although the geographical location will determine the intensity of wind loading. Local features around the buildings can vary considerably, making it difficult to generalize about windy environments. Hill tops are generally windy whereas built-up areas tend to slow down the wind. A failure to recognize the influence of local features may create problems.

**Fig. 16.1.** General wind effects.

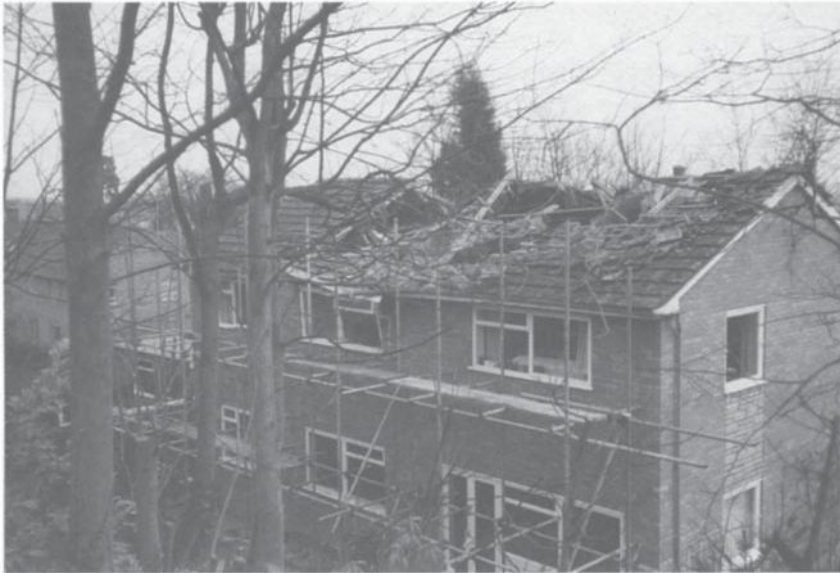
**Fig. 16.2.** Damage caused by a tree blown over in high winds. Although the roof structure has absorbed most of the impact, there is a need to inspect for any other structural damage. (Jack Hinks.)
